**FIELD, LABORATORY, AND ANALYTICAL INVESTIGATION OF
ANGLES-WITH-PLATE RETROFIT FOR DISTORTION-INDUCED
FATIGUE IN STEEL BRIDGES**

Submitted to the graduate degree program in
Civil, Environmental, and Architectural Engineering
and the Graduate Faculty of the University of Kansas
in partial fulfillment of the requirements for the degree of
Doctor of Philosophy.

Prior to the mid-1980s, steel girder bridges were designed with a detail susceptible to distortion-induced fatigue cracking. While a number of retrofit measures have been developed to repair this problem, many of those retrofits have long-term performance issues or are difficult and expensive to implement. Recent research at the University of Kansas has focused on the development of a new retrofit measure that could be effective in repairing distortion-induced fatigue cracking while also being inexpensive and easier to install than currently available retrofits. This new retrofit measure, referred to as the “angles-with-plate” retrofit, stiffens the problematic region and redistributes distortion-induced fatigue stresses away from cracking prone areas. By eliminating the need for cumbersome installation procedures, the angle

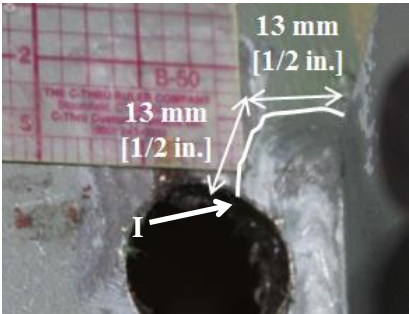
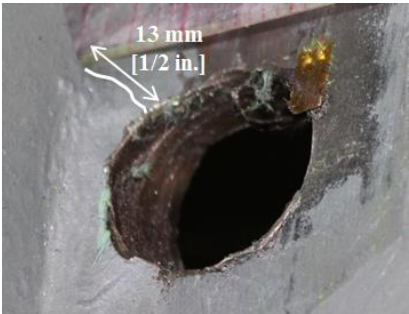
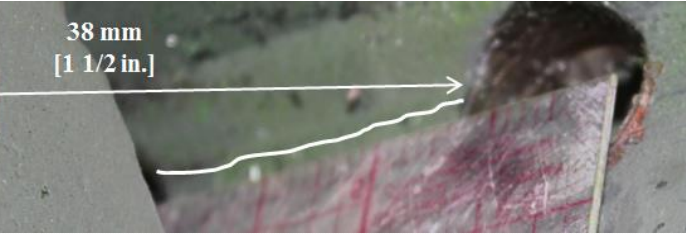
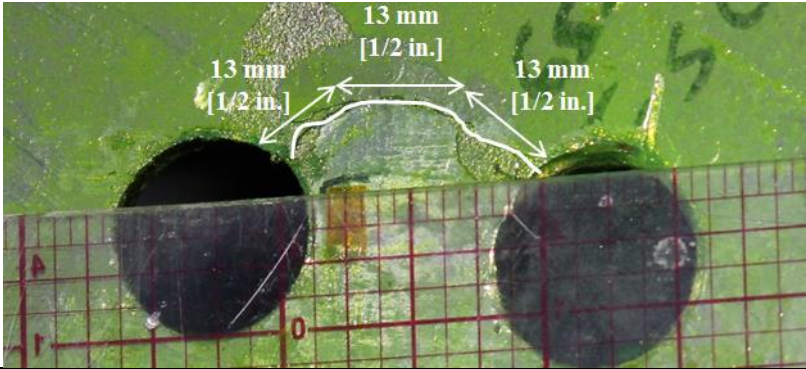
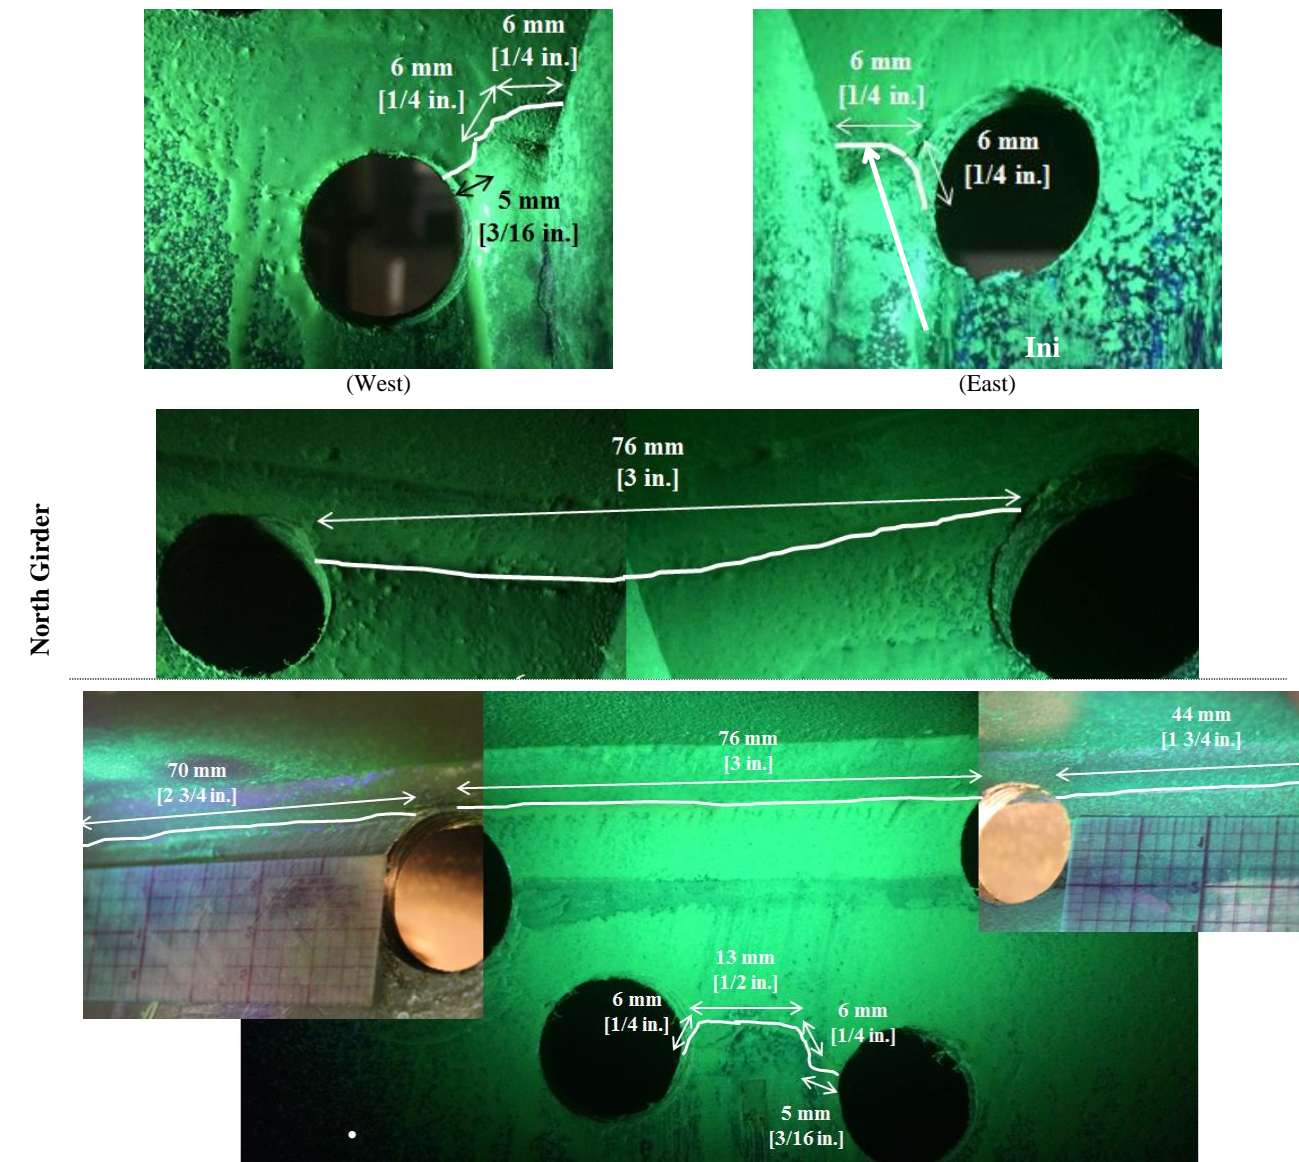
Table 6: Cracking at End of Trial 2.7 (4,016,092 Cycles)

During Trial 2.1S, a longitudinal crack at the flange-web weld was found in the top web gap of the south girder, directly above the connection plate. This crack did not propagate until initiation of the crack near the clip in the transverse connection plate, also in Trial 2.1S. The longitudinal crack propagated along the flange-web weld, while the connection plate-web weld progressed around and down each side of the weld toe. The connection plate-web weld cracks in

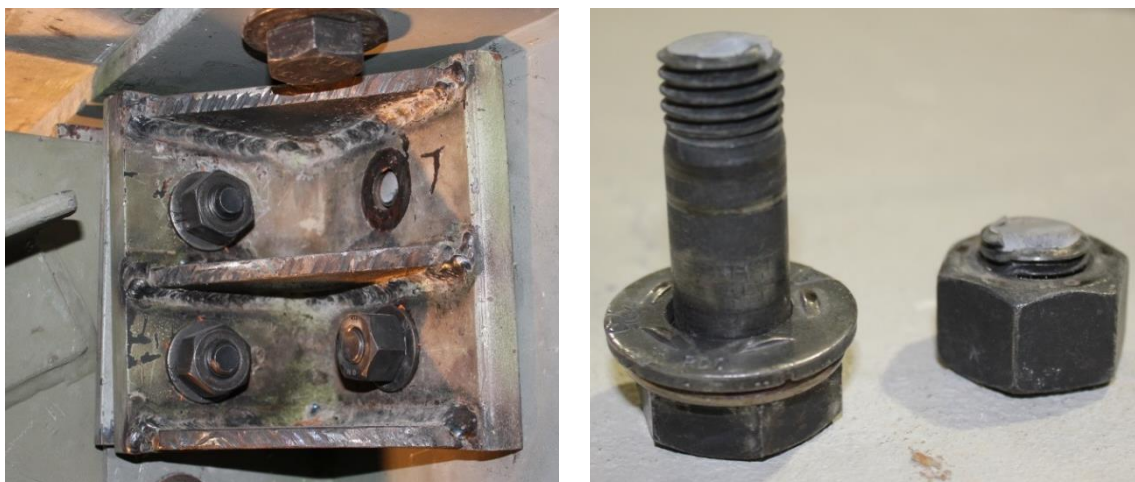
The stiffened version of the angles-with-plate retrofit was applied at the beginning of Trial 2.2N. Trial 2.2N reached 1.2 million cycles, after which no crack propagation was visually detected in the north girder. Trial 2.3N also reached 1.2 million cycles. However, upon removal of the retrofit at the end of Trial 2.3N, it was found that the top bolt connecting the east angle to the backing plate had failed in tension, as seen in Figure 15. Upon inspection, the crack at the connection plate-web weld had propagated 6 mm [1/4 in.] down the left (west) side of the weld and out into the web in the form of a spider crack 5 mm [3/16 in.]. The connection plate-web weld crack and spider crack were also visible on the fascia side of the girder. A 76 mm [3 in.] longitudinal crack was also found at the flange-web weld on the fascia side of the north girder's web at the end of Trial 2.3N.

A finite element study of the 9.1 m [30 ft.] test bridge was performed to study the effect that the failed bolt may have had on crack growth. Findings from this study can be found in Appendix D. Based on comparisons of stress demand in models that represented the bridge with an intact retrofit and another with the version of the retrofit with a failed bolt, development of the flange-web weld longitudinal crack and propagation of the connection plate-web weld crack under the retrofit were likely due to loss of stiffness from the failed bolt.

Figure 15: Broken bolt at the end of Trial 2.3N.

Crack-arrest holes with a 19 mm [3/4 in.] diameter were drilled at the crack tips at the start of Trial 2.4N. Due to the crack growth that occurred during Trial 2.3N, the retrofit was removed and the north girder was inspected 100,000 cycles into Trial 2.4N. No crack growth was detected and the trial was continued an additional 500,000 cycles. At this point, the retrofit was removed and the north girder was inspected again. The crack at the connection plate-web weld had propagated 6 mm [1/4 in.] down the right (east) side of the weld and was visible on both sides of the web. A 19 mm [3/4 in.] diameter crack-arrest hole was drilled at the crack tip and cyclic loading continued. Due to factors explained in the following paragraph, this was marked as the end of the trial. Therefore, Trial 2.4N reached a total of 600,000 cycles.

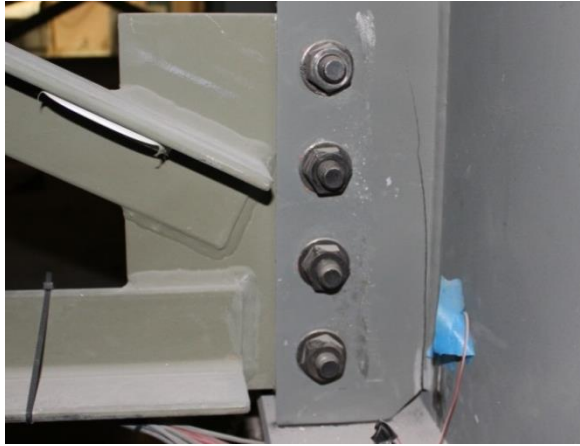
360,000 cycles into Trial 2.5N, a loud “thunking” sound was heard when removing load at the end of a testing cycle. Upon inspection, a large crack was found in the cross frame connection plate at the south face of the center girder, as shown in Figure 16. It appeared that the crack initiated at the weld toe where the connection plate framed into the center girder web and then propagated through the connection plate. No crack in the connection plate had been detected at the end of Trial 2.4N. Due to this, the 360,000 cycles that ran after the end of Trial 2.4N and before detection of the connection plate crack was deemed Trial 2.5N. The stiffened version of the angles-with-plate retrofit was removed and the north girder was inspected. No visible crack progression was seen past the crack-arrest holes in the top web gap, but the longitudinal flange-web weld crack did propagate through the web on the stiffener side of the girder.

Figure 16: Crack found in cross frame connection plate at the south face of the center girder.

The connection plate failure was repaired using four 25 mm [1 in.] thick angles. Two angles were placed back-to-back on both sides of the connection plate and bolted through the center girder web to another pair of back-to-back angles. The four-angle repair is shown in Figure 17.

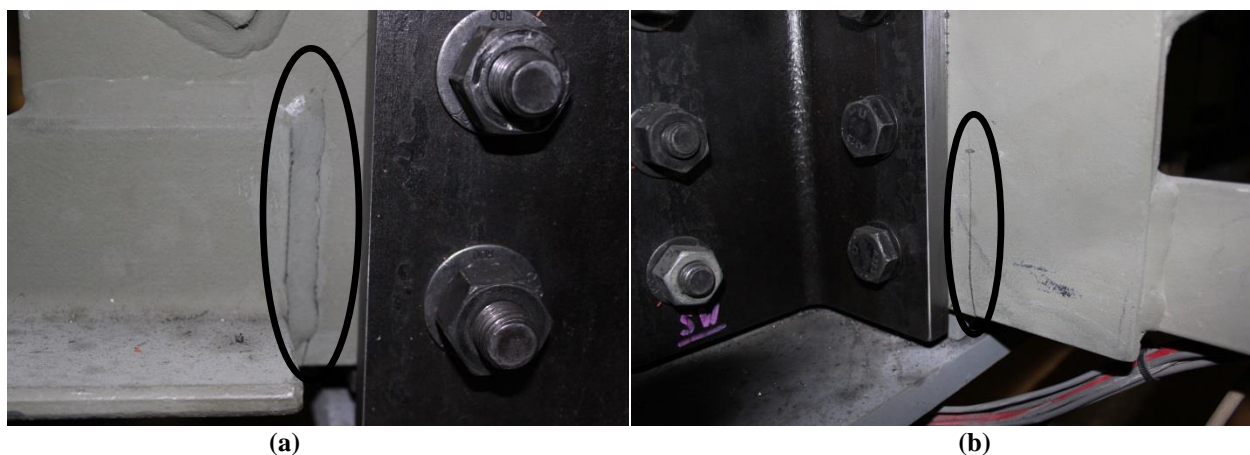
After the connection plate on the center girder was repaired, Trial 2.6N was performed. This trial reached only 181,092 cycles due to another failure at the cross frame connection, which occurred just outside the repaired failure from the previous trial. This failure, as shown in Figure 18, occurred in the tab plate where the bottom cross frame member (HB) framed into the tab plate near the south face of the center girder. It is estimated that the four-angle repair stiffened the weakened area, and thus moved the failure just outside the stiffened area to a more flexible region. After this failure occurred, the stiffened version of the angles-with-plate retrofit was removed and the north girder was inspected. No visible crack progression was detected.

Figure 18: South cross frame tab plate failure from (a) east and (b) west side of cross frame.

The cracked cross frame was repaired and replaced with a cross frame from the bridge support region, which had seen less demanding loading throughout its service life, and Trial 2.7N was performed. After each set of cyclic loading, visual inspections were performed to check for cracking in the cross frames and to inspect the bolts in the retrofit. After 425,000 cycles, it was found that the top bolt connecting the east angle to the backing plate had failed in tension in a very similar manner to that shown in Figure 15.

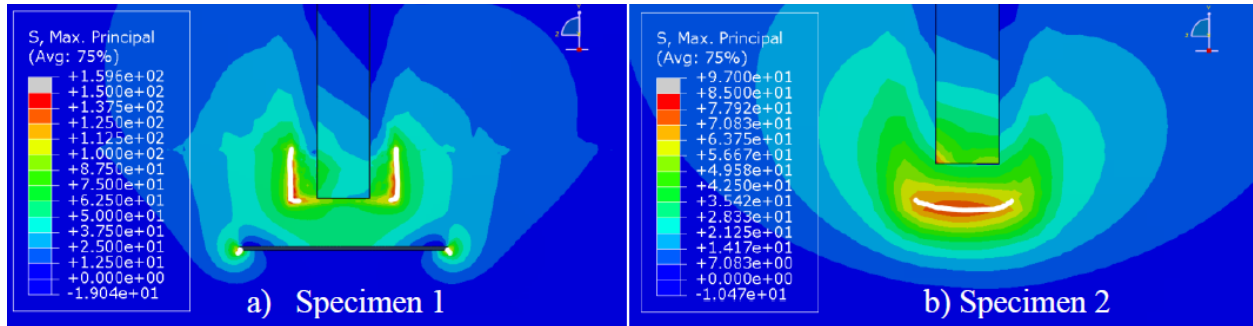
Traditionally, in-plane fatigue is classified using nominal stresses; however, the three-dimensional stress state in the web gap region cannot accurately be captured using only nominal bending stress. To capture both normal and out-of-plane stresses, maximum principle stresses were extracted from the models. Richardson (2012) and Nagati (2012) found that crack growth closely followed maximum principal hot spot as shown in Figure 5. White lines superimposed on the stress contours in Figure 5 denote crack growth seen experimentally.

Figure 5: Cracking and maximum principal hot spot stresses (Nagati 2012).

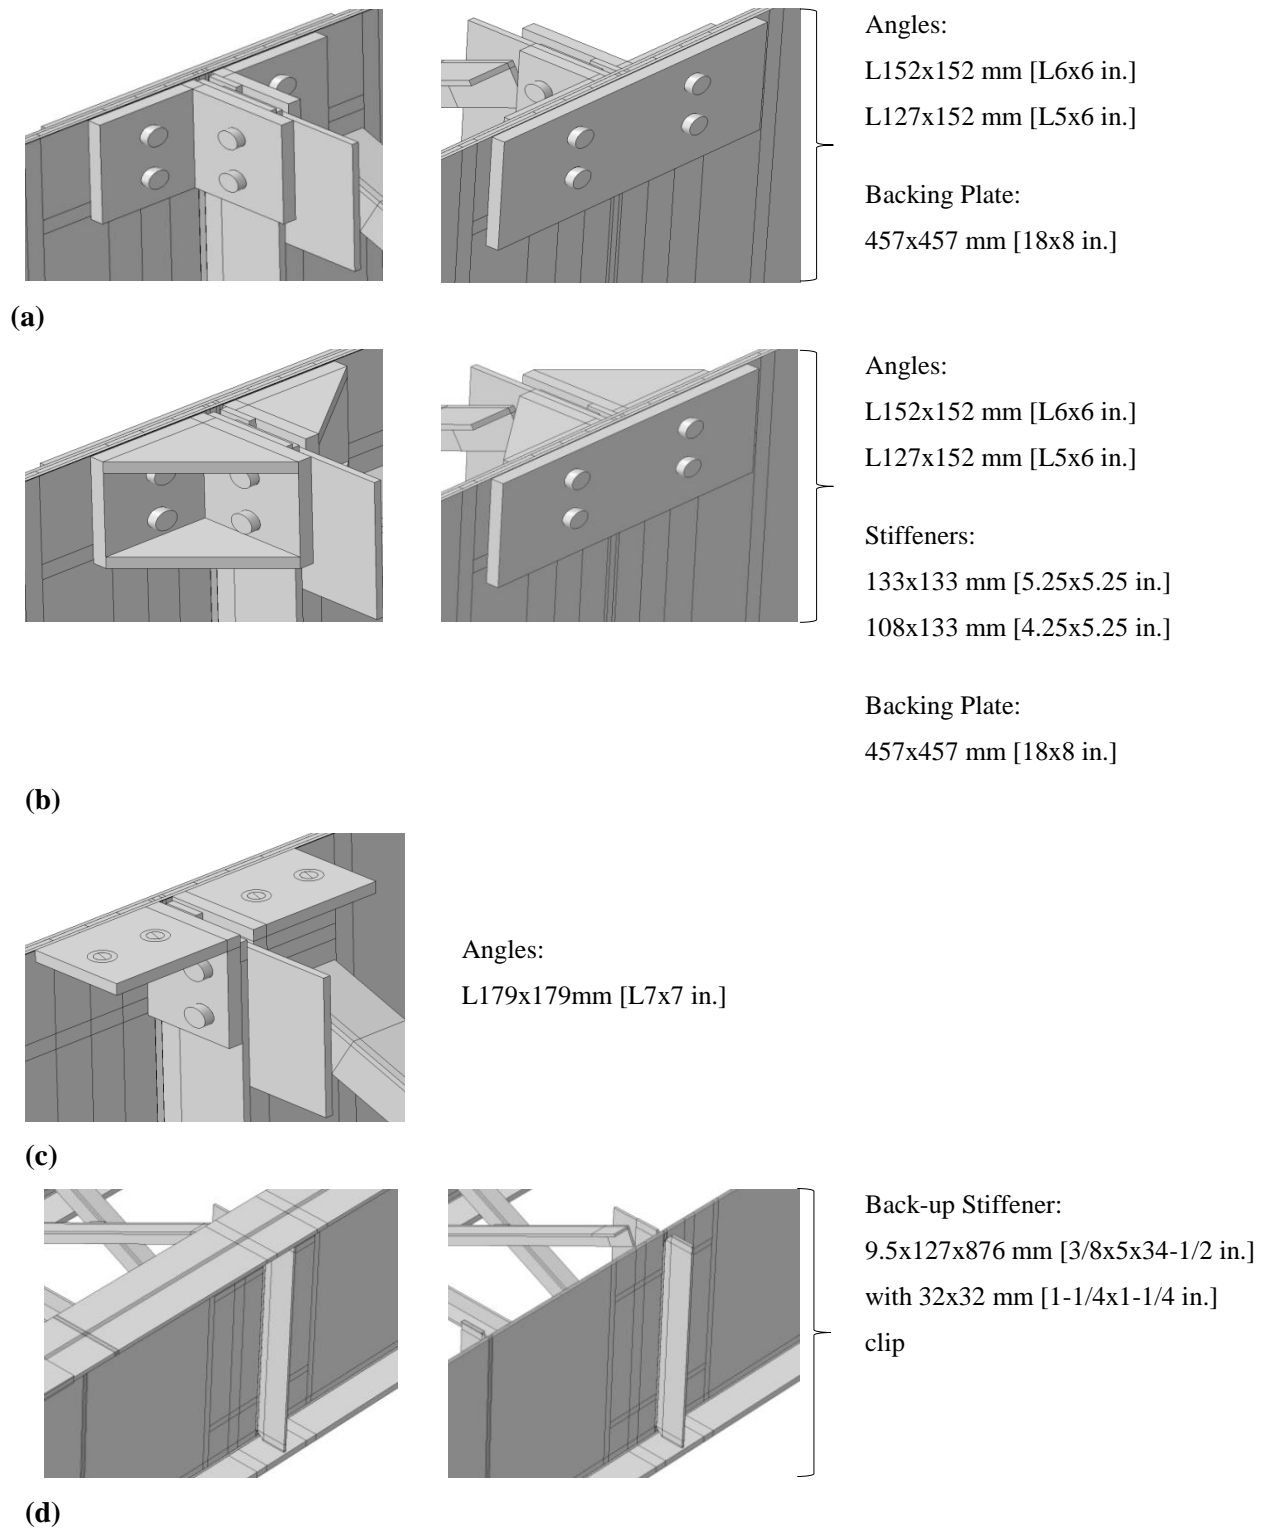
Figure 7: Views of various retrofits examined in finite element models: (a) angles-with- plate retrofit; (b) stiffened angles-with-plate retrofit; (c) positive attachment between transverse connection stiffener and top flange retrofit; and (d) full depth back-up stiffener bearing on top and bottom flanges.

Three retrofit configurations were investigated in the computational simulations. First, an existing retrofit technique was explored in which positive attachment was provided between the connection plate and top flange using two angles oriented back-to-back. Next, a back-up stiffener technique was studied in which the web gap was stiffened by a secondary stiffener placed on the opposing web face. This retrofit can be applied using either a partial depth or full depth transverse stiffener; however, only a full depth stiffener was studied as it was expected to produce the best result, based upon findings from previous studies (Hassel et. al 2010). Back-up stiffeners were modeled using transverse stiffener dimensions and placed on the girder fascia side. Third, a retrofit in which attachment was provided between the connection plate and web through two angles and a back plate was explored. This last retrofit has been extensively investigated at the University of Kansas and has been termed the “angles-with-plate” technique (Alemdar et al. 2013a; 2013b). Several variations of the angles-with-backing plate retrofit were explored, in which the thickness of the angle and plate elements were varied (with retrofit-to-web ratios of 2 and 3), and one case in which the angles were modified to include internal stiffeners. Schematics of the retrofits studied are shown in Figure 7.

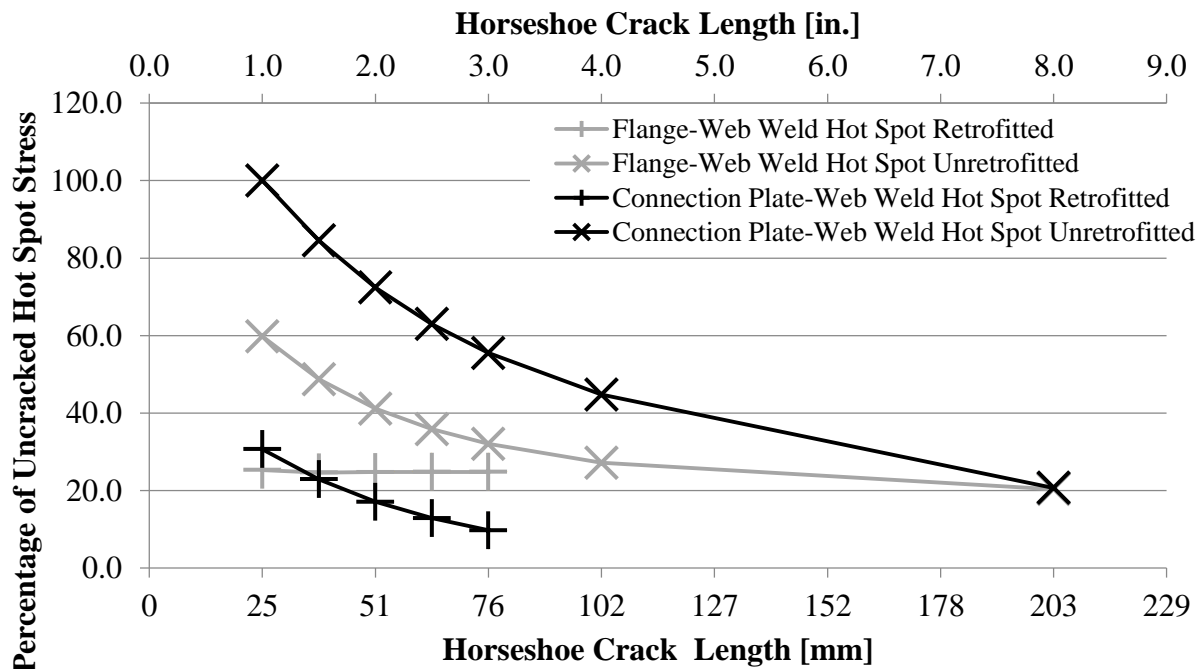
For all horseshoe-shaped crack lengths studied, hot spot stress decreased or remained nearly constant as crack length increased for both retrofitted and unretrofitted conditions. The percentage of uncracked hot spot stress due to change in length of the horseshoe-shaped crack has been presented in Figure 8.

Figure 8: Percentage of uncracked hot spot stresses with change in horseshoe crack length for connection plate-web weld and flange-web weld.

Cracks were physically located at the connection plate-to-web weld toe on the web. For both the unretrofitted and retrofitted conditions, hot spot stress at the connection plate-to-web weld decreased as crack length was increased. At the flange-to-web weld in an unretrofitted state, the hot spot stress decreased as the horseshoe-shaped crack length was increased; however, for the retrofitted condition, hot spot stress remained nearly constant.

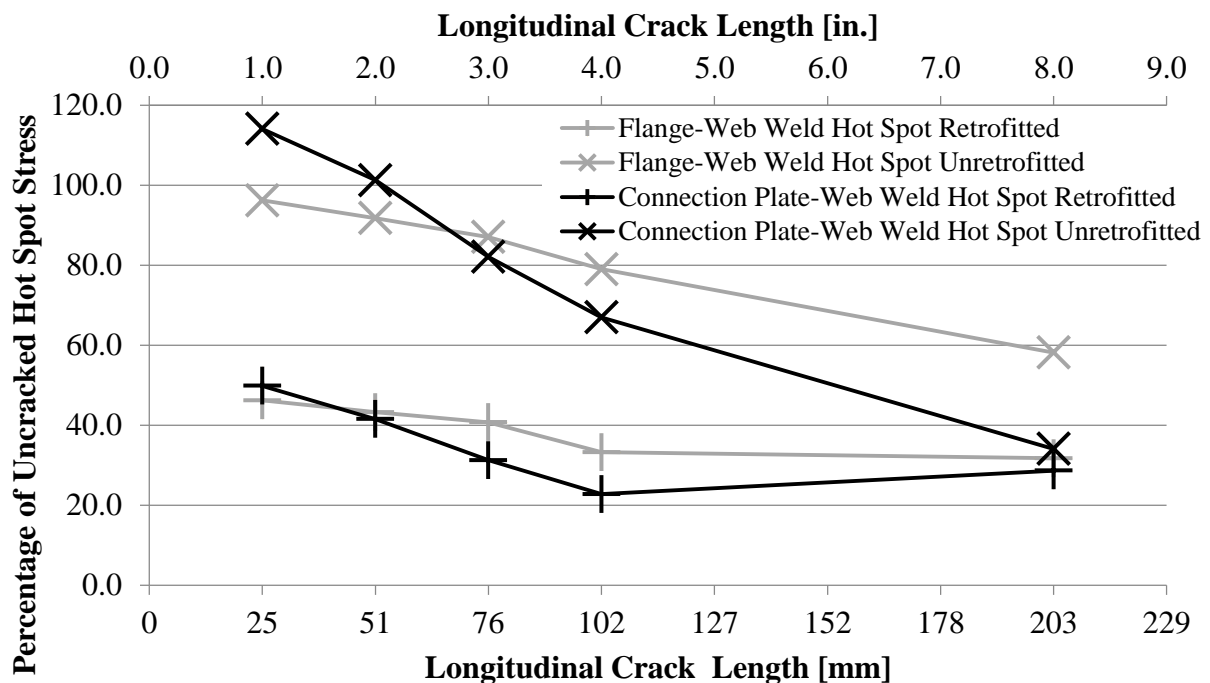
For the longitudinal flange-to-web crack lengths studied, hot spot stress behavior was found to be similar to that for the horseshoe-shaped cracks. As longitudinal crack length was increased, hot spot stresses for both the flange-to-web weld and connection plate-to-web weld decreased as shown in Figure 9. Initiation of a 25 mm [1 in.] longitudinal crack provided little reduction in flange-to-web hot spot stress demand, and increased stress demand at the connection plate-to-web weld by approximately 14%. Since both stresses were normalized to similar uncracked hot spot stresses (within 3% of each other), Figure 9 indicates that once a longitudinal crack initiated, a horseshoe-shaped crack is highly likely to initiate due to increased stresses at the connection plate-to-web weld.

Figure 9: Percentage of uncracked hot spot stresses with change in longitudinal crack length for connection plate-web weld and flange-web weld.

Retrofit effectiveness in the presence of only a longitudinal crack was found to decrease for the connection plate-to-web weld as crack length increased. The reduction in stress from cracked, unretrofitted to cracked, retrofitted for the connection plate-to-web weld was approximately 5% for a 203-mm [8-in.] longitudinal crack and 64% for a 25-mm [1-in.] crack. For the flange-to-web weld location, stress reduction due to retrofitting did not vary greatly with increasing crack length.

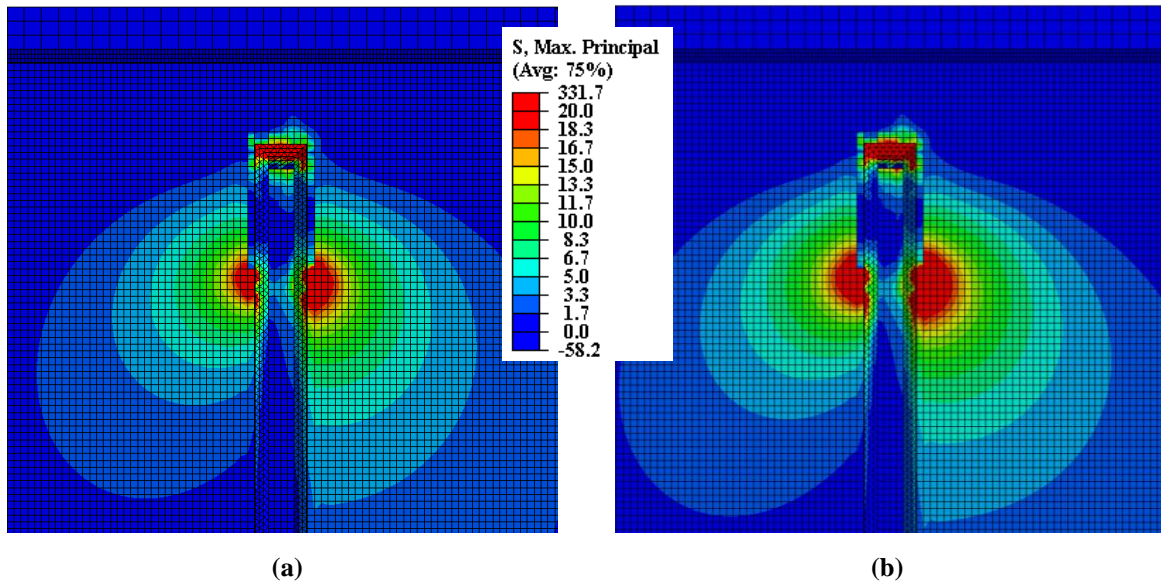
Since cracking should be expected to occur in a concrete deck, reduced deck stiffness was applied to the model to determine the effect of deck stiffness on stress demand in the web gap region. For this condition, only a horseshoe-shaped crack was considered. In both hot spot locations in the top web gap, halving the concrete deck stiffness was found to increase stresses in the web gap region. This increase was approximately 20% of the hot spot stresses computed in a model with full deck stiffness with a horseshoe-shaped crack around the connection plate-to-web weld. Effect of reduced deck stiffness on south girder top web-gap stresses can be seen in Figure 10.

Figure 10: Maximum principal stresses with scale from 0 MPa to 138 MPa [0 ksi to 20 ksi] for (a) unretrofitted model with normal deck stiffness and (b) unretrofitted model with reduced deck stiffness and a 51 mm [2 in.] crack. Legend stresses are in ksi.

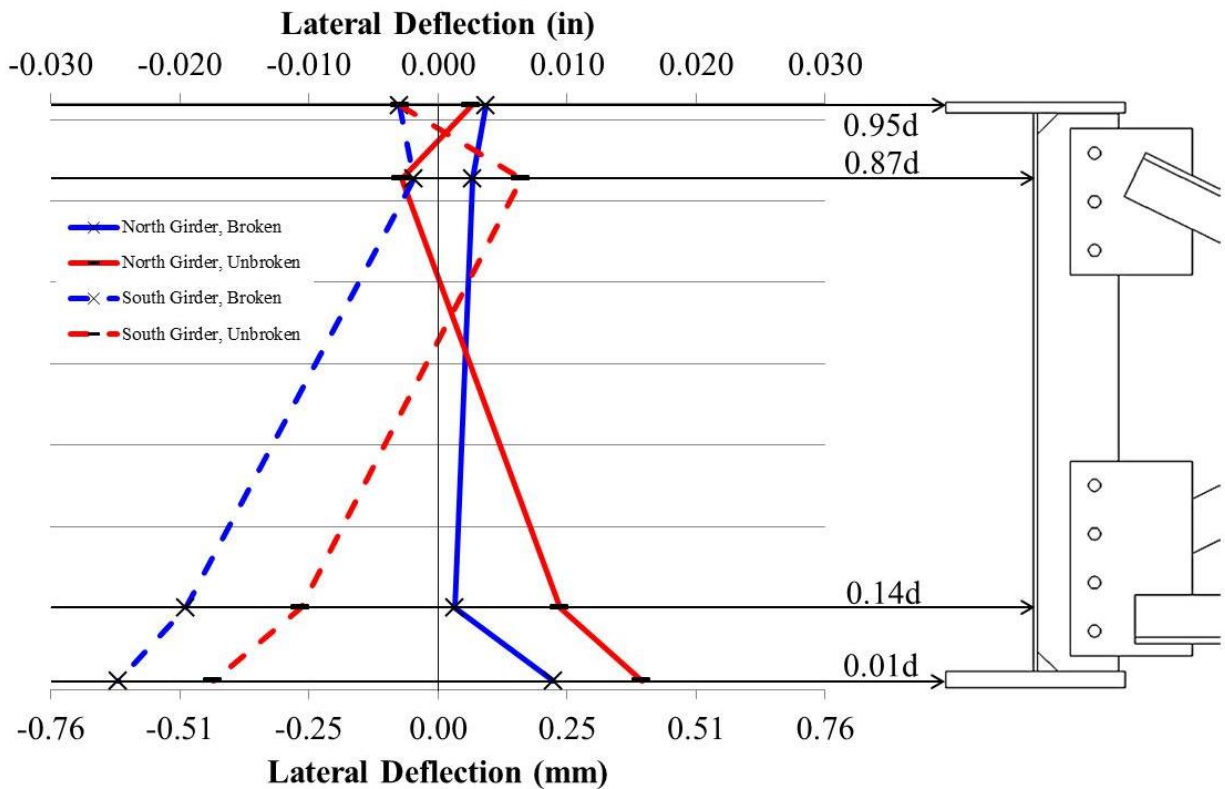
Girder lateral deflections can be seen in Figure 11. Deflections show as if looking at the girder deflection profiles. The north girder bottom flange moves out toward the right (positive deflection in the plot) and the south girder bottom flange moves out toward the left (negative deflection in plot). The response of the north and south girders in the cracked, unretrofitted condition (25 mm [1 in.] horseshoe-shaped crack) and the response of the girders with the same crack geometry under the angles-with-plate retrofit were found to be symmetric. For the north girder (where the cross frame element was broken), lateral girder deflections were decreased after the cross-frame member was severed, resulting in decreased girder rotation between top and bottom flanges. Additionally, top web-gap differential deflection was found to be nearly zero. Different behavior was found to define the south girder after the cross-frame was severed. In the

south girder, top web-gap differential deflection was still decreased, but bottom flange deflection increased, resulting in larger girder rotation between top and bottom flanges.

Figure 11: Girder lateral deflections with unbroken cross frame elements and broken cross frame element framing into the north girder top web-gap.

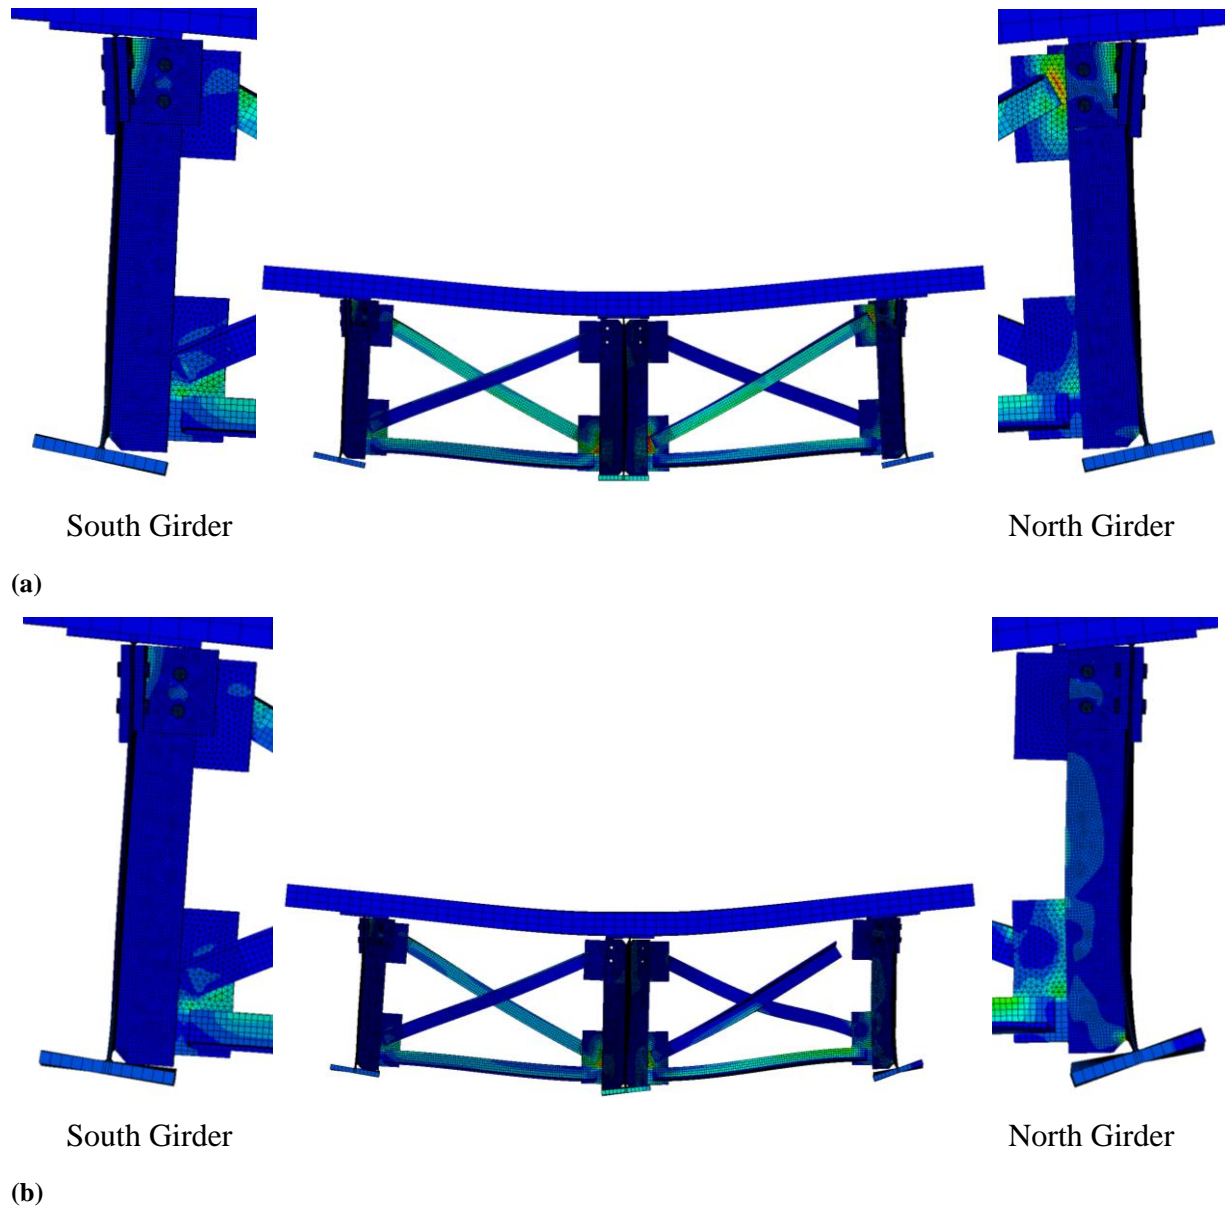
Cross section deflected shapes have been shown in Figure 12. These figures provide images for the results outlined in Figure 11. A localized stress concentration (hot spot) can be seen at the on the tab plate near the end of the inclined cross frame angle as shown in Figure 12(a). Once the cross frame element is broken, little force exists in the tab plate and therefore little out-of-plane forces are transferred into the north girder top web-gap as seen in Figure 12(b). Symmetric bending was found to occur while both cross frames were fully attached; however, deflections were asymmetric under the broken cross frame condition. For the north girder, slightly more flange rotation and less web rotation as shown in Figure 12.

Figure 12: Girder deflection profiles for (a) 25 mm [1 in.] cracked and retrofitted model and (b) 25 mm [1 in.] cracked and retrofitted model with broken north cross frame element.

Hot spot stresses were influenced by the broken north cross frame element framing into the top web-gap. Stresses extracted from finite element models have been presented in Table 3. When the north girder cross frame element framing into the north girder top web-gap was severed, the hot spot stress at the north girder connection plate-to-web weld decreased by more than 50%. In the north girder bottom web-gap, connection plate-to-web weld stress more than doubled. South girder stresses were only slightly affected by the broken north cross frame.

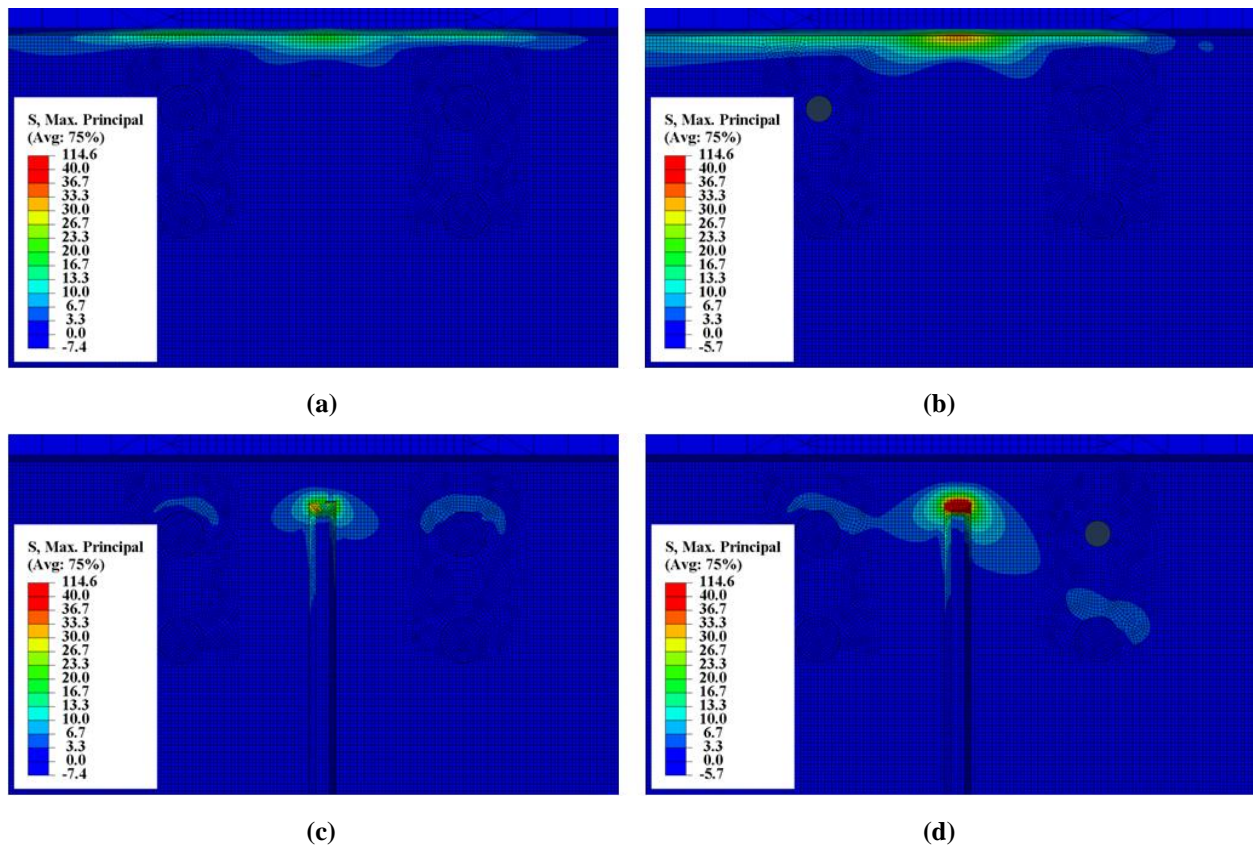
2.3N, cracking conditions were modeled as small crack at the top of the connection plate-to-web weld that had not yet propagated around the toe of the weld. For Trial 2.7N, cracking conditions were modeled as a 25-mm [1-in] horseshoe-shaped crack around the connection plate-to-web weld and 121-mm [4-3/4-in.] longitudinal crack near the flange-to-web weld. Two models for each bolt failure were analyzed, one with a functioning bolt and one without a functioning bolt at the top east corner of the retrofit. The hot spot stresses were compared between the two models to determine if the bolt failure was a major factor in the crack growth seen in the north girder during the corresponding experimental testing of the 9.1-m [30-ft] long test bridge. Results from the models replicating Trials 2.3N and 2.7N are shown in Figure 13 and Figure 14, respectively.

Figure 13: Maximum principal stresses for model replicating Trial 2.3N under the stiffened angles-with-plate repair with (a) functioning bolt, shown from fascia side, (b) missing bolt, shown from fascia side, (c) functioning bolt, shown from stiffener side, and (d) missing bolt, shown from stiffener side. Legend stresses are in ksi.

Table 4. Stresses at the connection plate-to-web weld and the flange-to-web weld increased by 76% and 78%, respectively, after the bolt was removed in the finite element model that replicated Trial 2.3N. Stresses at the flange-to-web weld increased by 54% after the bolt was removed in the finite element model that replicated Trial 2.7N. These increases in stress demands offer a probable explanation as to why large crack growth was recorded in the top web-gap of the north girder under application of the stiffened version of the angles-with-plate retrofit during experimental testing. Loss of stiffness in the retrofit caused by the bolt failure likely led to increases in web-gap stress, thus causing crack growth at the connection plate-to-web weld and flange-to-web weld in Trial 2.3N and at the flange-to-web weld in Trial 2.7N.

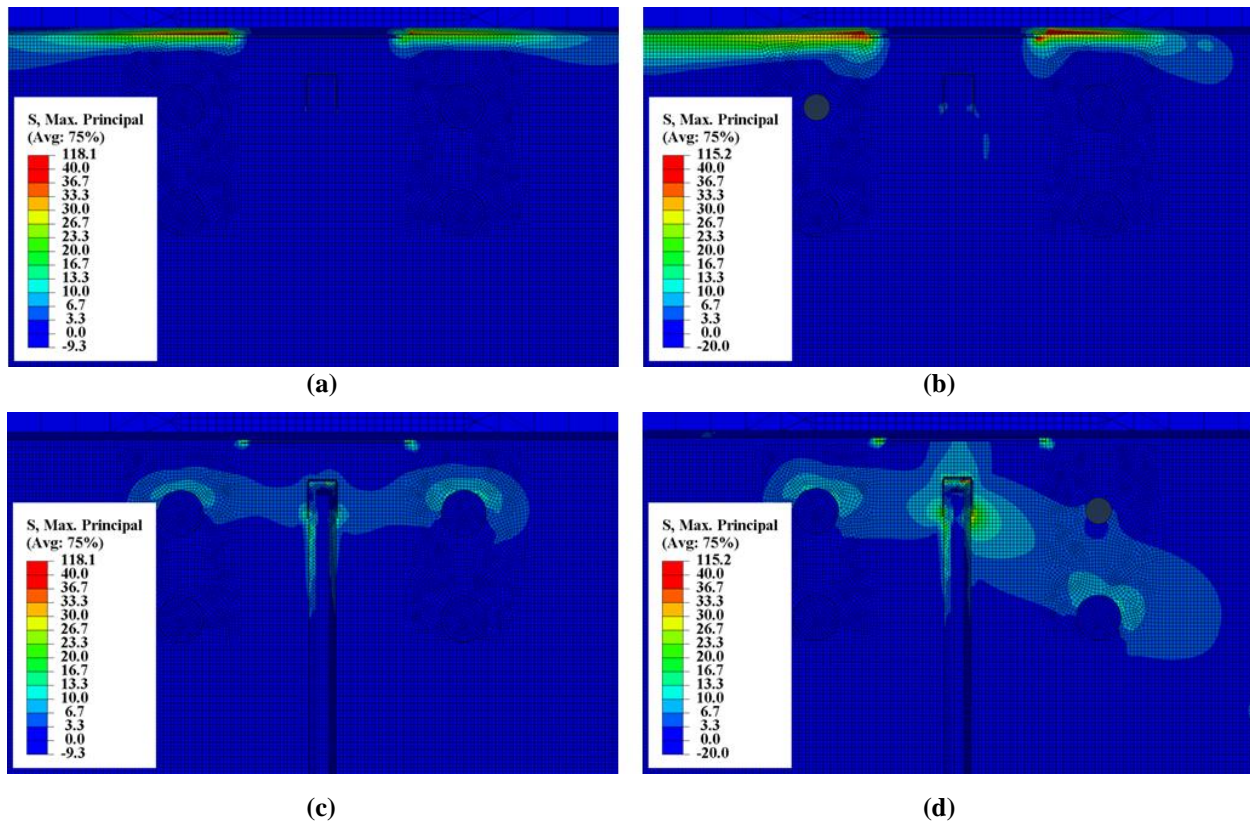
Figure 14: Maximum principal stresses for model replicating Trial 2.7N under the stiffened angles-with-plate repair with (a) functioning bolt, shown from fascia side, (b) missing bolt, shown from fascia side, (c) functioning bolt, shown from stiffener side, and (d) missing bolt, shown from stiffener side. Legend stresses are in ksi.

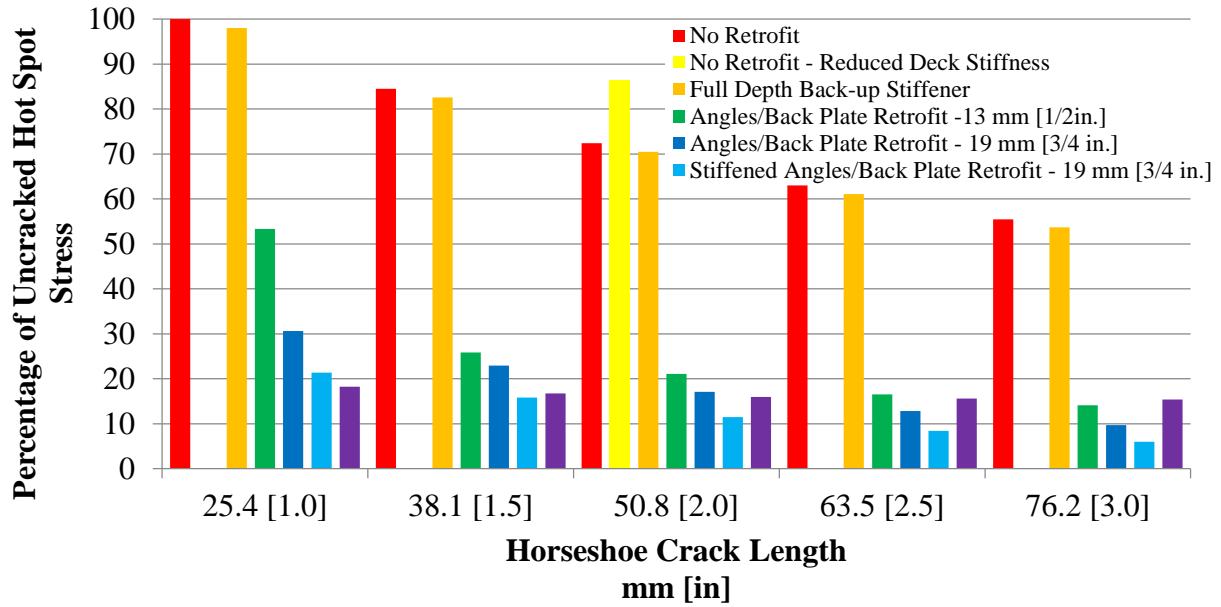
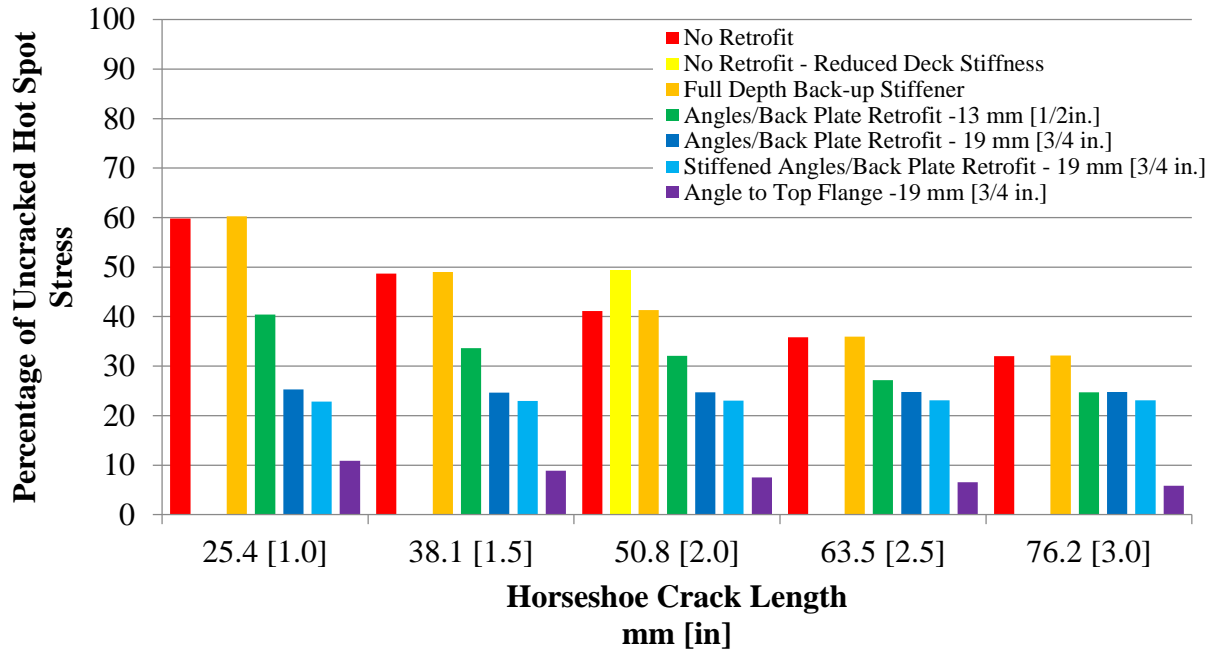
The relative effectiveness of the various retrofits investigated have been presented by showing the stress demands in the web gap region in the retrofitted condition as percentage of the stress demands from the uncracked, unretrofitted condition. All retrofits were analyzed and applied over a horseshoe-shaped crack only. The angles-with-plate retrofit was also analyzed with longitudinal cracks. The percent of uncracked stress in connection plate-to-web weld and flange-to-web weld for changing horseshoe-shaped crack lengths are shown in Figure 15(a) and 13(b), respectively. For all retrofits considered, the pattern of stress reduction was similar for all crack lengths studied. As crack length increased from 25 mm [1 in.] to 76 mm [3 in.], the percent reduction in hot spot stress decreased for both the connection plate-to-web weld and flange-to-web weld locations. As crack length increases, hot spot stresses decrease as shown in Figure 8 and Figure 9. As the retrofit was applied to larger cracks with lower initial stresses, the reduction in stress decreased. Additionally, at a crack length of 76 mm [3 in.], all retrofits provide a reduction in stress of more than 80%. Continuing to improve on this stress (which is already low) becomes inefficient.

Figure 15: Percent of uncracked stress at (a) connection plate-web weld and (b) flange-web weld for various retrofit techniques and crack lengths.

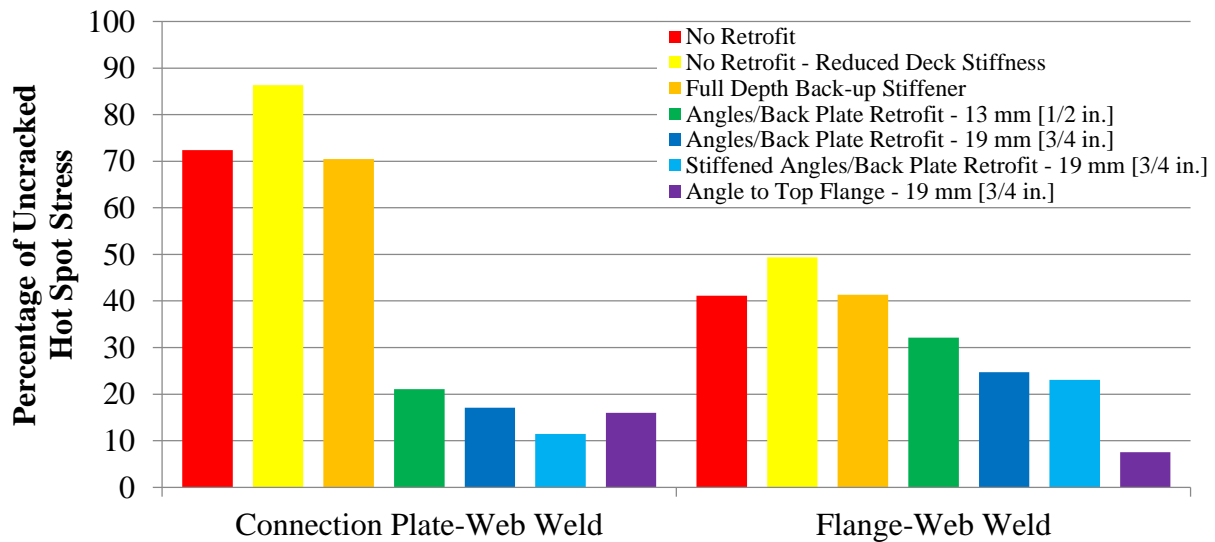
Figure 16: Percentage of uncracked hot spot stresses for connection plate-web weld and flange-web weld with various retrofit conditions and a 51 mm [2 in.] horseshoe crack.

As shown, an initial horseshoe-shaped crack length of 51 mm [2 in.] resulted in a connection plate-web weld hot spot stress of approximately 72% of the uncracked state while flange-web weld hot spot stress was approximately 41% of the uncracked state. Retrofit performance was based on additional reduction from the cracked state. As stated previously, initial uncracked hot spot stresses for each location were within 3% of each other. Therefore, all retrofitted hot spot stresses were normalized against a similar value and can be compared directly. In other words, because of this coincidence, a reduction of 10% in the connection plate-web weld is approximately the same as a 10% reduction in the flange-web weld.

Full depth back-up stiffeners provided minimal relief in hot spot stress for both welds of interest. Since the bridge studied was a non-skewed bridge with cross frames placed back-to-back, this corroborates previous findings (Hartman et. al 2010). Excluding back-up stiffeners, all other retrofits resulted in a reduction of stress demand.

Based on all models studied, the best retrofit for reduction of hot spot stress around the connection plate-web weld was found to be the stiffened angles-with-backing plate. For a 51

mm [2 in.] crack, stiffening the angles resulted in an additional reduction of over 5% when compared with the performance of the unstiffened retrofit; however, adding stiffeners did not greatly improve the stress reduction for the flange-to-web weld. In this location, the additional reduction due to added stiffness was less than 2%.

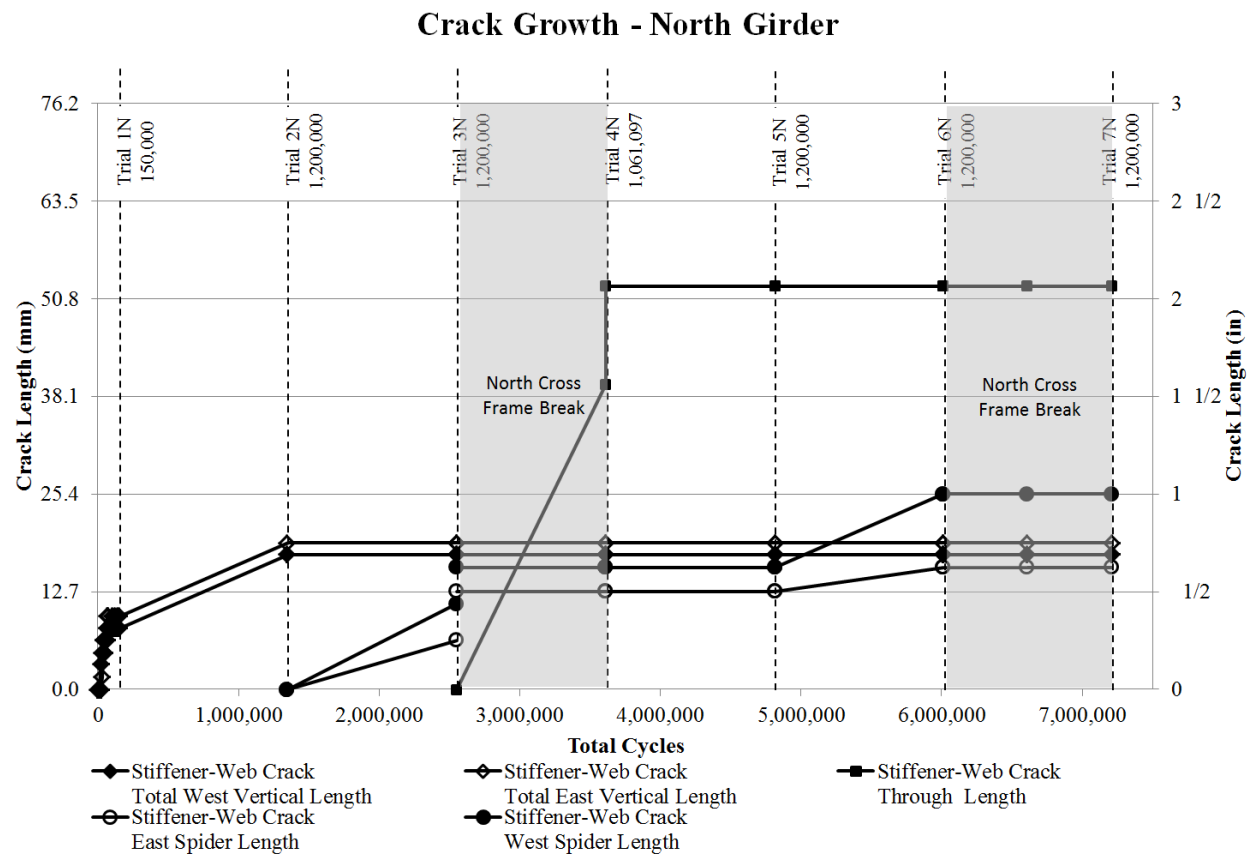
Figure E. 2: North girder crack growth
