**FIELD, LABORATORY, AND ANALYTICAL INVESTIGATION OF
ANGLES-WITH-PLATE RETROFIT FOR DISTORTION-INDUCED
FATIGUE IN STEEL BRIDGES**

Submitted to the graduate degree program in
Civil, Environmental, and Architectural Engineering
and the Graduate Faculty of the University of Kansas
in partial fulfillment of the requirements for the degree of
Doctor of Philosophy.

Prior to the mid-1980s, steel girder bridges were designed with a detail susceptible to distortion-induced fatigue cracking. While a number of retrofit measures have been developed to repair this problem, many of those retrofits have long-term performance issues or are difficult and expensive to implement. Recent research at the University of Kansas has focused on the development of a new retrofit measure that could be effective in repairing distortion-induced fatigue cracking while also being inexpensive and easier to install than currently available retrofits. This new retrofit measure, referred to as the “angles-with-plate” retrofit, stiffens the problematic region and redistributes distortion-induced fatigue stresses away from cracking prone areas. By eliminating the need for cumbersome installation procedures, the angle

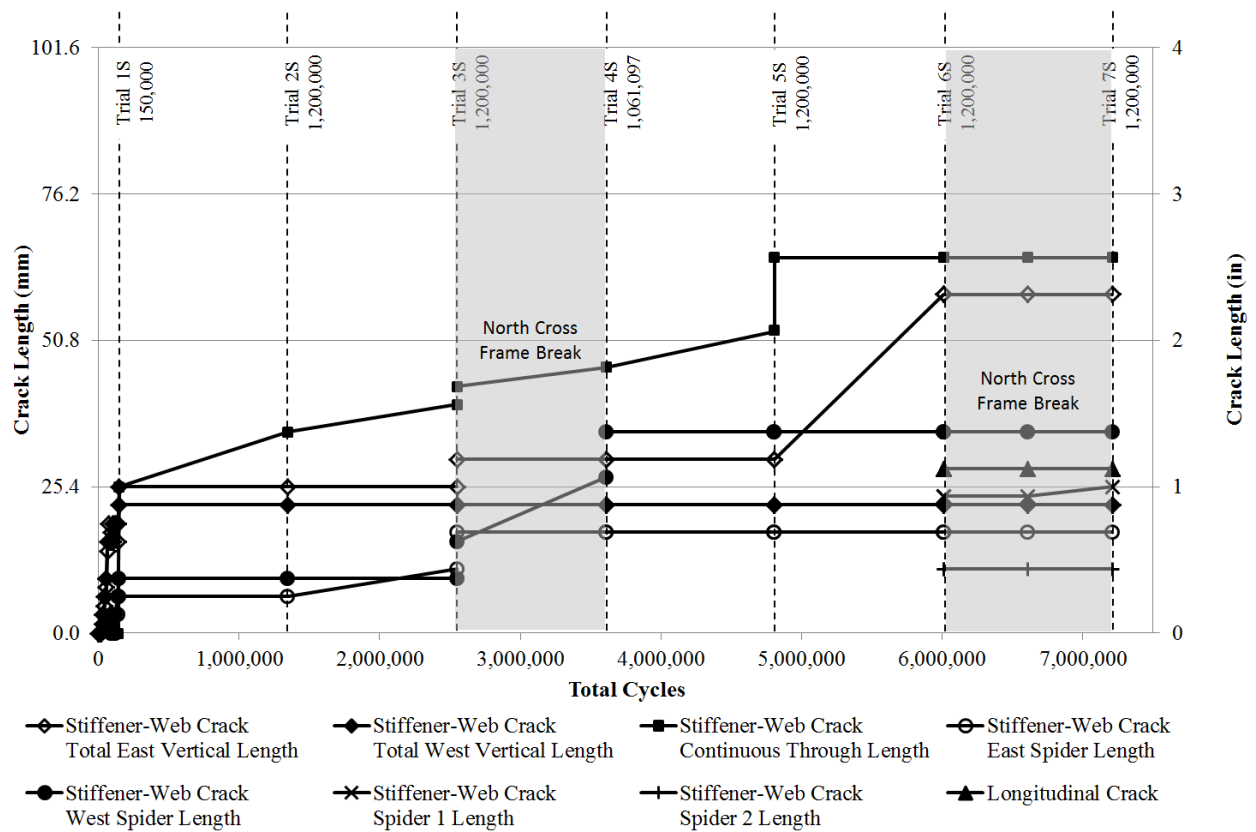
Figure E. 3: South girder crack growth

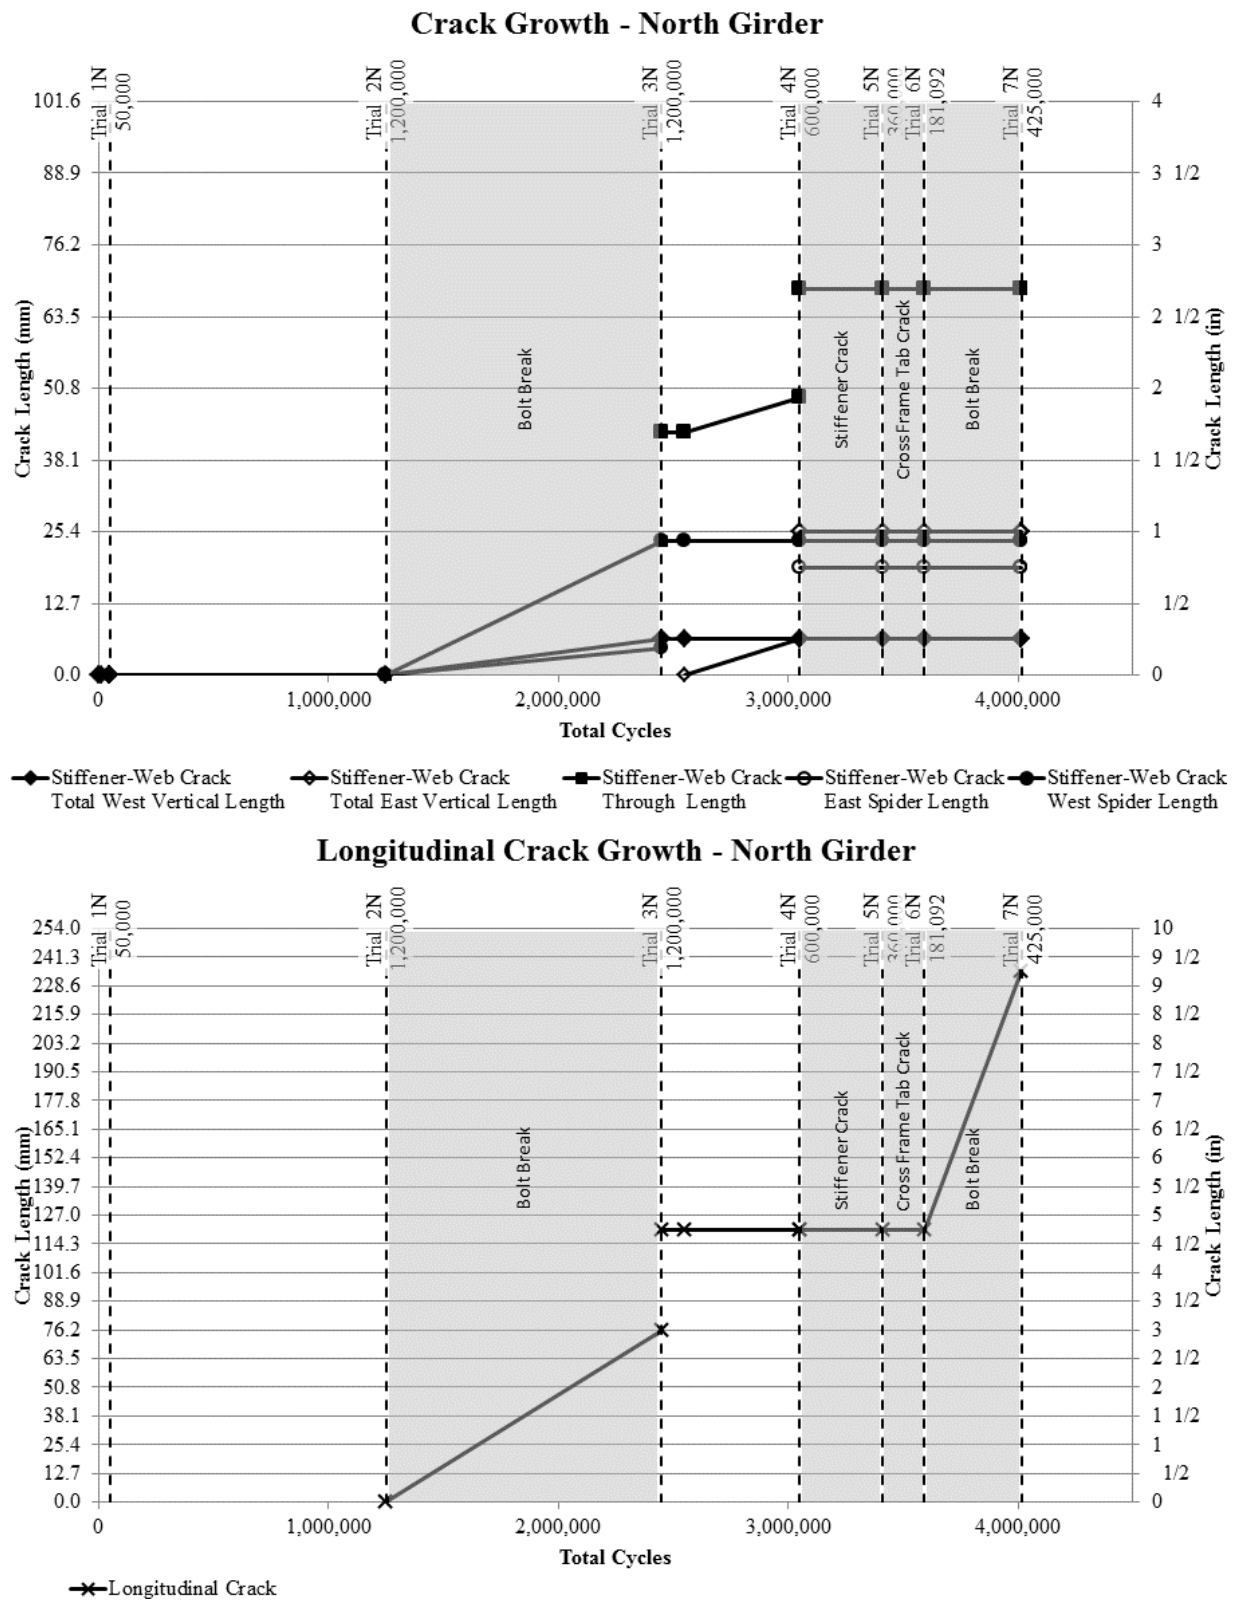
Figure E. 4: North girder crack growth

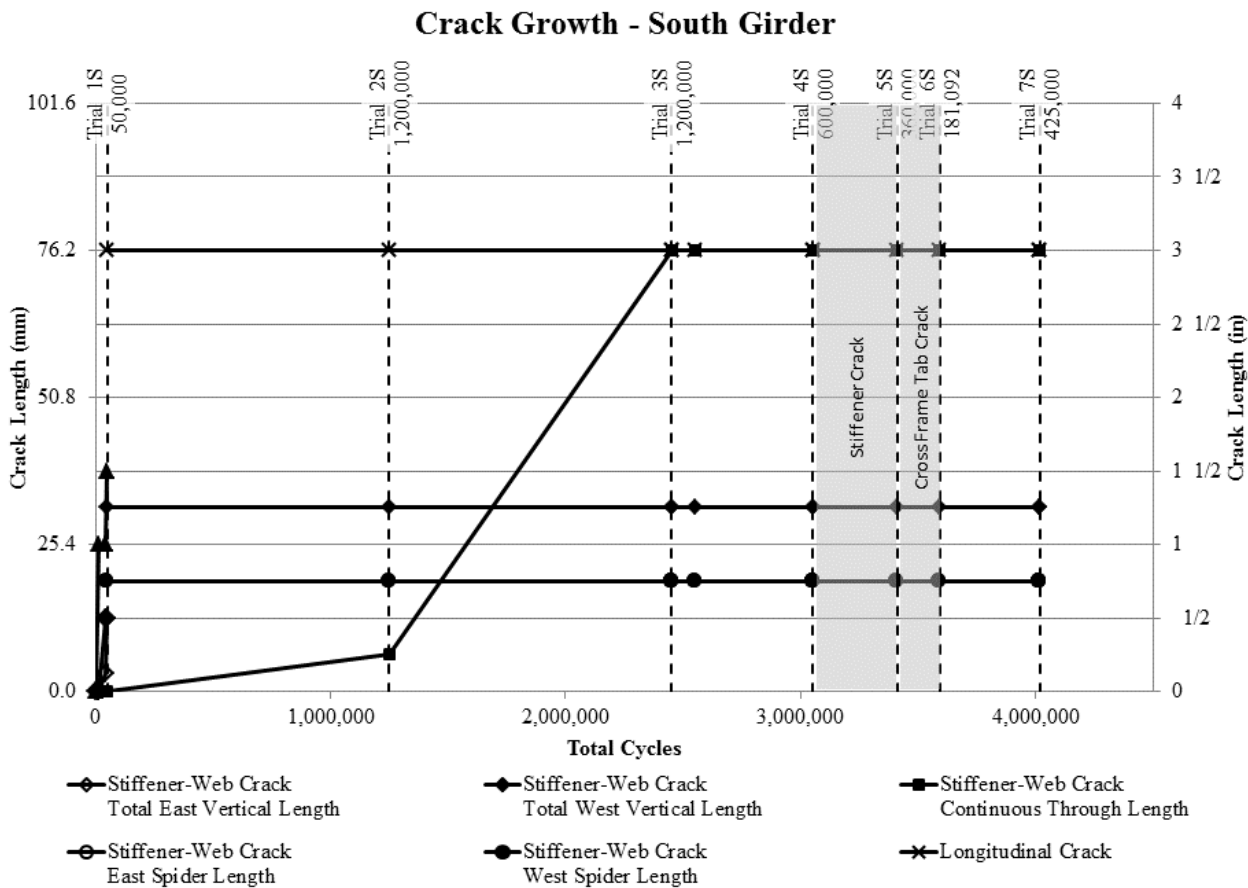
Figure E. 5: South girder crack growth

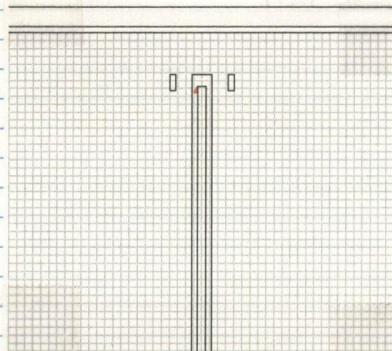
$\frac{1}{8}$ " CRACK IN NORTH GIRDER,
SOUTH FACE, WEST OF
STIFFENER

CRACK IN WELD AT JUNCTURE
BETWEEN WELD AND STIFFENER
PROPAGATING DIAGONAL FROM
CORNER AS SHOWN
CRACK ON OPPOSITE SIDE OF ANGLE
FRAMING IN

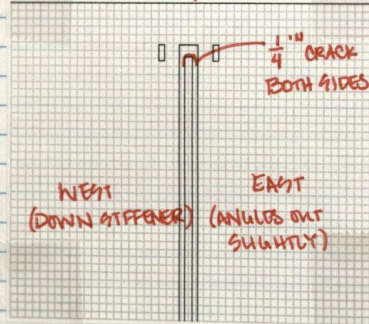
NORTH GIRDER, SOUTH FACE

NO CHANGE IN SOUTH
GIRDER CRACKS09.31.2012
(10:49)09.30.2012
(11:54)

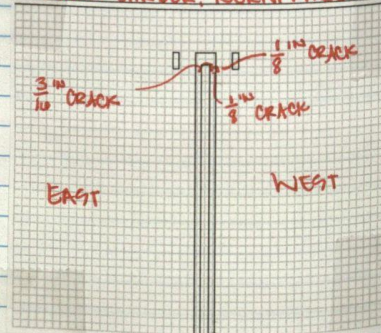
SOUTH GIRDER, NORTH FACE

NO CHANGE IN NORTH
GIRDER CRACKS

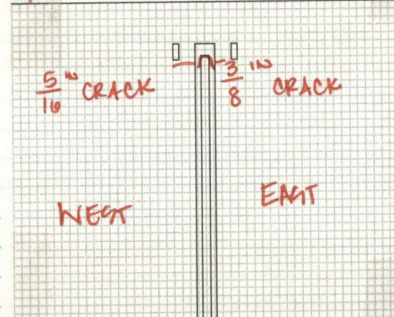
NORTH GIRDER, SOUTH FACE

CRACK

CRACK
(E OF WELD)

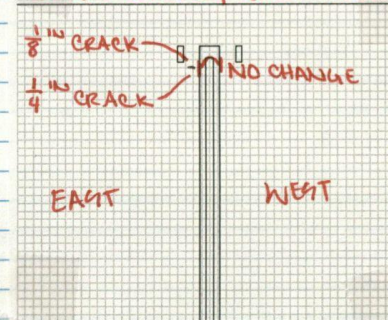
SOUTH GIRDER, NORTH FACE

NO CHANGE IN NORTH
GIRDER CRACKS

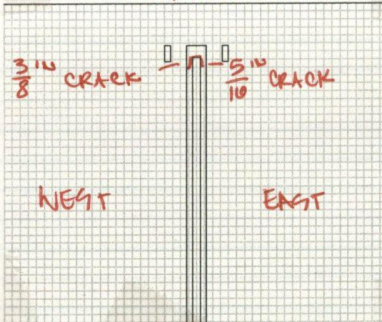
NORTH GIRDER, SOUTH FACE

CRACK

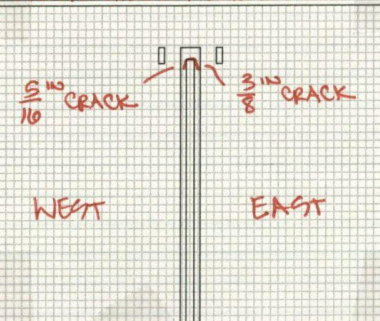
NORTH GIRDER, SOUTH FACE

NO CRACK

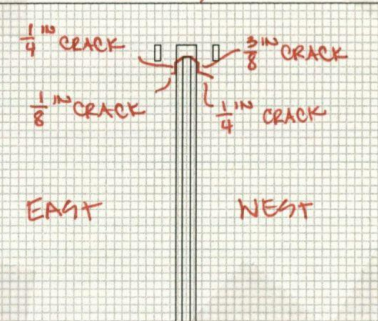
SOUTH GIRDER, NORTH FACE

NO CRACK

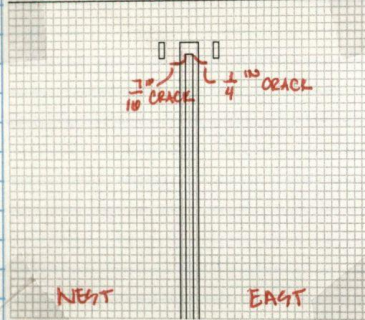
NORTH GIRDER, SOUTH FACE

RETOFIT REMOVEDEDGE OF CRACK AT
EDGE OF CSH

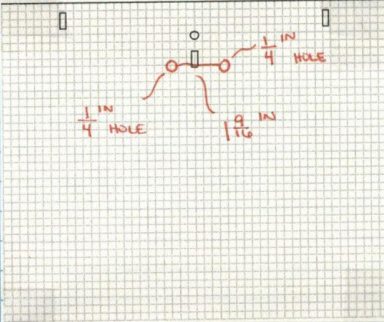
NORTH GIRDER, NORTH FACE

RETROFIT REMOVED

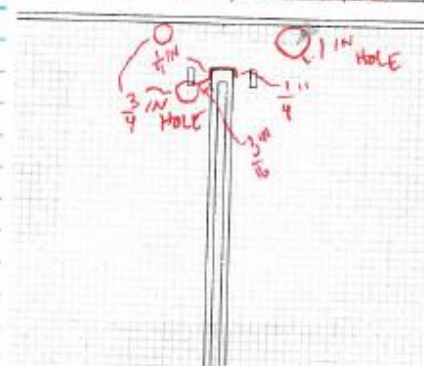
NORTH GIRDER, SOUTH FACE

- GROWTH IN CRACK AT STIFFENER ON SOUTH FACE OF N6 ON EAST SIDE

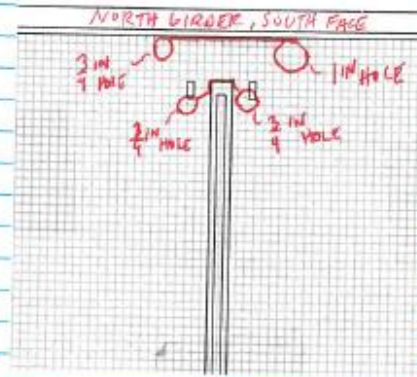
- N6

- CRACK IN TOP FLANGE TO WEB WELD BETWEEN CRACK ARREST HOLES GREW THROUGH ON SOUTH SIDE. NO VISIBLE CRACK GROWTH PAST CRACK ARREST HOLES ON SOUTH OR NORTH FACES

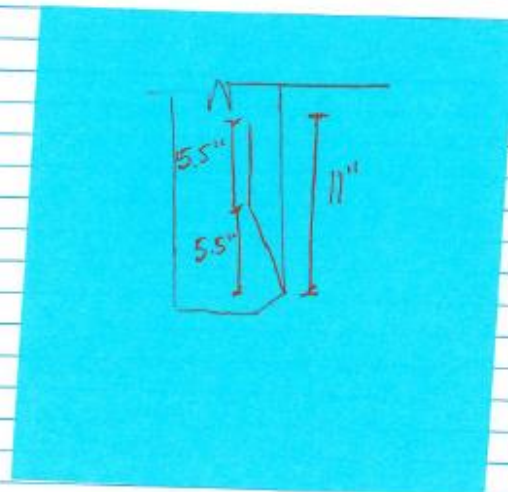
- S6

- NO VISIBLE CRACK GROWTH

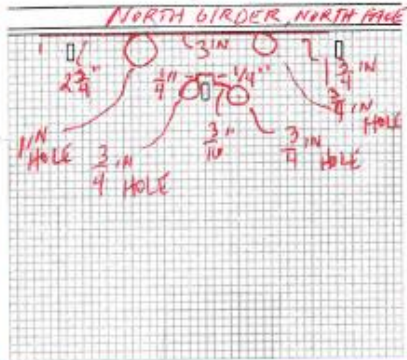
- N6

- CRACK IN TOP FLANGE TO WEB WELD GREW PAST CRACK
ARREST HOLES
