Repair of Distortion-Induced Fatigue Damage in Bridge No. 135-87 (043SB and 044NB) Using Newly-Developed Strengthening Schemes

Structural Engineering and Engineering Materials
SM Report No. 112

September 2015

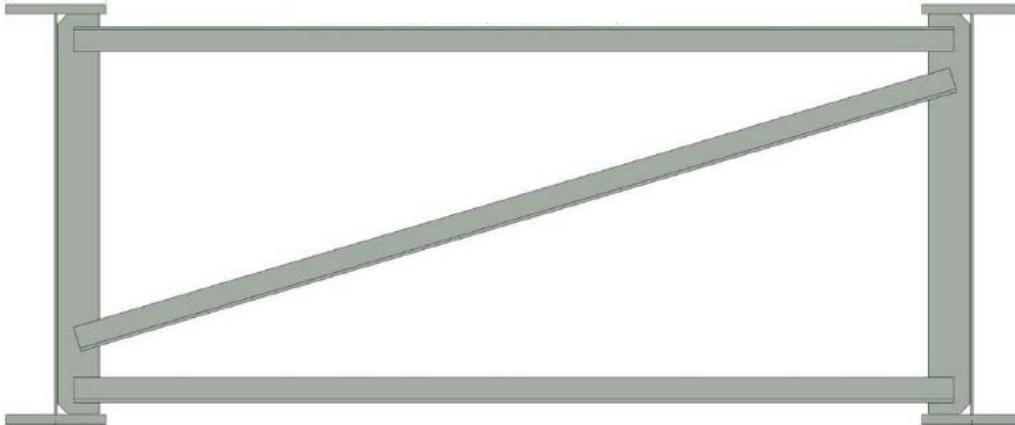
Also, Kansas Bridge 135-87 (043/044) has cross frames with two horizontal cross frame members framing directly into the connection stiffener at the top and bottom web gaps, as shown in Figure 6.

Figure 6: Cross frame geometry of Kansas Bridge 135-87(043/044) (Richardson 2012).

In bridges with cross frame geometry such as this, application of the existing retrofit technique would first require removal of at least the horizontal cross frame members. Similarly, the KDOT-proposed retrofit technique of applying angles at each corner of the cross frame would also require cross frame members to have to be first removed before application (Richardson 2012).

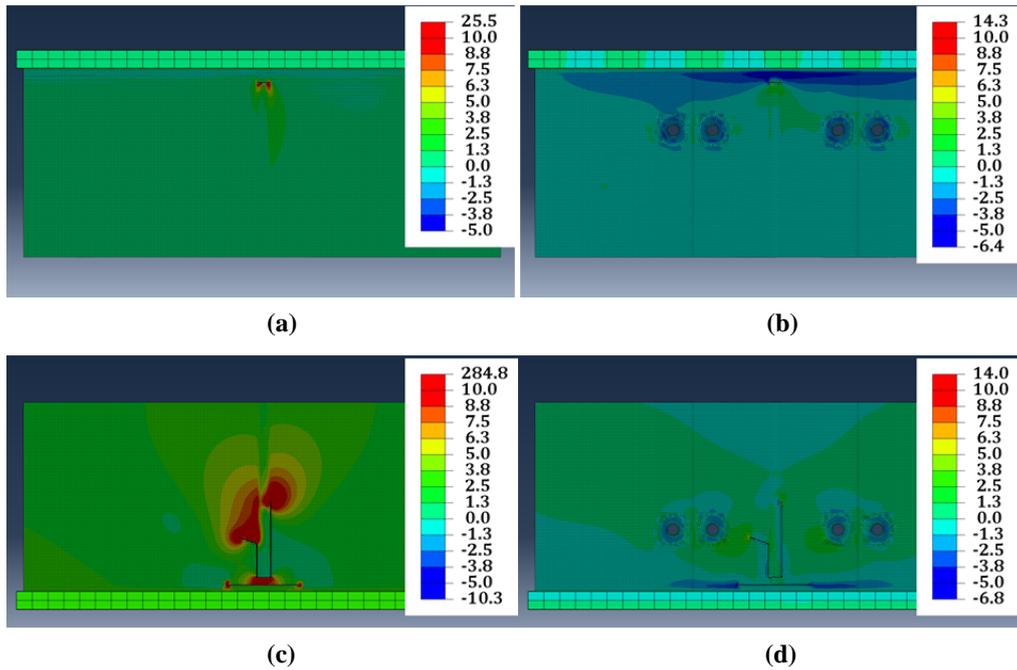
For all loading scenarios, field test and FE results show that peak stresses in the bottom web gap were significantly reduced after application of the angles-with-plate retrofit. Reduction of stresses in this area is very favorable because, as previously mentioned, the bottom web gap is the region of Kansas Bridge 135-87(043/044) in which the highest web gap out-of-plane stress demands are experienced. Therefore, the reduction of stresses in the bottom web gap region shows that the angles-with-plate retrofit should be successful in greatly slowing or halting crack propagation for the most problematic areas on the bridge.

For stresses nearest the top flange, peak stresses showed favorable reduction and behavior after application of the angles-with-plate retrofit for the center truck loading test. However, for the east and west lane truck loadings, low levels of stress decrease, and in a few cases, stress increase, in the top web gap region were observed. Although the top web gap region was found to experience lower stress demands before the retrofit than the bottom web gap, this is still a result that warranted further investigation. For this reason, an additional analytical investigation was performed that focused on the top web gap region of the bridge.

Figure 21: Maximum principal stresses for center load truck placement at (a) top web gap, before retrofit (b) top web gap, after retrofit (c) bottom web gap, before retrofit (d) bottom web gap, after retrofit. Legend stresses are in ksi.

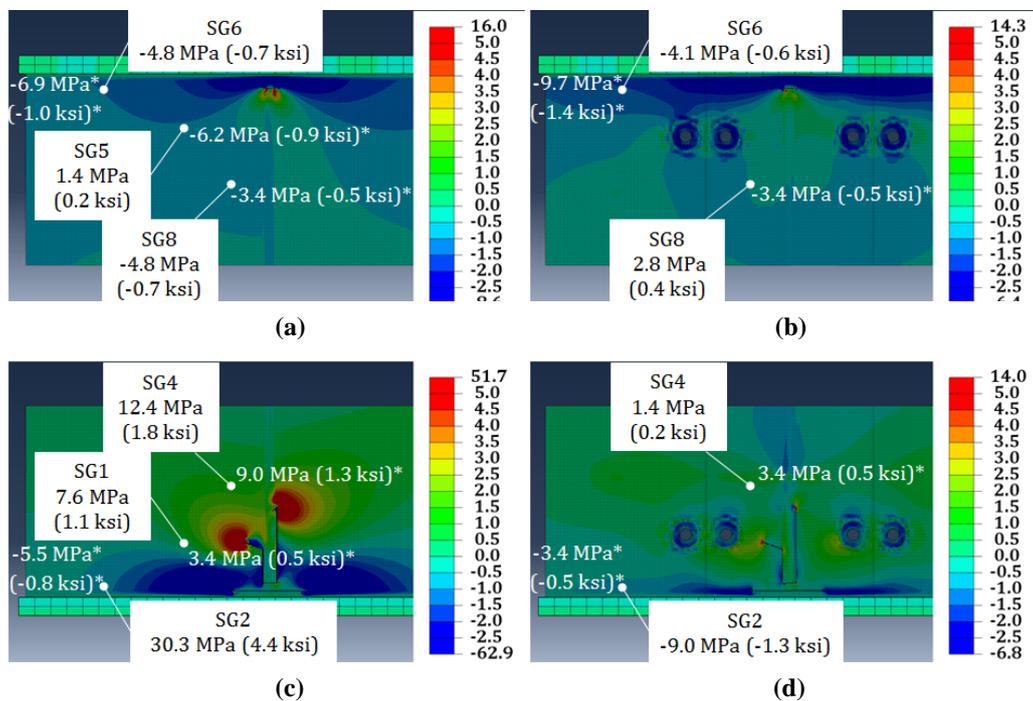
Figures 21, 22, 23, and 24 show results and comparisons of strain gage results between the unretrofitted and retrofitted states. Corresponding strain gage measurements and FE results generally show that the stress demand at the bottom web gap was at least 20% higher than that of the top web gap for tests before the retrofit was applied. Since the majority of fatigue cracks found on the bridge have occurred in the bottom web gap, this was expected. It also supports the findings

Figure 22: Directional stresses for center load truck placement at (a) top web gap, before retrofit (b) top web gap, after retrofit (c) bottom web gap, before retrofit (d) bottom web gap, after retrofit. Legend stresses are in ksi. *FE analyses values.

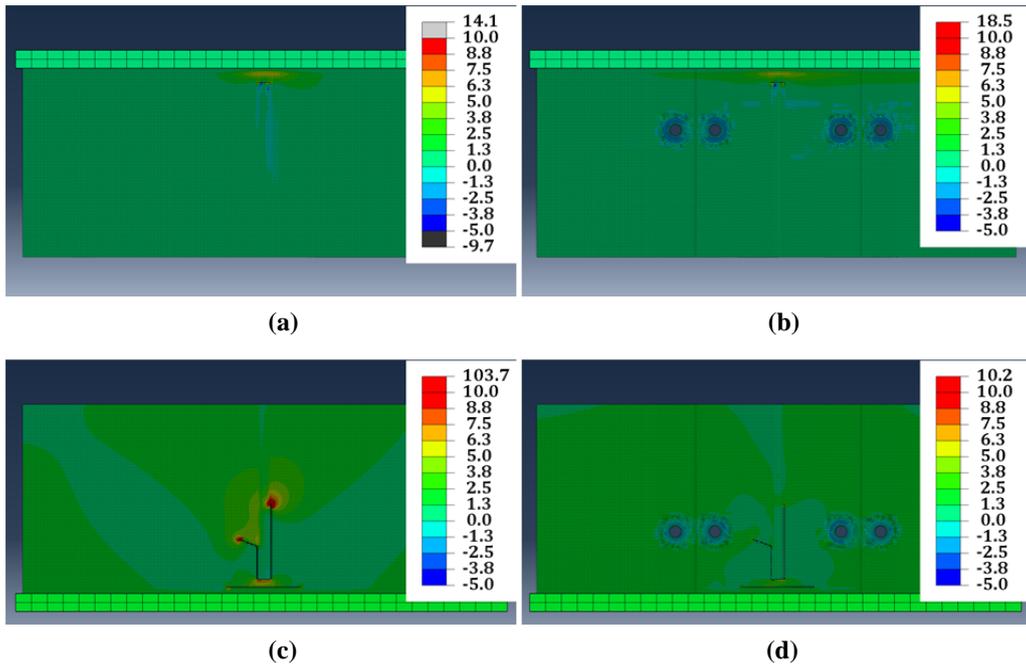
Figure 23: Maximum principal stresses for west load truck placement at (a) top web gap, before retrofit (b) top web gap, after retrofit (c) bottom web gap, before retrofit (d) bottom web gap, after retrofit. Legend stresses are in ksi.

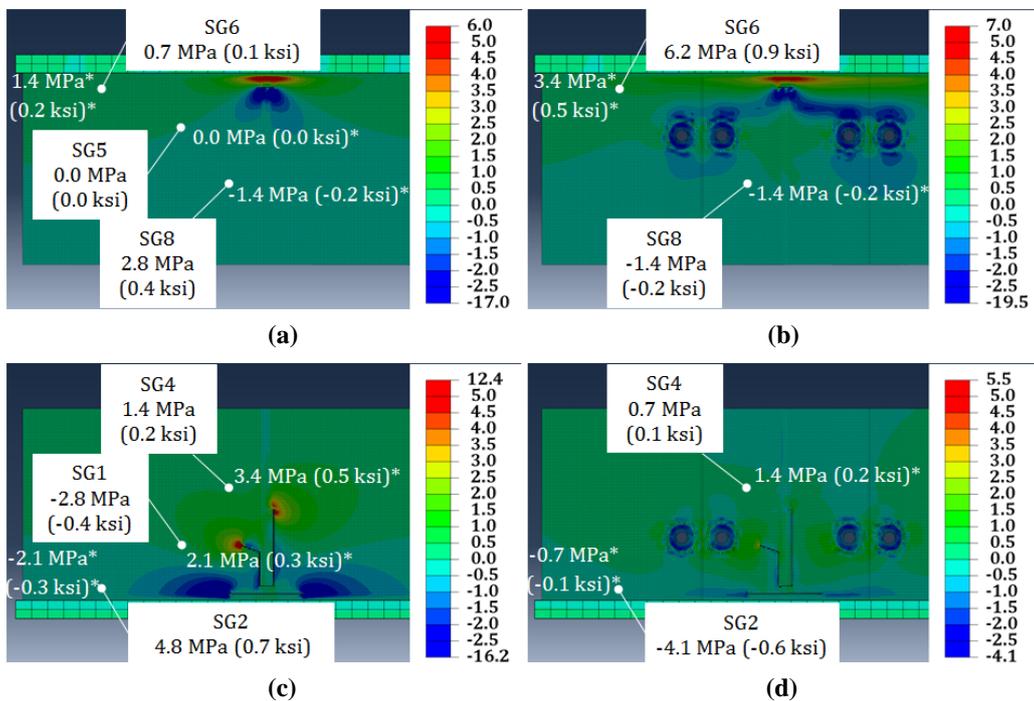
Figure 24: Directional stresses for west load truck placement at (a) top web gap, before retrofit (b) top web gap, after retrofit (c) bottom web gap, before retrofit (d) bottom web gap, after retrofit. Legend stresses are in ksi. *FE analyses values.

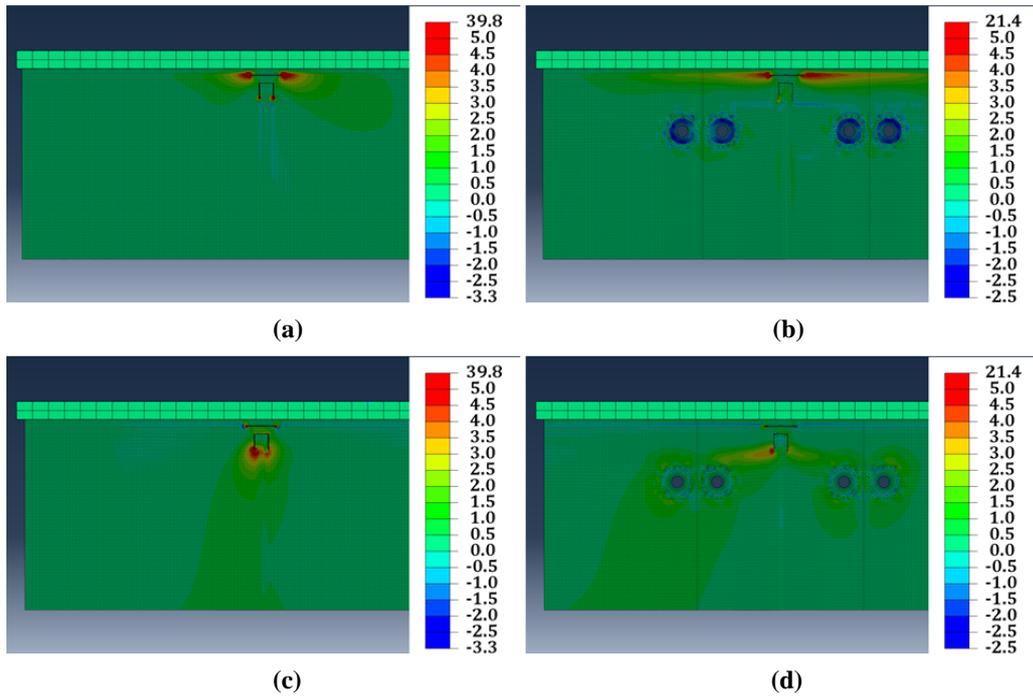
Figures 25, 26, and 27 show maximum principal stresses when both the connection plate-to-web weld and flange-to-web weld cracks were present for all three truck location loadings, both before and after retrofit application. Under bridge center truck loading, the retrofit reduced HSS 1 and HSS 2 stress demands by 66% and 35%, respectively. Under west lane truck loading, HSS 1 stress was reduced by 27% and HSS 2 stress was reduced by 26%. Under east lane truck loading, HSS1 and HSS 2 stresses were reduced by 53% and 23%, respectively.

Figure 25: Maximum principal stresses at top web gap for west load truck placement when both the connection plate-to-web and flange-to-web weld cracks are present for (a) stiffener side, before retrofit (b) stiffener side, after retrofit (c) non-stiffener side, before retrofit (d) non-stiffener side, after retrofit. Legend stresses are in ksi.

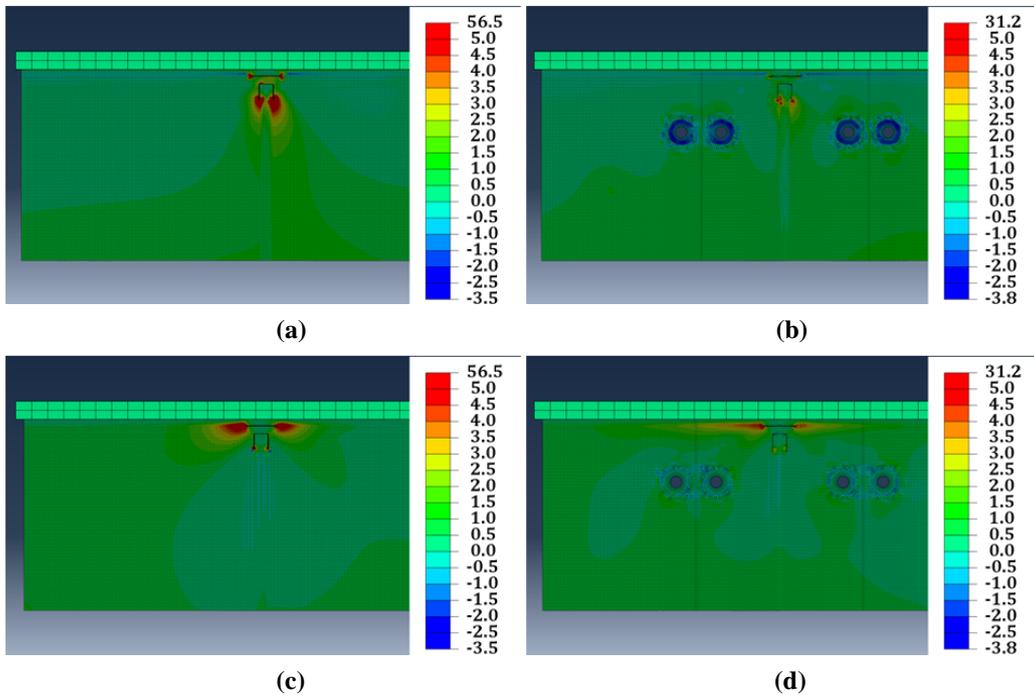
Figure 26: Maximum principal stresses at top web gap for center load truck placement when both the connection plate-to-web and flange-to-web weld cracks are present for (a) stiffener side, before retrofit (b) stiffener side, after retrofit (c) non-stiffener side, before retrofit (d) non-stiffener side, after retrofit. Legend stresses are in ksi.

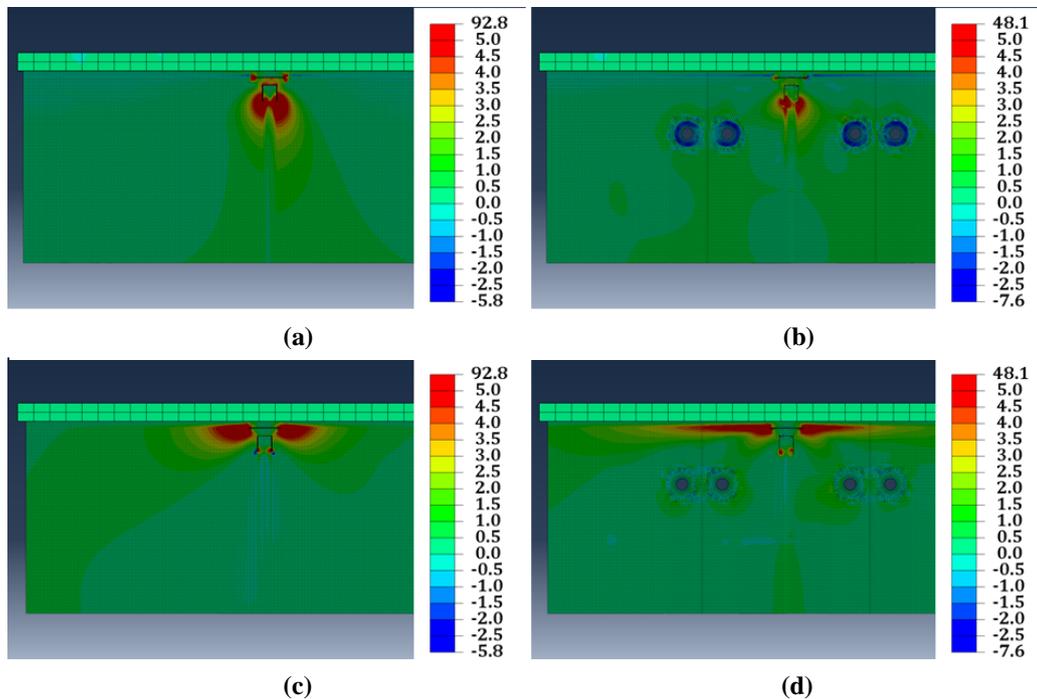
Figure 27: Maximum principal stresses at top web gap for east load truck placement when both the connection plate-to-web and flange-to-web weld cracks are present for (a) stiffener side, before retrofit (b) stiffener side, after retrofit (c) non-stiffener side, before retrofit (d) non-stiffener side, after retrofit. Legend stresses are in ksi.

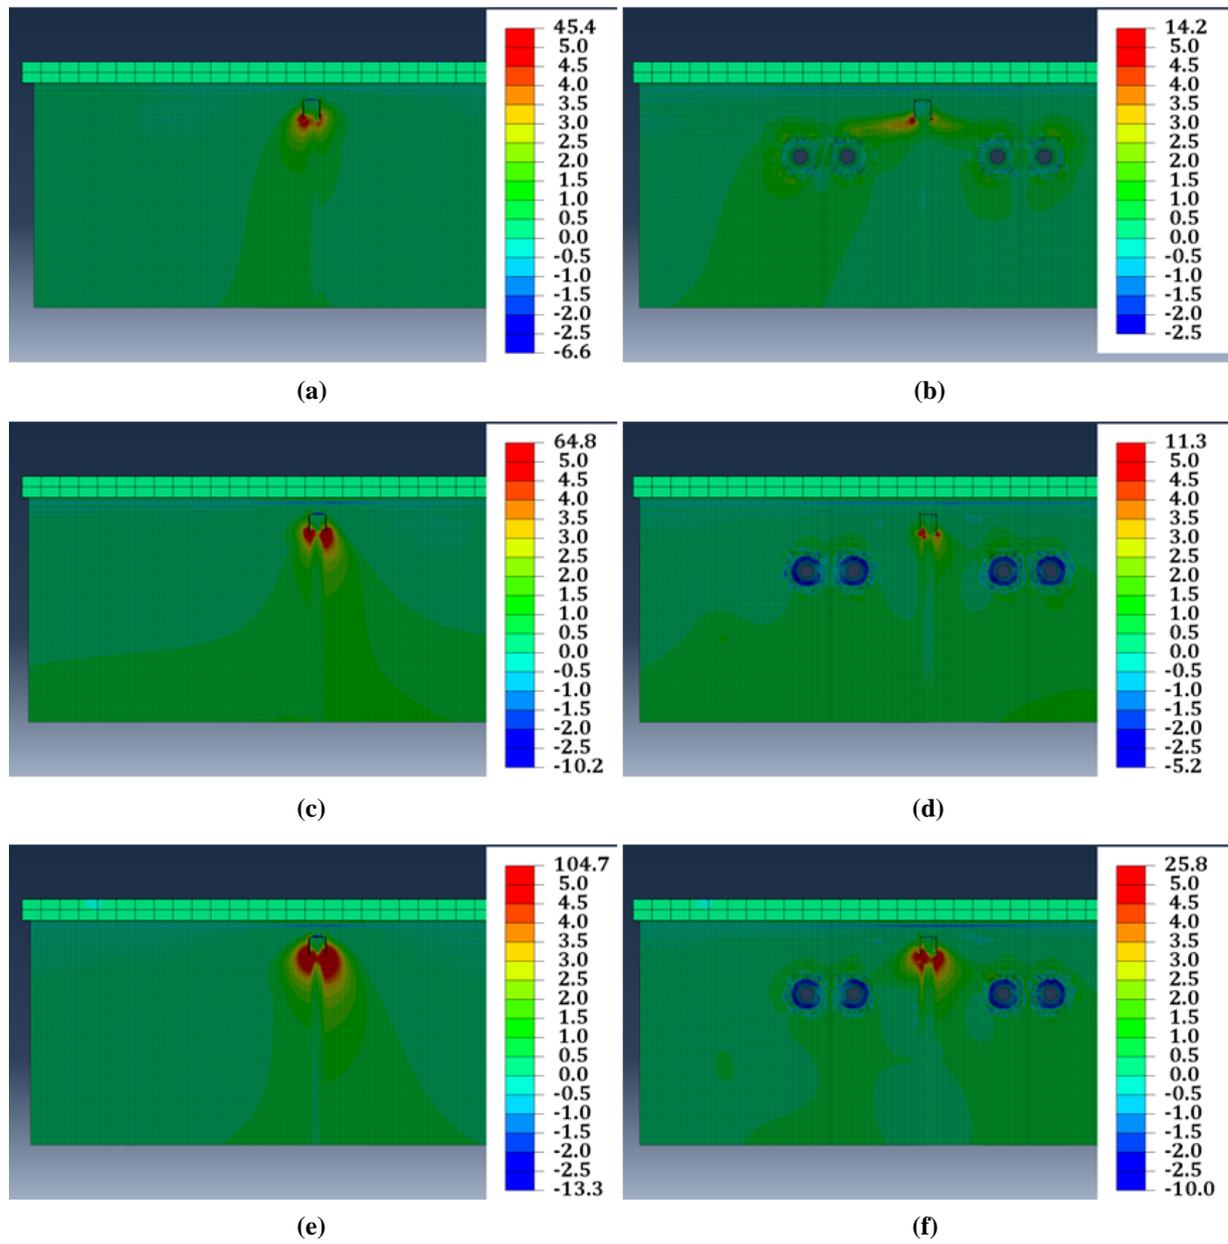
Figure 28 shows maximum principal stresses from all three truck location loadings, both before and after retrofit application, for the top web gap when only the connection plate-to-web weld crack was present. After application of the retrofit, HSS 1 stress was reduced under the bridge center, west lane, and east lane truck loadings by 63%, 26%, and 50%, respectively. Figure 29 shows maximum principal stresses, both before and after retrofit application, for the top web gap when only the flange-to-web weld crack was present. Application of the retrofit reduced HSS 2 stress demand under the bridge center, west lane, and east lane truck loadings by 23%, 14%, and 2%, respectively.

Figure 28: Maximum principal stresses at top web gap when only connection plate-to-web weld crack is present for (a) west load truck placement, before retrofit (b) west load truck placement, after retrofit (c) center load truck placement, before retrofit (d) center load truck placement, after retrofit (e) east load truck placement, before retrofit (f) east load truck placement, after retrofit. Legend stresses are in ksi.

connection plate-to-web weld crack with respect to the stress patterns in the flange-to-web weld crack region, as shown in Figure 28. These are favorable results in that the appearance of both the connection plate-to-web weld and flange-to-web weld cracks only improves the performance of the angles-with-plate retrofit.

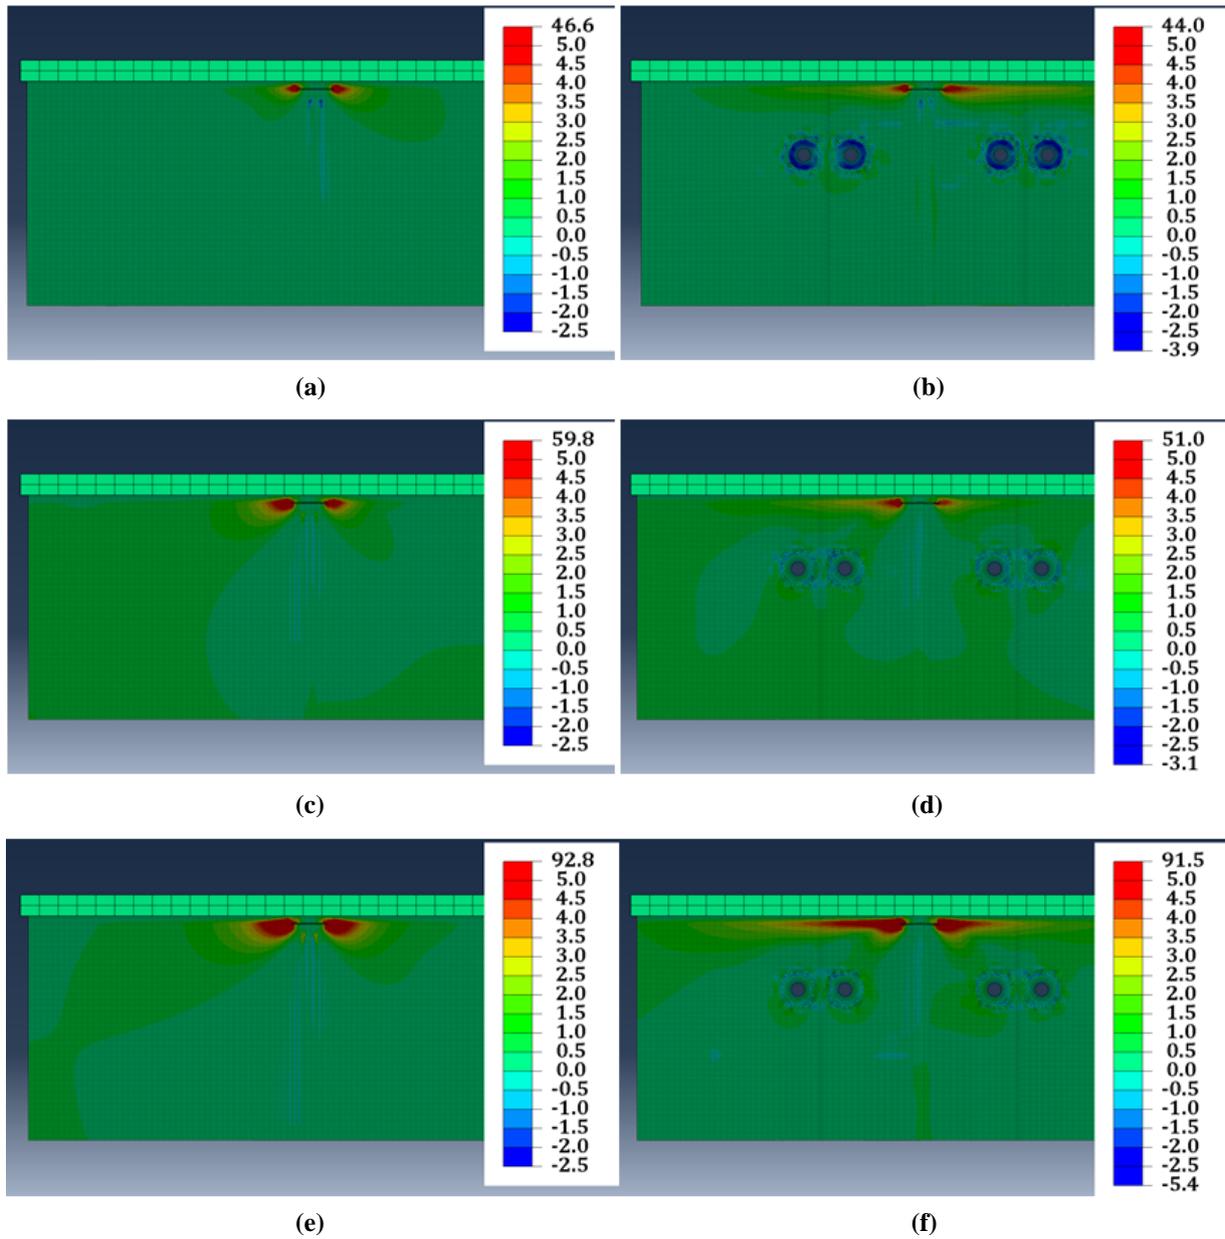
Figure 29: Maximum principal stresses at top web gap when only flange-to-web weld crack is present for (a) west load truck placement, before retrofit (b) west load truck placement, after retrofit (c) center load truck placement, before retrofit (d) center load truck placement, after retrofit (e) east load truck placement, before retrofit (f) east load truck placement, after retrofit. Legend stresses are in ksi.

In all cases, stress demands were reduced in the top web gap region by application of the retrofit. Although stresses were reduced much less when just the flange-to-web weld crack was present, the stress patterns shown in Figure 29 indicate that when the flange-to-web weld crack is present, the stresses in the connection plate-to-web weld crack region are also high and are likely to produce the connection plate-to-web weld crack. The same is true for the case with just the
