KU-16-1
**Determination of Fatigue Resistance of Coupler
Connections in Aluminum Overhead Truss Structures**

A Report on Research Sponsored by
The Kansas Department of Transportation

Structural Engineering and Engineering Materials
SM Report No. 137
August 2020

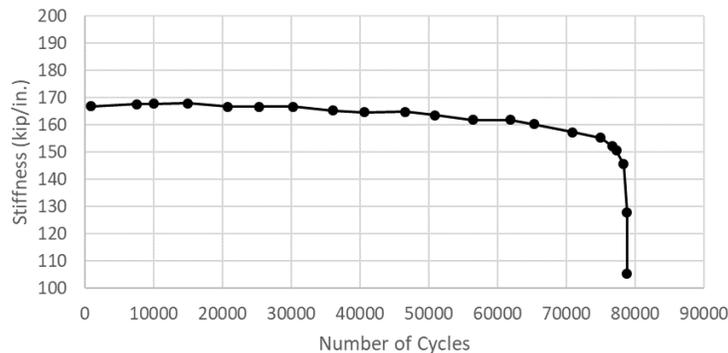
Figure 27. Stiffness vs. Number of Cycles for *FAT-TENS13* Tested at 15.1 ksi

The graph of the assembly stiffness versus the number of applied cycles is presented in Figure 27. The stiffness started to reduce at approximately 30,000 cycles and then began to rapidly decrease at approximately 750,000 cycles. However, despite regular inspections, cracks were not observed until complete failure of the coupler.

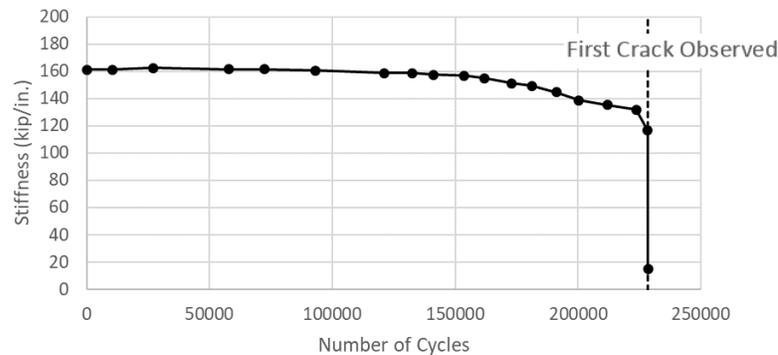
Figure 29. Stiffness vs. Number of Cycles for *FAT-TENS11* Tested at 10.5 ksi

Figure 29 presents assembly stiffness with respect to the number of applied cycles. Stiffness started to decrease at approximately 150,000 cycles. However, when the researcher observed the crack, it was only 55 cycles away from failure.

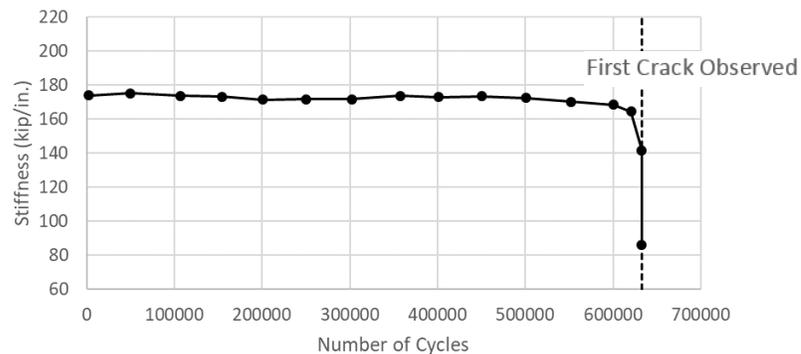
Figure 31. Stiffness vs. Number of Cycles for *FAT-TENS12* Tested at 10.5 ksi

The record of assembly stiffness during testing is shown in Figure 31. The stiffness started to reduce slightly at approximately 450,000 cycles, but did not change much before it started to decrease rapidly at approximately 600,000 cycles. When the first crack was observed, it was still thin but the coupler was only 323 cycles away from failure.

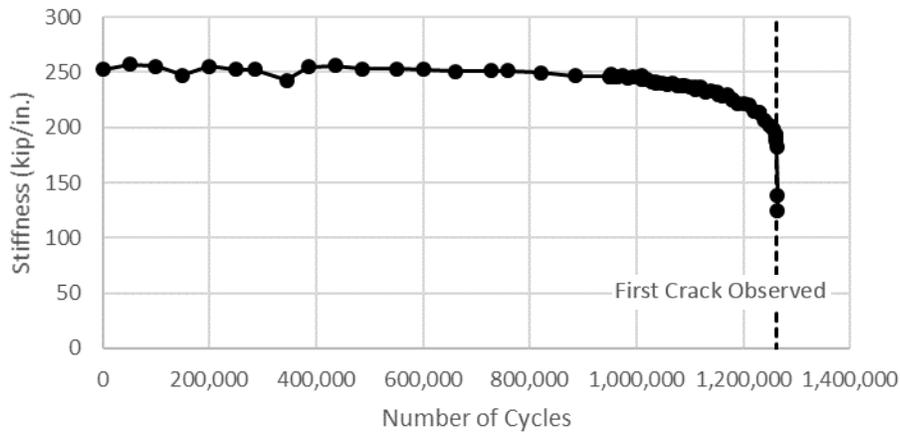
Figure 34. Stiffness vs. Number of cycles for FAT-TENS3 Tested at 8.3 ksi

The load and displacement are shown in Figure 34. The stiffness of the coupler assembly started to decrease at approximately 950,000 cycles, but no visible fatigue damage was observed until half of the 8-in. coupler cracked at 1,263,000 cycles. An additional 600 cycles led to complete failure of the coupler.

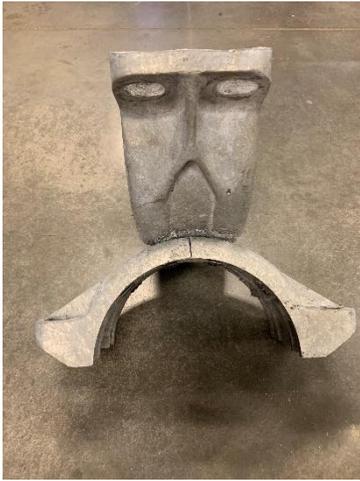
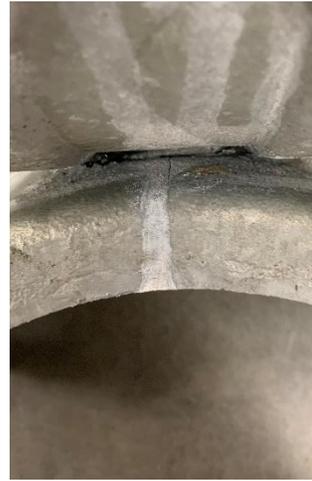
Figure 35. Failure of FAT-TENS9 Tested at 8.3 ksi

4.2.3.3 FAT-TENS9: FAT-TENS9 was a new “off-the-shelf” coupler tested at a stress range of 8.3 ksi. The test was stopped at 2,124,128 cycles when cracking of the 8-in. coupler triggered the displacement interlock of the loading machine. A crack was found to have propagated through-thickness on one side of the coupler. On the other side, the crack propagated to the edge of the coupler but had not yet propagated through-thickness. Photographs of the specimen after failure are presented in Figure 35.

(a) Crack on One Side Cut Through the Thickness

(b) Crack on the Other Side Propagated to the Edge

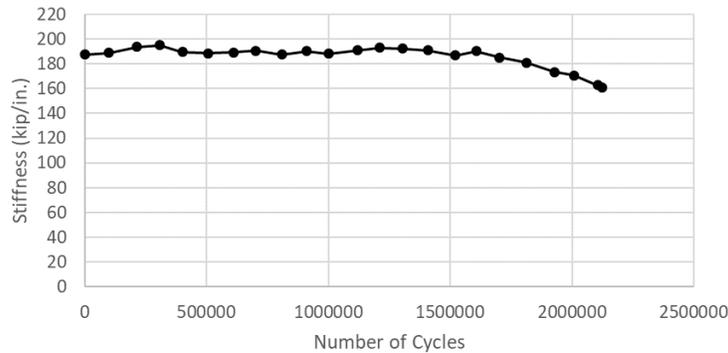
Figure 36. Stiffness vs. Number of Cycles for FAT-TENS9 Tested at 8.3 ksi

The record of coupler assembly stiffness during the test is presented in Figure 36. The last inspection performed before failure was at approximately 1.9 million cycles. Although the stiffness of the assembly started to decrease at approximately 1.6 million cycles, no visible cracks were observed in the last inspection.

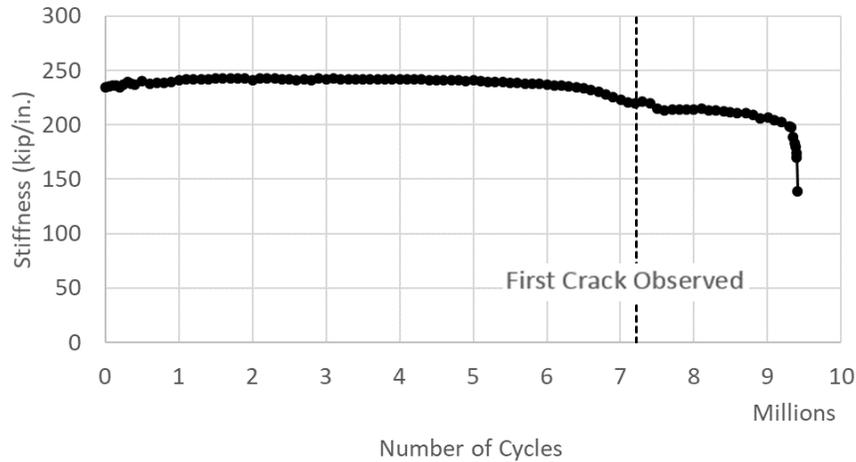
Figure 39. Stiffness vs. Number of Applied Cycles for FAT-TENS5 Tested at 5.8 ksi

The stiffness record for FAT-TENS4 is presented in Figure 39. In this test, the first crack was detected at about 7.2 million cycles, and it took an additional 2 million cycles to reach complete failure. This was different than other tests, since in most of the tests cracks were not visually-observable until complete failure was imminent.

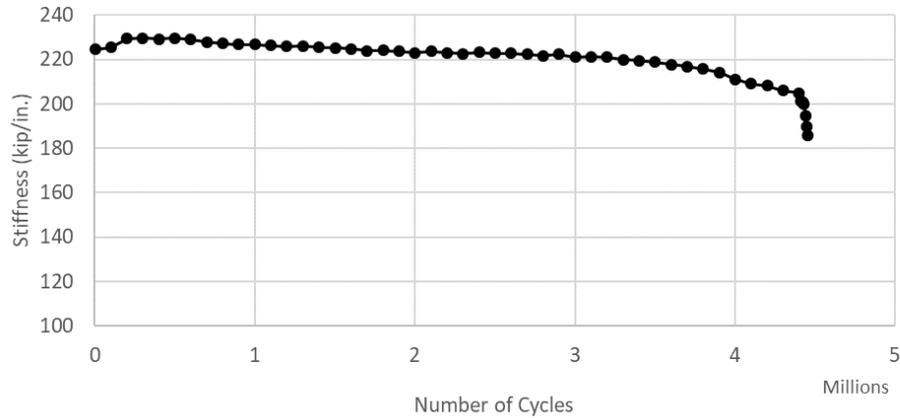
Figure 41. Stiffness vs. Number of Cycles for FAT-TENS5 Tested at 5.8 ksi

The stiffness record for *FAT-TENS5* is presented in Figure 41. Although stiffness of the assembly started to decrease at approximately 3.2 million cycles, no cracking was observed until complete failure occurred.

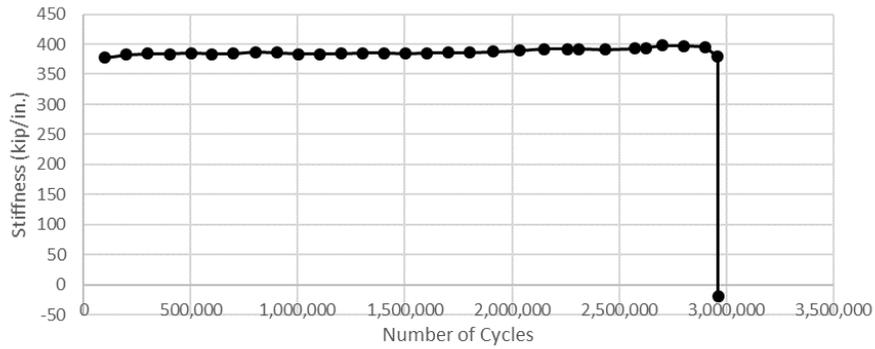
Figure 43. Stiffness vs. Number of Cycles for FAT-TENS7 Tested at 5.8 ksi

The stiffness record for *FAT-TENS7* is shown in Figure 43. No gradual decrease in stiffness was observed as occurring in this test.

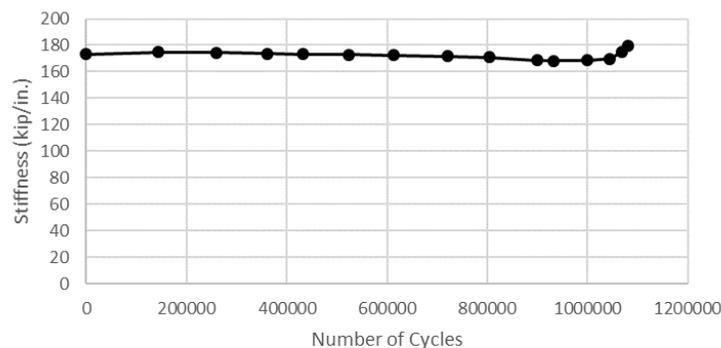
Figure 45. Stiffness vs. Number of Cycles for FAT-TENS8 Tested at 5.8 ksi

The stiffness record for *FAT-TENS8* is shown in Figure 45. Similar to the behavior observed for *FAT-TENS7*, reductions in stiffness were not observed as occurring before failure.

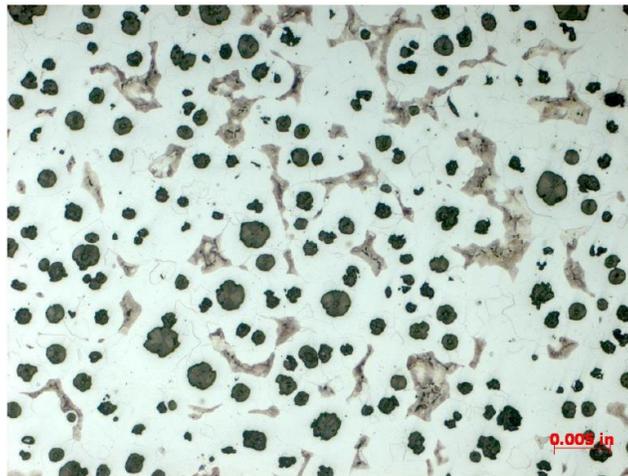
Figure 48. Photomicrograph of Coupler Material Sample

To determine the material composition of the coupler connections, a sample was cut from one of the couplers taken from an out-of-service OHTSS and sent to a materials testing laboratory. The material test was performed by Pacific Testing Laboratories, Inc., Valencia, CA. Figure 48 shows a photomicrograph showing the microstructure of the material sample. Graphite nodules in a matrix of α -ferrite (with some pearlite) were observed. The microstructure is characteristic of ductile cast irons.
