# Observations about the Seismic Response of RC Buildings in Mexico City

Over 2000 buildings were surveyed by members of the Colegio de Ingenieros (CICM) and Sociedad Mexicana de Ingenieria Estructural (SMIE) in Mexico City following the Puebla-Morelos Earthquake of 2017. This inventory of surveyed buildings included 40 collapses and over 600 buildings deemed to have structural damage. Correlation of damage with peak ground acceleration (PGA), peak ground velocity (PGV), predominant spectral period, building location, and building properties including height, estimated stiffness, and presence of walls or retrofits was investigated for the surveyed buildings. The evidence available suggests that: 1) ground motion intensity (PGV) and not ground motion predominant period drove the occurrence of damage, and 2) buildings with more infill and stiff retrofit systems did better than other buildings.

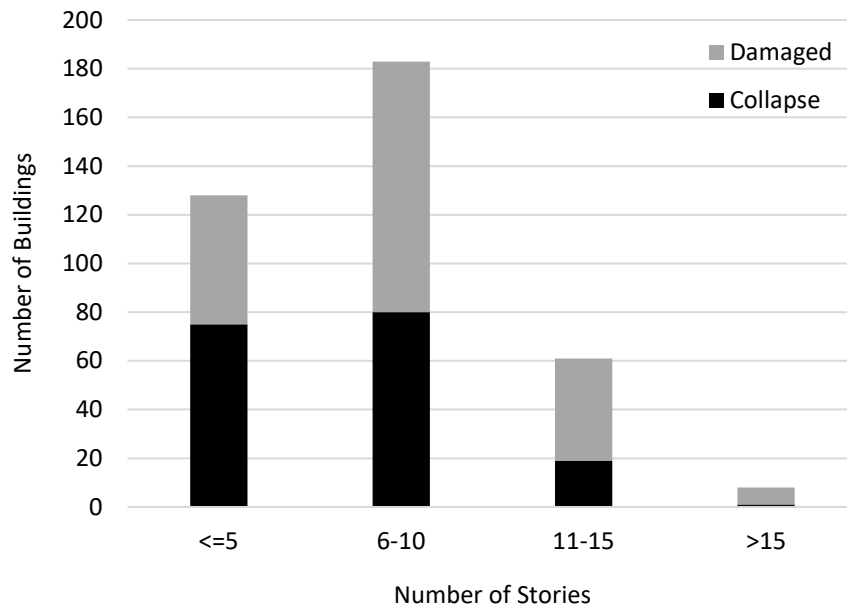
**Figure 4.** Reinforced concrete buildings with severe structural damage and partial or complete collapse, Mexico City, 1985 (Reproduced using data from Aguilar et al. 1989)

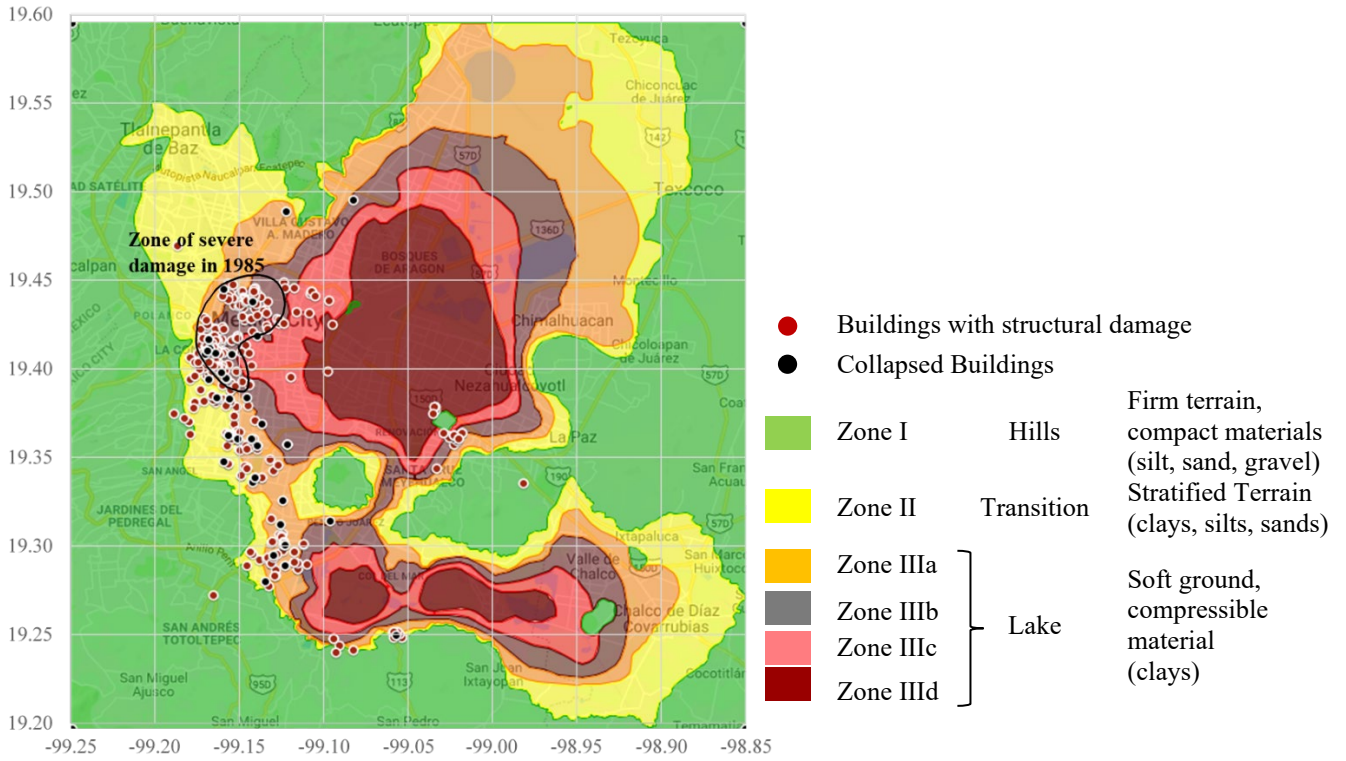
**Figure 6.** Locations of damaged and collapsed buildings after 2017 Puebla-Morelos Earthquake

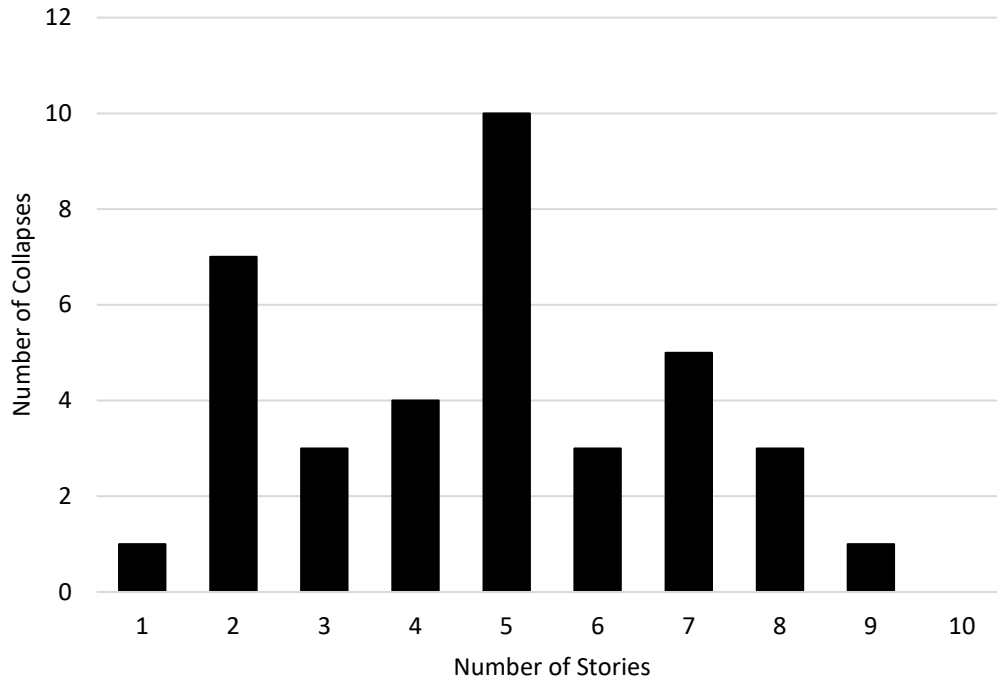
**Figure 8.** Height, in terms of number of stories, of collapsed buildings in Mexico City, 2017  
Puebla-Morelos Earthquake

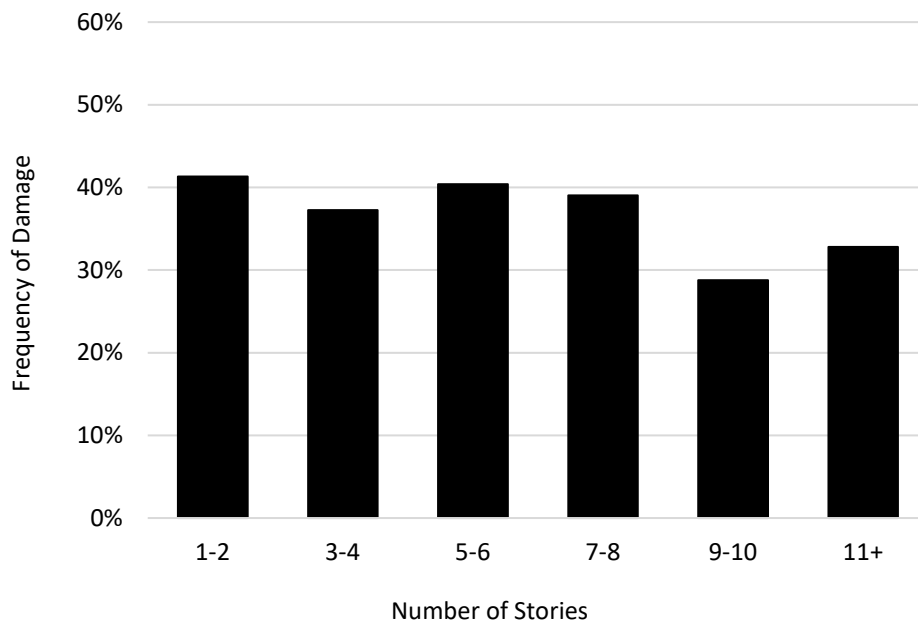
**Figure 9.** Frequency of damage vs. number of stories in 2017

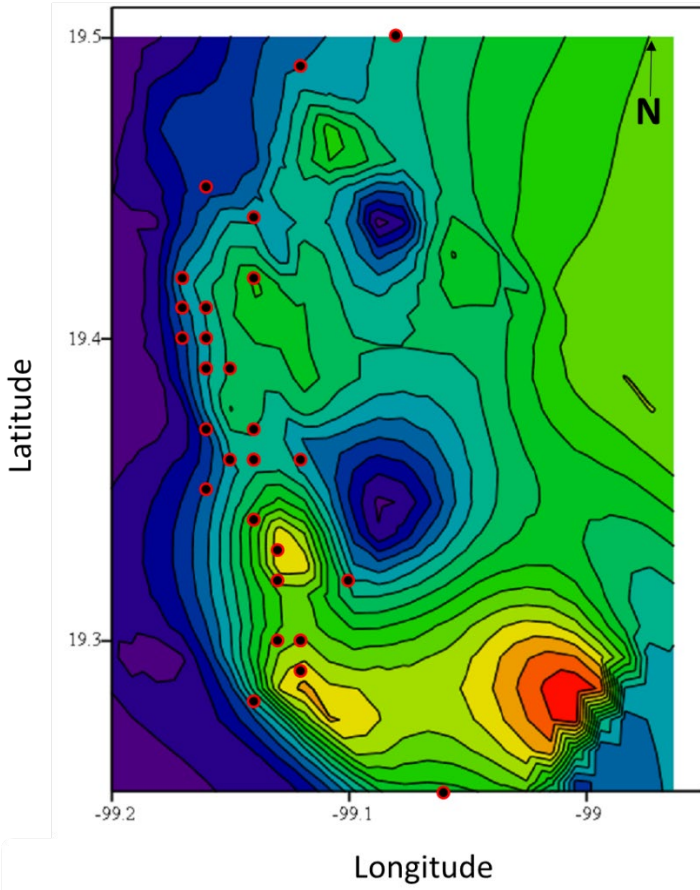
To try to understand better the distribution of damage, a contour map of ground motion intensity (**Fig. 14**) was produced using values of peak ground velocity (PGV) obtained from acceleration records published by CIRES. PGV has been reported to correlate well with drift demand (Sozen 2003, and Laughery 2016).

**Figure 14.** Contour of PGV (purple represents low PGV (~10cm/s) and red represents high PGV (~50cm/s), and black dots represent collapsed buildings) (COLOR)

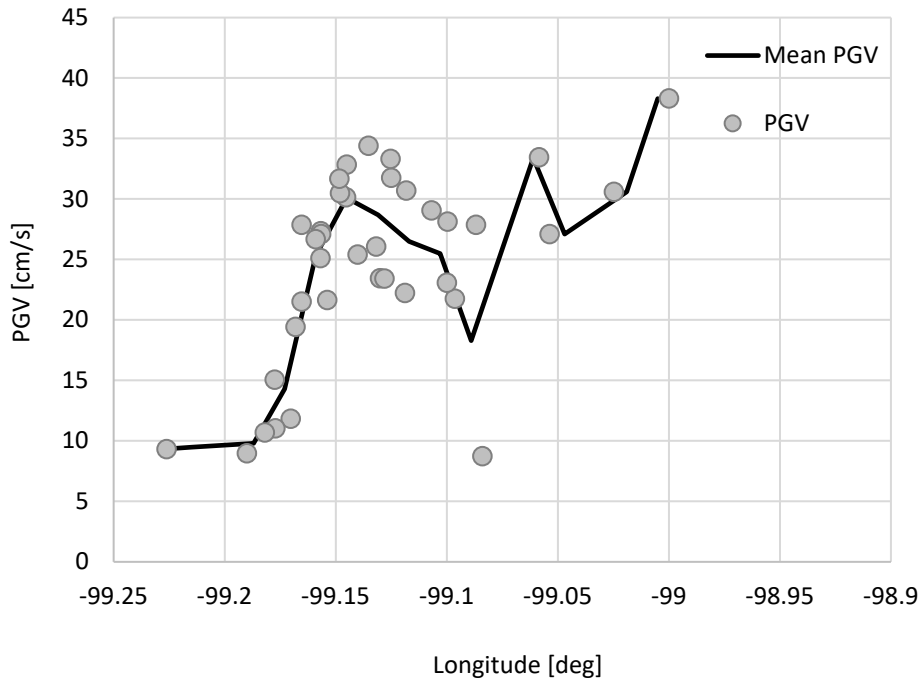
The low intensities on the West are attributed to the presence of rock and shallow soil deposits. The high intensities on the East could be attributed to deep soil deposits from the original lakebed and basin effects. But the fluctuations in the center are not as easy to attribute to the properties of the soils indicated by the soils map in **Fig. 6**.

**Figure 15.** Variation of PGV from West to East between latitudes 19.35 and 19.45 degrees

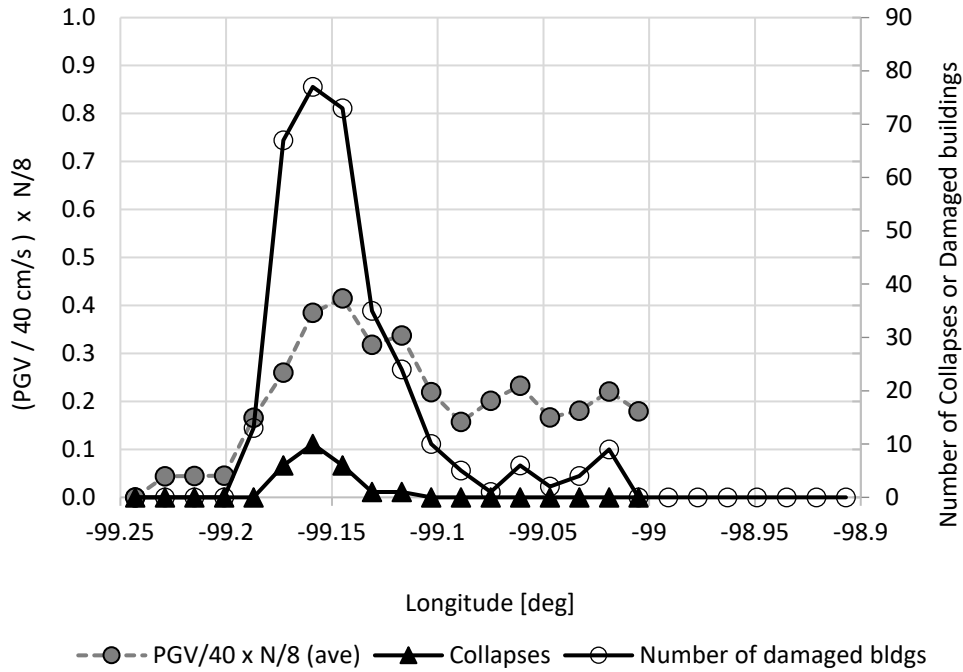
The number of collapses and damaged buildings near a given meridian is superimposed on the plot in **Fig. 17** to show that damage concentrated where two rather obvious (in retrospect) factors

coincided: RC frame buildings (as opposed to one or two story masonry houses) and high ground motion intensity (PGV). This figure also implies that matching soil and building period may be less important. **Fig. 17** emphasizes indirectly the relevance of drift demand because, as stated above, PGV has been reported to correlate well with drift demand.

**Figure 17.** Variation of drift demand and collapsed buildings

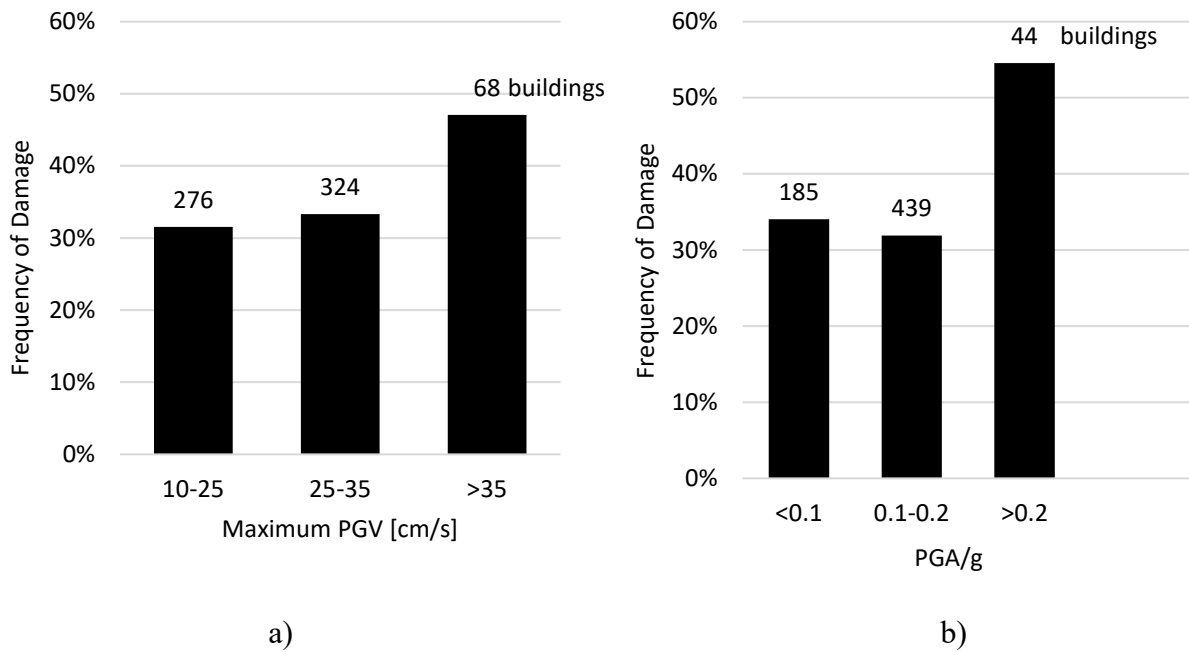
Two more sets of plots confirm the observations above about the importance of intensity and fundamental period (as a measure of stiffness and mass). **Fig. 18** shows that damage frequency among the surveyed buildings increased with both PGV and PGA. Incidentally, reexamining the effect on damage frequency of the ratio of building period to dominant spectral period to focus on only areas with high PGV did not produce better correlation than obtained for the entire dataset.

**Figure 18.** Frequency of damage in buildings with  $N > 2$  vs. PGV and PGA

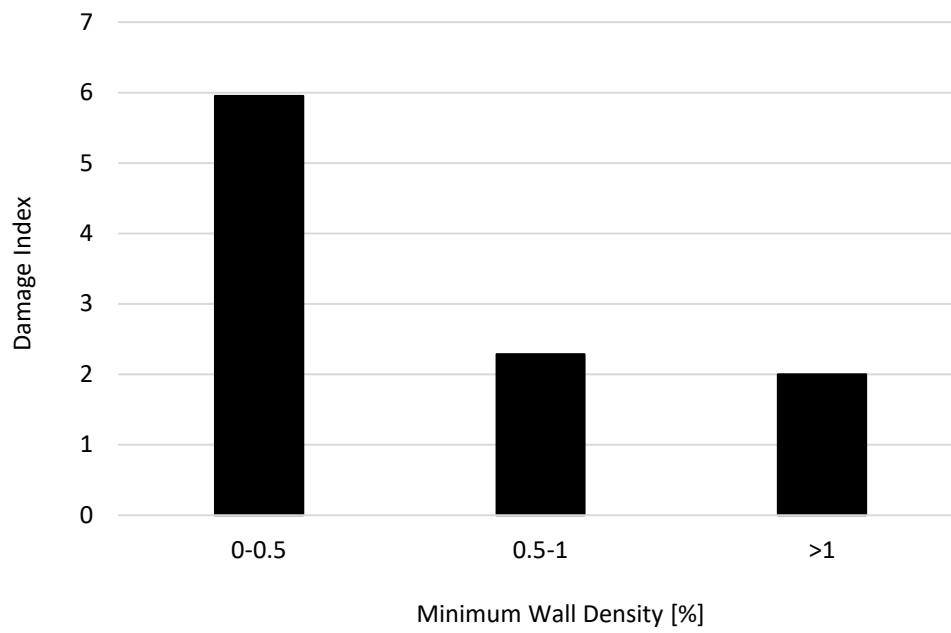
**Fig. 19** shows the mean damage index assigned by the authors based on data collected on-site plotted versus wall density (measured as the ratio of cross-sectional area of infill wall<sup>15</sup> to floor plan area). The damage index was chosen to be 1 for little or no structural damage, 5 for moderate damage, and 10 for building collapse and structural failures (Appendix A). **Fig. 19** shows that the buildings with larger wall densities performed better despite the modest drift capacity of infill. If said capacity is exceeded-of course- the apparent benefits of the infill can be compromised and the bare frame may see increased deformation demands and column shear forces where infills fail. In addition, it was clear that buildings retrofitted following the 1985 event by adding stiffening elements (often RC infill walls) performed quite well in 2017 (Roselin et al., 2019).

**Figure 19.** Average damage index vs. wall density
