Utilizing Fiber-Reinforced Polymers to Retrofit Steel Bridge Girders Damaged by Fatigue Loading.

Submitted to the graduate degree program in Civil Engineering and the Graduate Faculty of the University of Kansas in partial fulfillment of the requirements for the degree of Masters of Science.

Keywords: Bridge, Girder, Steel, Retrofit, Composite, FRP, Kevlar, Fatigue, Fracture, Stiffen
Connection

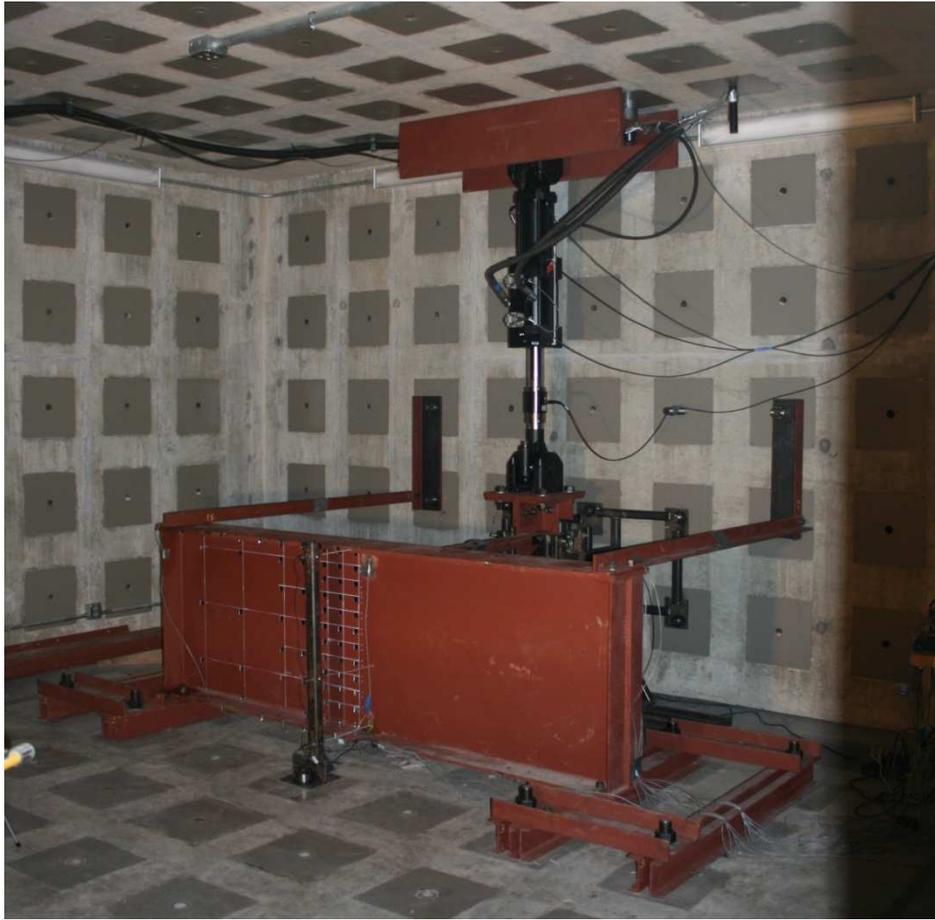
Figure 6: Experimental Setup in Fracture and Fatigue Lab at M2SEC

Figure 7: Elevation view of girder subassembly in Fracture and Fatigue Lab at M2SEC

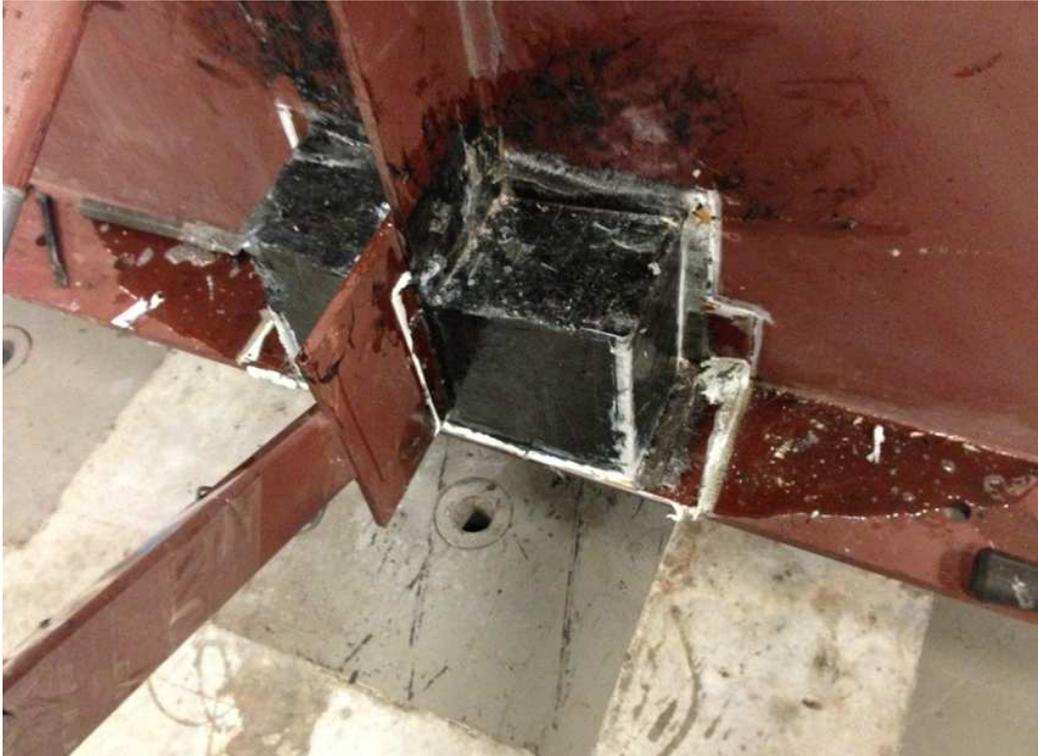
Figure 9: Composite block retrofit installed in the lower web-gap region

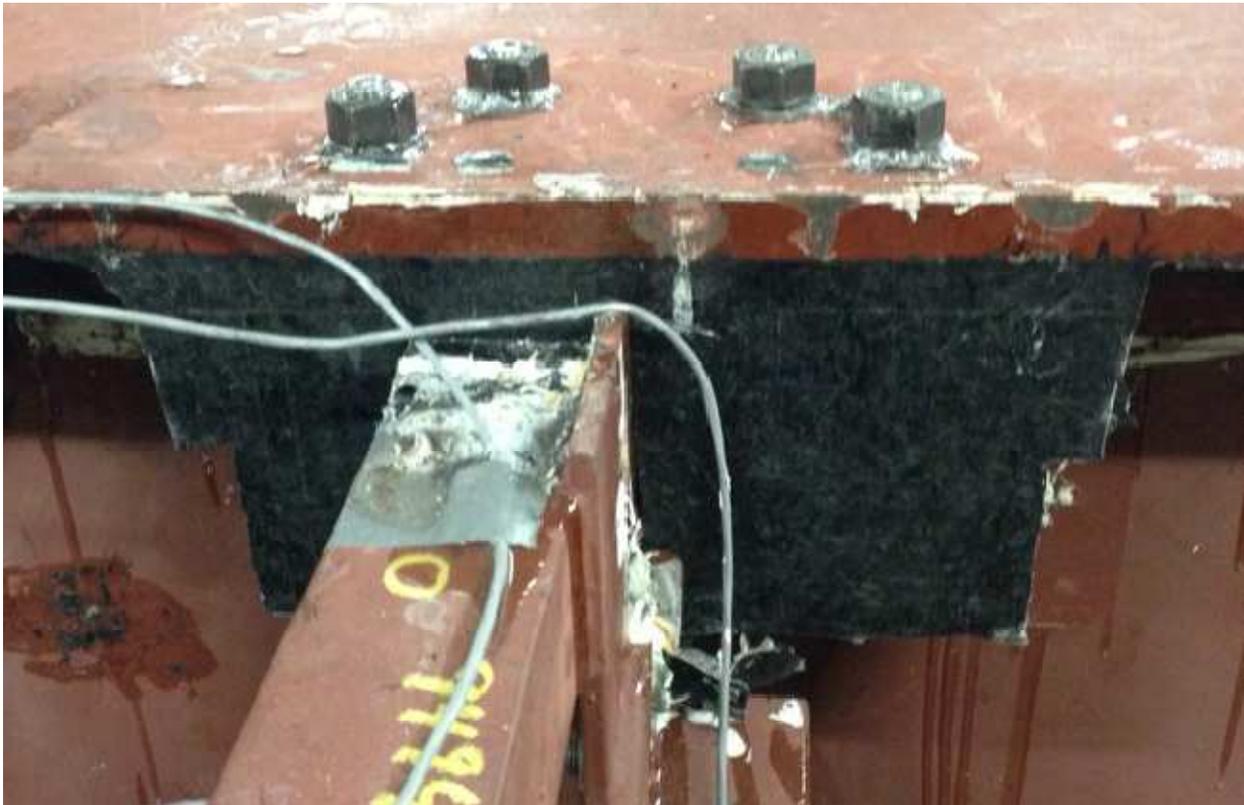
Figure 10: Upper web-gap region with composite block retrofit

In Trial G1.4, CFRP blocks were cast in the top web-gap region of the girder as shown in Figure 10. The block geometry mirrored the geometry used in the lower web-gap region (the upper web-gap installation process can be found in Appendix F). The composite blocks installed in the upper web-gap region more closely resembled how a composite block would be installed on a bridge in the field because, on a bridge in the field, the composite block needs to overcome the force of gravity during its casting and curing process. To achieve this, a mold was constructed around the upper web-gap region with a 127x102-mm (5x4-in.) tunnel on the side of the mold. CFRP was put into the mold through the side tunnel. After the mold was full of CFRP a 127x102-mm (5x4-in.) piece of plywood was forced into the side tunnel of the mold by a 51x102-mm (2x4-in.) compacting the CFRP while it cured. After the CFRP cured the mold was removed.

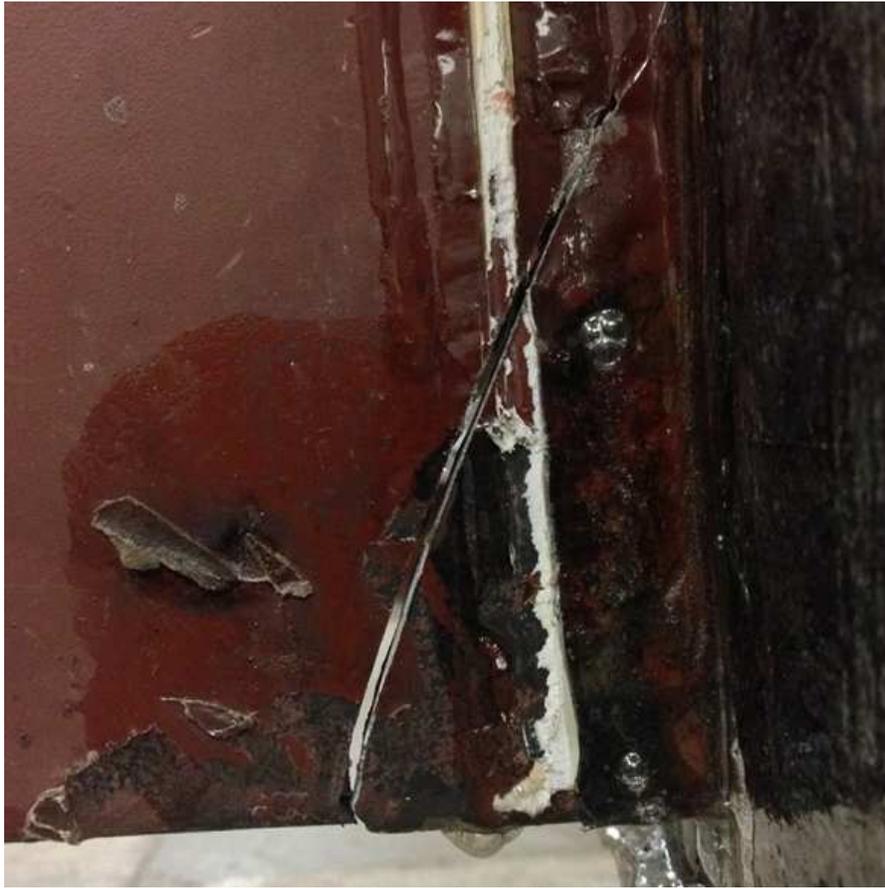
Figure 12: Crack on tab plate

the tab plate connecting the cross-frame to the connection plate in the bottom web-gap region, as shown in Figure 11 and Figure 12.

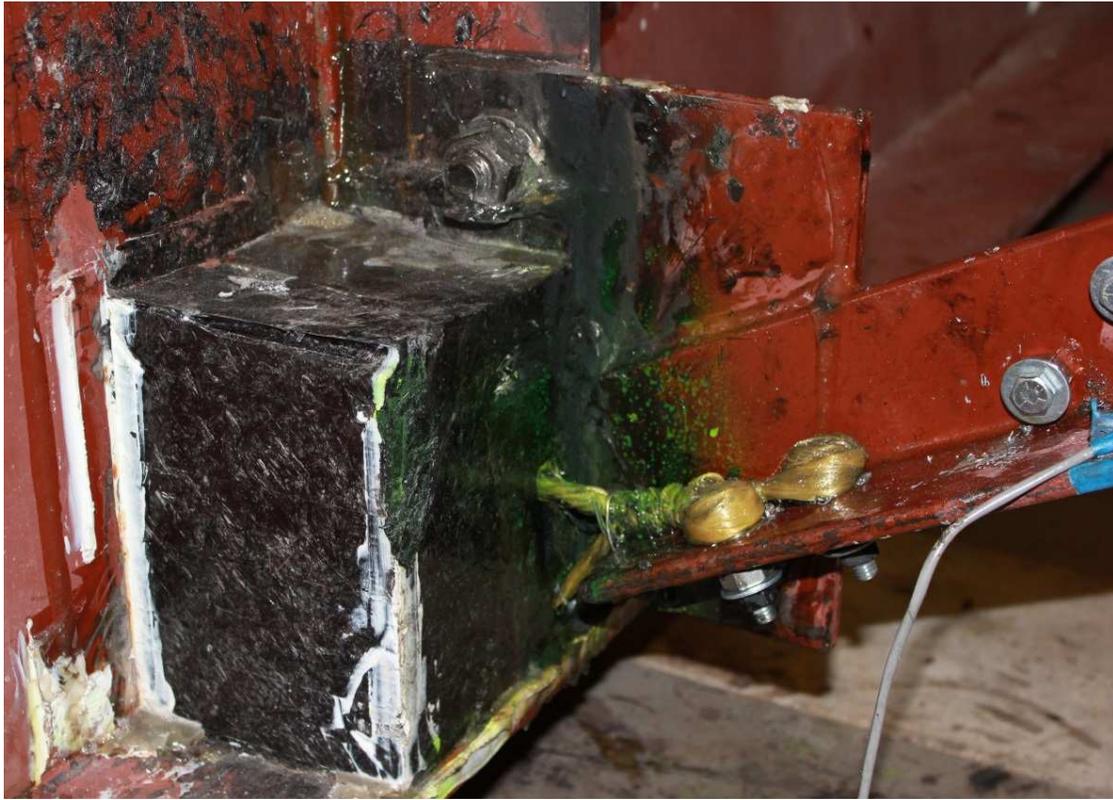
Figure 14: Kevlar stitching retrofit, south stiffener side

through the lower cross frame angle section and 10-mm (3/8-in.) diameter medium strength steel screws were installed in the holes on the angle section. Kevlar strands coated in epoxy were then used to stitch the tab plate together. Appendix G further explains the preparation and application of the stitching retrofit. Figure 13, Figure 14 and Figure 15 show the Kevlar stitching retrofit applied to the specimen.

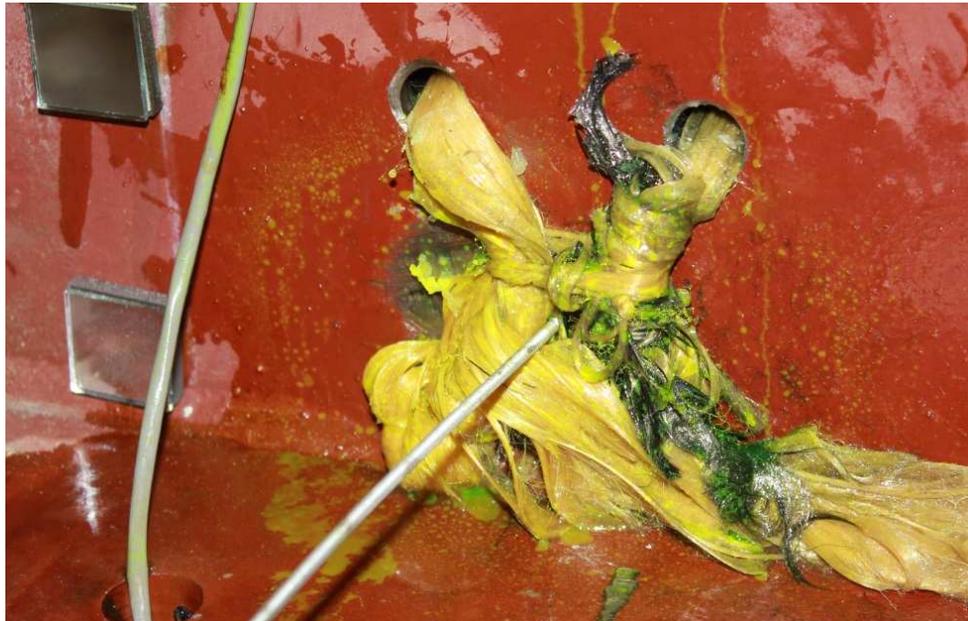
Figure 15: Kevlar stitching retrofit, fascia side

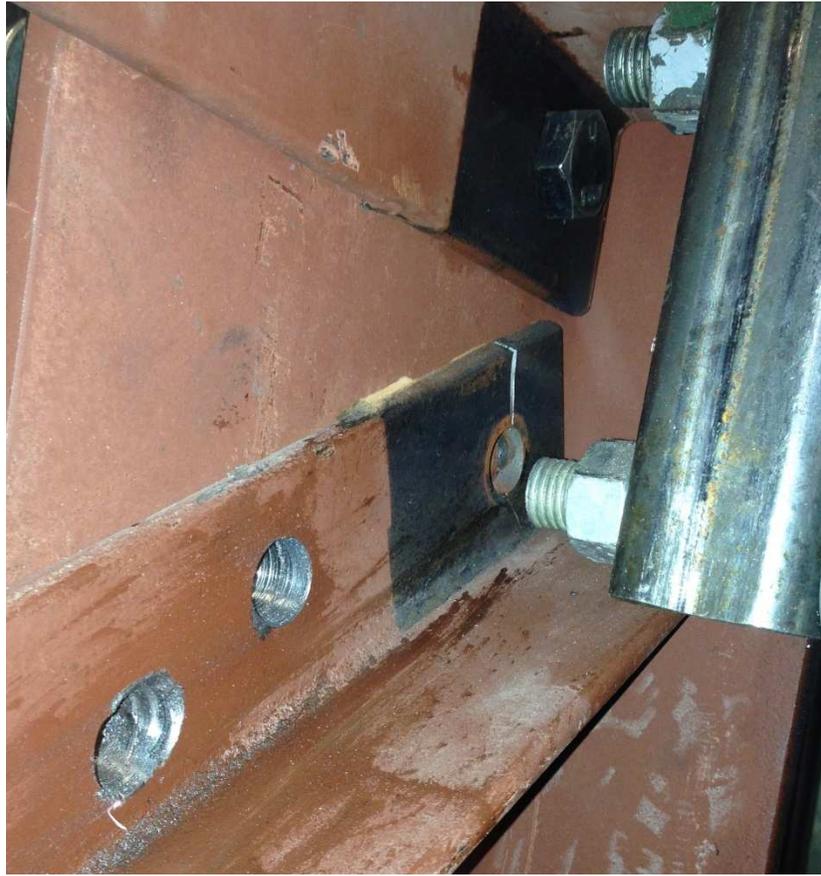
Figure 16: Crossframe angle fracture at bolt hole

The only fracture that occurred during test trial G1.4 occurred at 2.73 million total cycles at a bolt hole location below the MTS actuator at the cross frame-to-WT connection. This bolt hole fracture location was on the opposite end of the same angle section to which the stitching retrofit was applied, as shown in Figure 16. Two new holes were drilled through the angle section and the WT, then new 19-mm (3/4-in.) A325 bolts were installed. For the remainder of testing (another 1.42 million cycles) the angle section did not fracture.

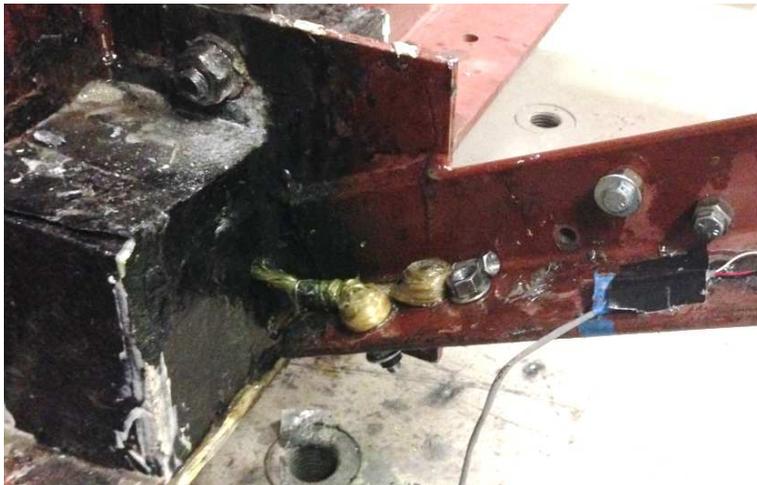
Figure 18: First bolt wrapped in Kevlar fractures at 4,024,848 total cycles

For Trial G1.5 the actuator force range was further increased to a force range of 4.4 kN (1.0 kips) - 48.9 kN (11 kips), at a loading rate of 2 cycles per second. The displacement range of the actuator for this load range was approximately 15 mm (0.58 in.). After 377,000 cycles (4,127,000 total cycles), the welded repair on the tab plate refractured. Testing continued with the fractured weld, the force in the cross frame being fully carried by the Kevlar stitching. When the girder subassembly reached 400,000 cycles (4,150,000 total cycles), the crack on the tab plate propagated all the way to the top bolt hole as shown in Figure 17. After the specimen underwent almost 25,000 additional cycles the closest bolt wrapped in Kevlar on the vertical leg of the cross frame L angle fractured in shear, as shown in Figure 18. Less than 1,000 cycles later, all three of the bolts wrapped in Kevlar on the vertical leg of the L angle fractured in shear as shown in Figure 19. After those bolts fractured the actuator was displacing 19 mm ($\frac{3}{4}$ in.) each load cycle, and for that reason the actuator frequency was lowered from 2Hz to 1Hz. Less than 100 cycles after the three bolts wrapped in Kevlar fractured in shear the tab plate fully fractured above the last bolt hole as shown in Figure 20.

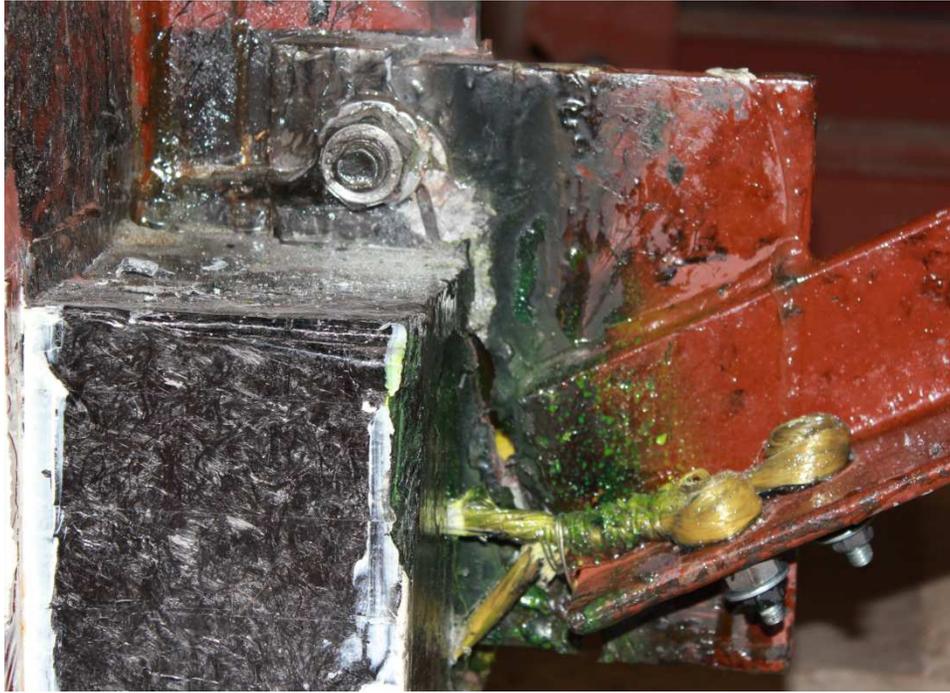
Figure 20: Tab plate fully fractured

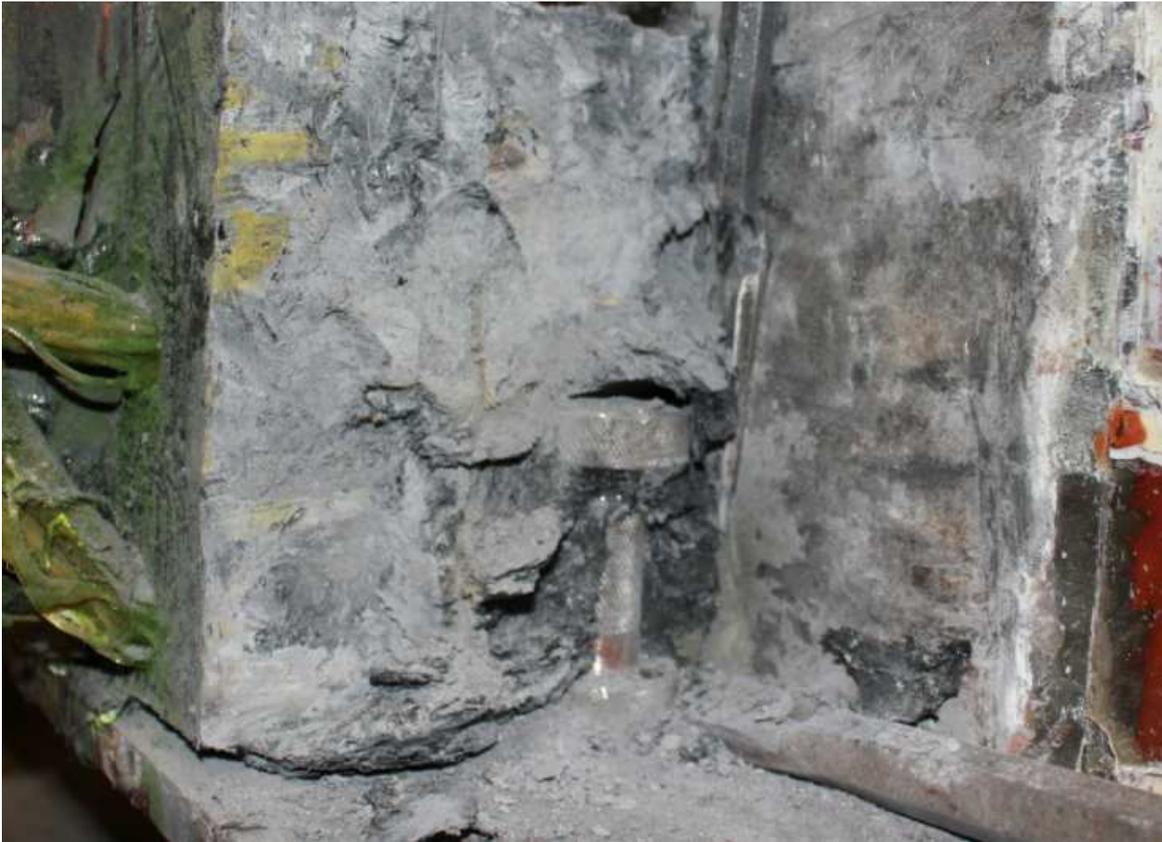
Figure 21: Removing composite block, Bonet stud fully embedded in CFRP

After testing concluded, the composite block retrofit needed to be removed from the lower web-gap region of the girder subassembly to inspect the stiffener side of the web-gap region for crack growth. The composite block was removed with steel chisels, drills and a reciprocating saw. Figure 21 shows the final Bonet Stud in the lower web-gap region of the composite block, on the north side of the girder subassembly. After the studs were removed from the composite block the remainder of the CFRP material was easily detached. With the block successfully removed, the lower web-gap region the crack was visually inspected. Due to the fracture of the tab plate the girder subassembly was unable to be cycled under load to inspect the crack. However, there was no visible crack growth; in fact, epoxy from the CFRP had made its way into the crack during casting of the composite block in the lower web-gap region. This epoxy was still inside the crack after over 4 million cyclic load cycles.

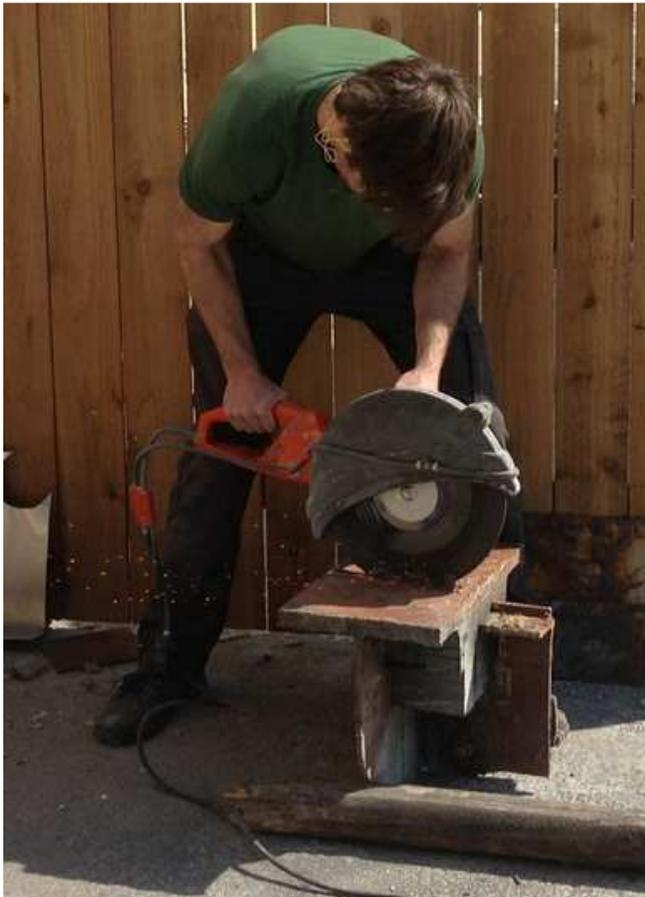
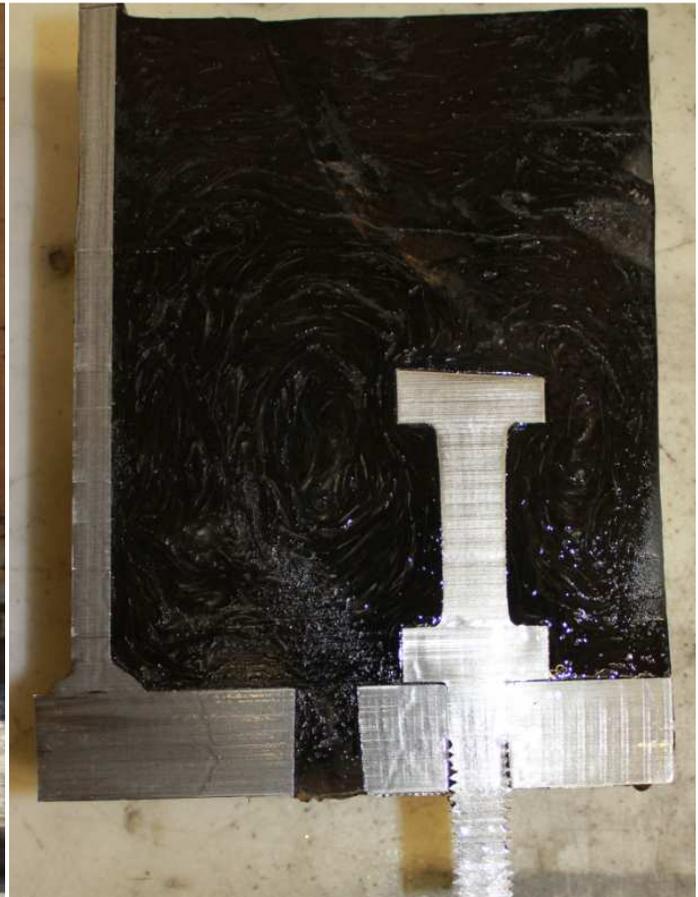
Figure 22: Section cut of composite block in upper web-gap region

The upper web-gap region was detached from the girder subassembly by plasma cutting the section of the girder where the composite block was installed. The detached upper web-gap region was then used for corrosion testing as described in Appendix L. After the corrosion testing was concluded a 355mm (14-in.) chop saw with a steel worker chop saw blade was utilized to take a section cut of the block. Figure 22 shows how the block was cut and a section cut of the composite block in the upper web-gap region. From visually inspecting the section cut of the composite block in the upper web-gap region it appeared that the block had not debonded from the girder web or flange and that the crack in the upper web-gap region did not appear to have experienced growth.

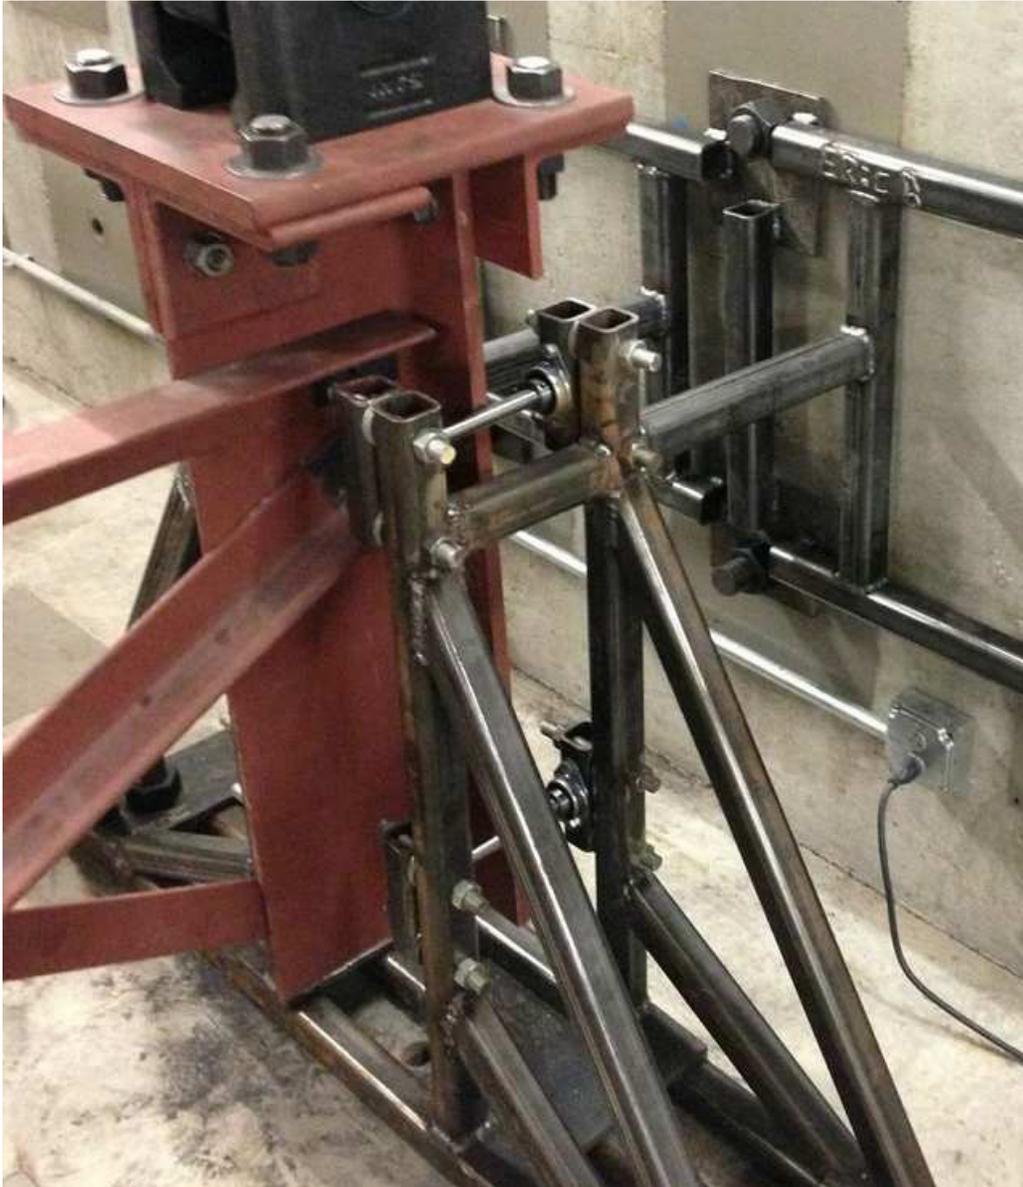
Figure B 4: Horizontal Movement Inhibiting Device

To prevent this horizontal movement a horizontal movement inhibiting device (HMID) was invented and constructed. The structure for the HMID was constructed out of 19-mm (3/4-in.) steel plate and HSS51x51x6-mm (HSS2x2x1/4) tubular steel. The HMID is shown in Figure B 4. 19-mm (3/4-in.) diameter Steel Flange-

Mounted Ball Bearings were mounted to 152-mm (6-in.) long pieces of HSS steel. 203-mm (8-in.) drive shafts were installed in the ball bearings and the drive shafts were placed snug up against the flange of the WT. 19-mm (3/4-in.) diameter washers were used to create space between the frame of the HMID and the steel tubes which the ball bearings were attached to. The HMID was extremely successful in preventing any horizontal movement at the free end of the cross frame.

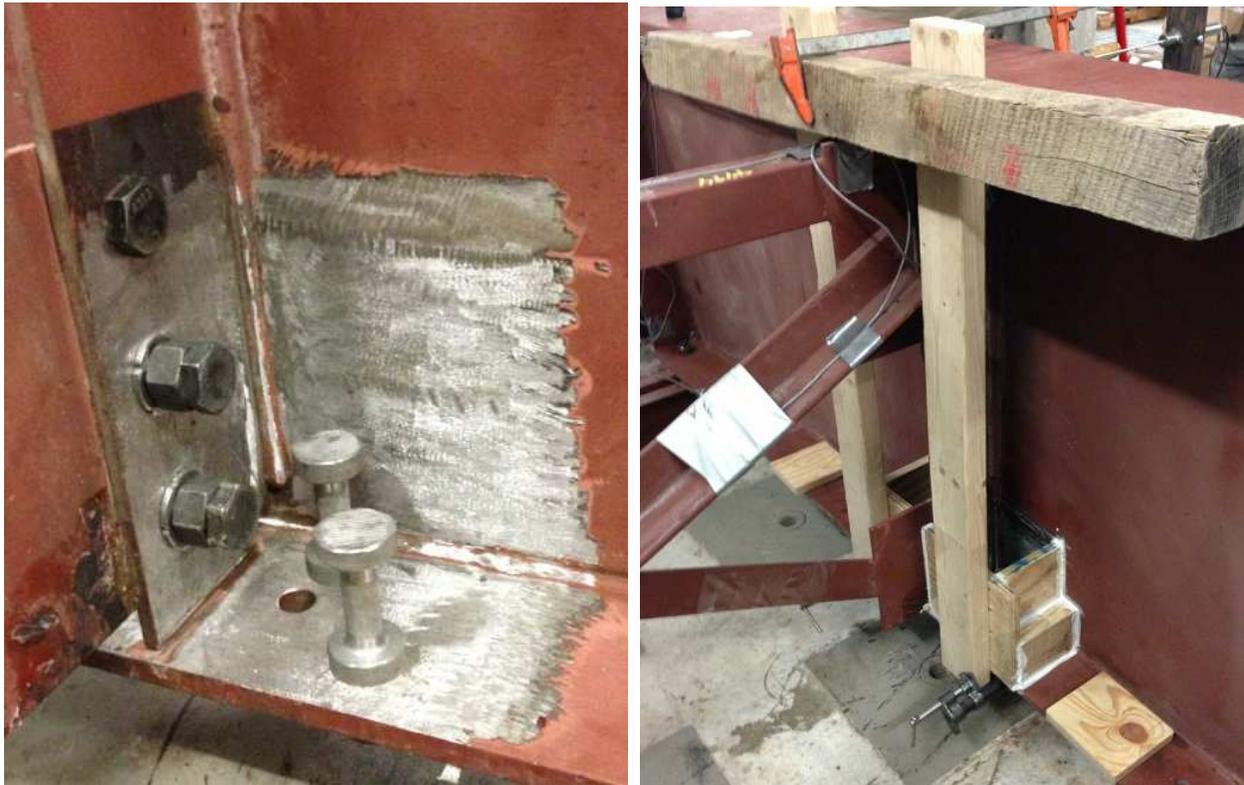
Figure C 3: Web-gap region prepared for the composite block retrofit

the threads drilled out was placed between the head of the bolt and the connection stiffener. This nut was used to create extra surface area for the CFRP to bond to. The Bonet Studs were then bolted to the bottom flange. The bolts were fully-tightened as indicated by TurnaSure Direct Tension Indicator washers. The entire region was then cleaned with Acetone. The prepared web-gap region with the Bonet Studs installed is shown in Figure C 3.

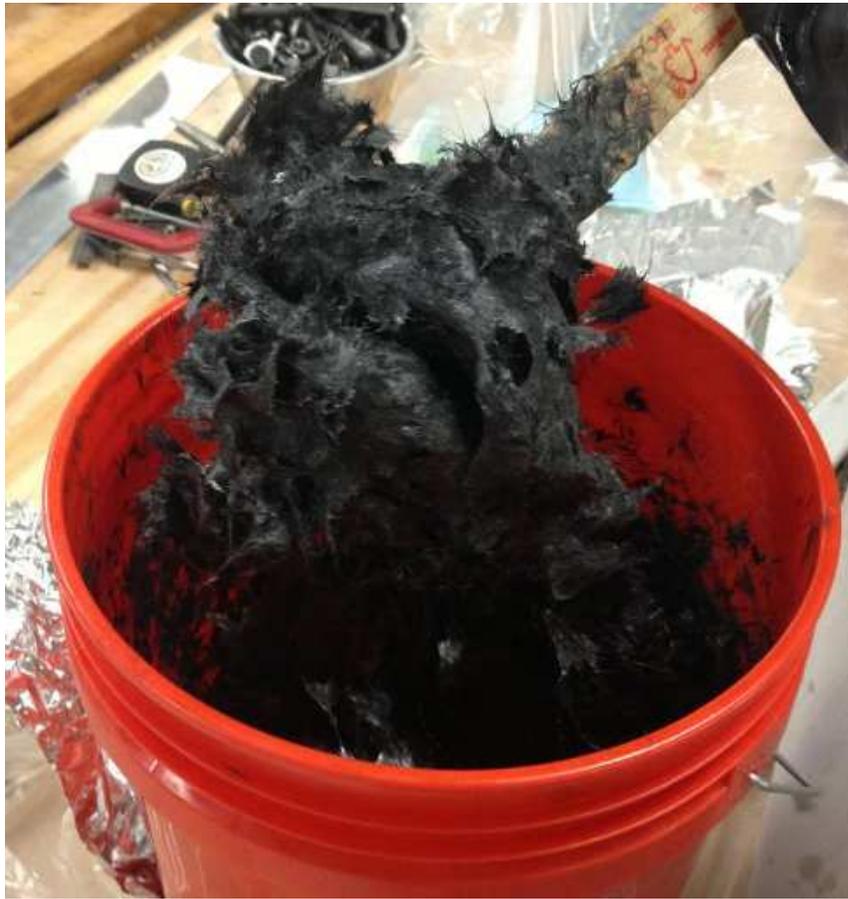
Figure C 4: CFRP mixture after mixing

added. A paint stick was used to mix the fibers and the epoxy together. After all fibers were added the composite was mixed for 5 minutes. Figure C 4 shows the composite mixture after 5 minutes of mixing.

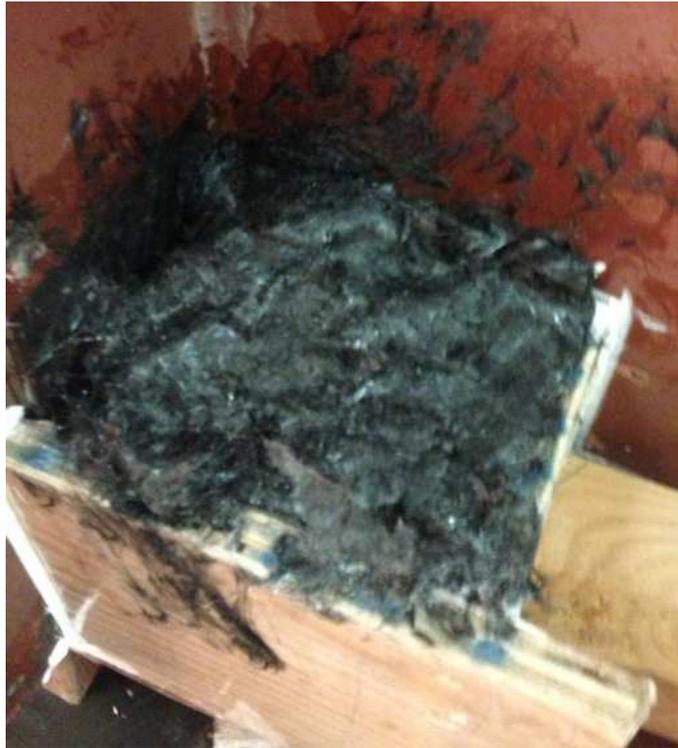
Figure C 5: CFRP inside mold

The CFRP mixture was then put into the mold at the web-gap region. The experimenter took handfuls of the composite and shoved it into the mold until the composite was flush with the top of the box as shown in Figure C 5. A 127x152-mm (5x6-in.) piece of 16-mm (5/8-in.) thick plywood wrapped in packing tape was placed on the top of the box. A 667-mm (26 1/4-in.) long 51x102-mm (2x4-in.) was wedged up against the underside of the girder's top flange. This 51x102-mm (2x4-in.) was used to push the plywood piece on top of the box into the form in order to compact the composite and insure there wouldn't be any air pockets present in the block. Clear epoxy then began to leak through the form insuring that the block was under pressure as shown in Figure C 6. The temperature in the lab when the block was casted was 24.3-C° (75.7-F°).

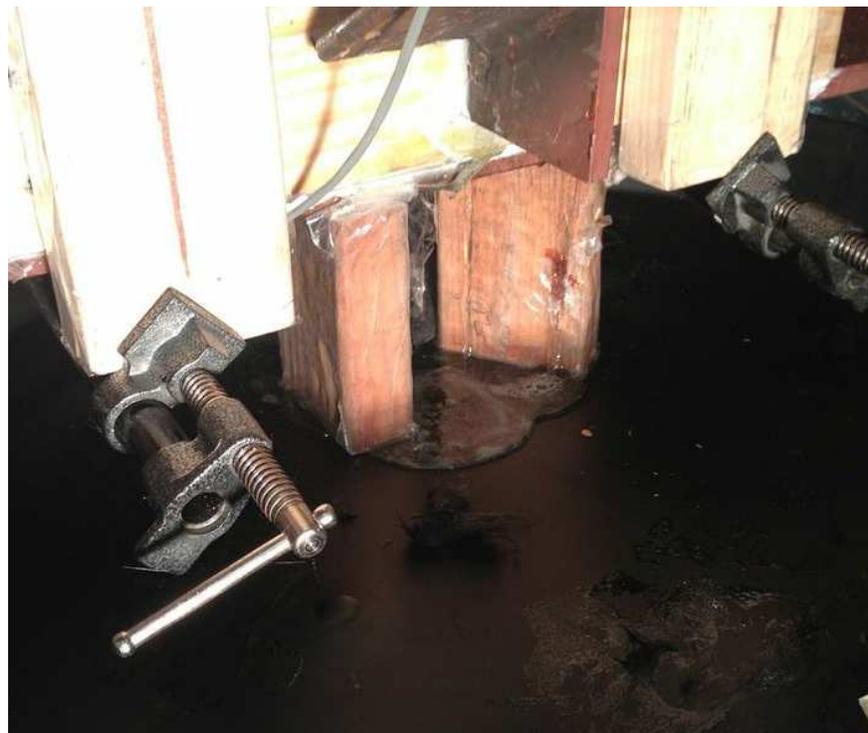
Figure C 6: Epoxy leaking out of mold insuring air pockets wouldn't be present in the block

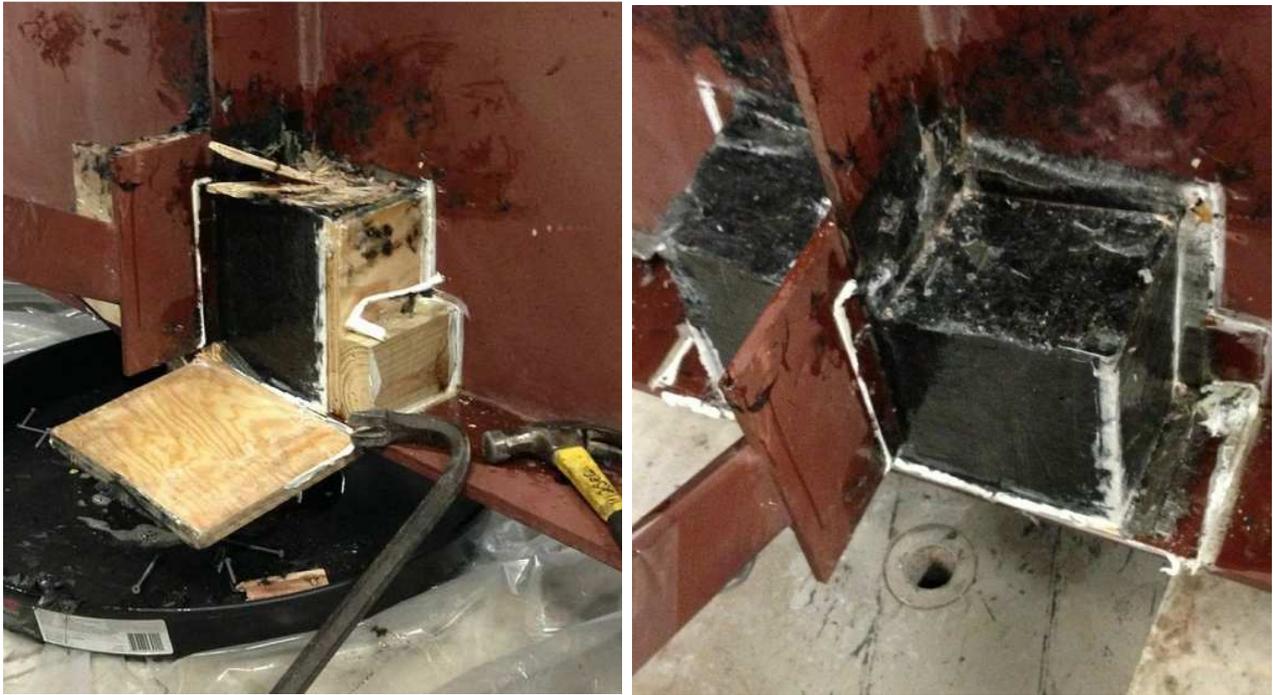
Figure C 7: Cured composite block

The block was given nine full days to cure. On the 10th day of curing the plywood mold was removed. A crowbar and hammer was used to remove the mold from the block. Figure C 7 shows the mold being removed and the fully cured composite block. Testing of the composite block retrofit commenced shortly after the wooden mold was removed and the lab space was cleaned.

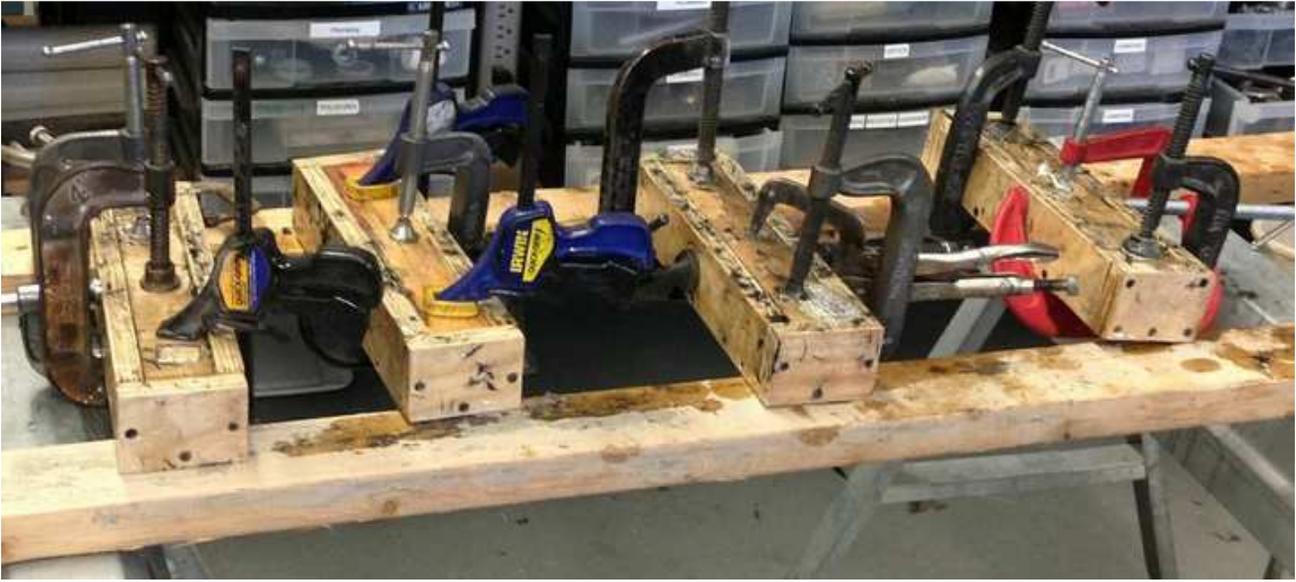
Figure D 6: 25x51x305 mm (1x2x12 in) Tension specimens curing

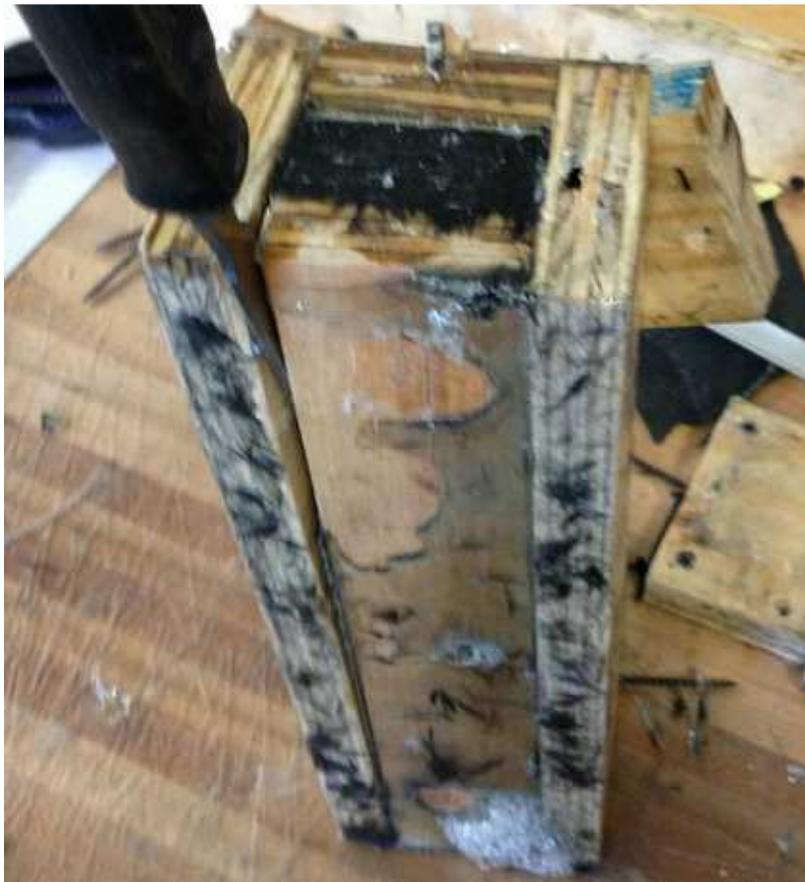
Figure D 7: Removing cured specimen from mold

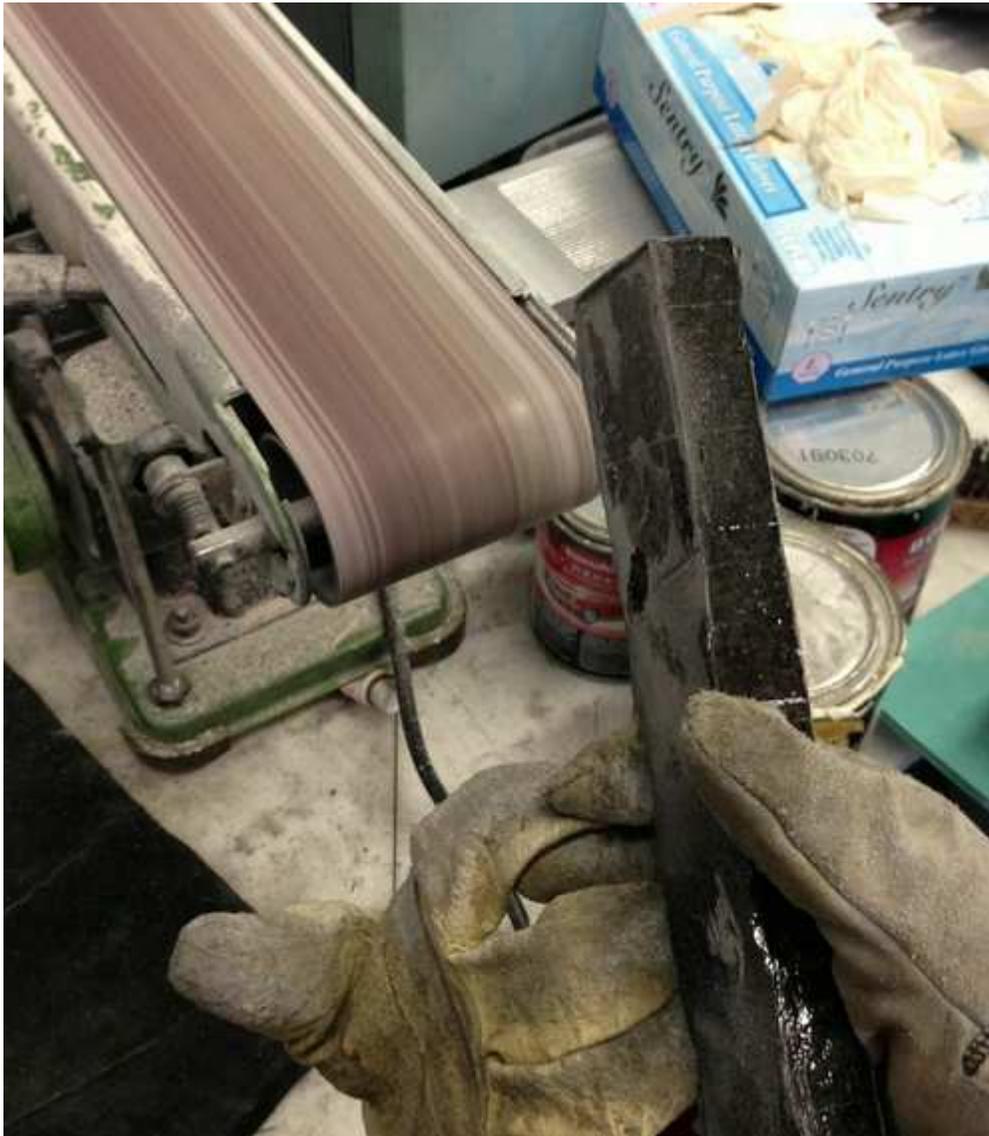
Figure D 8: Sanding specimen

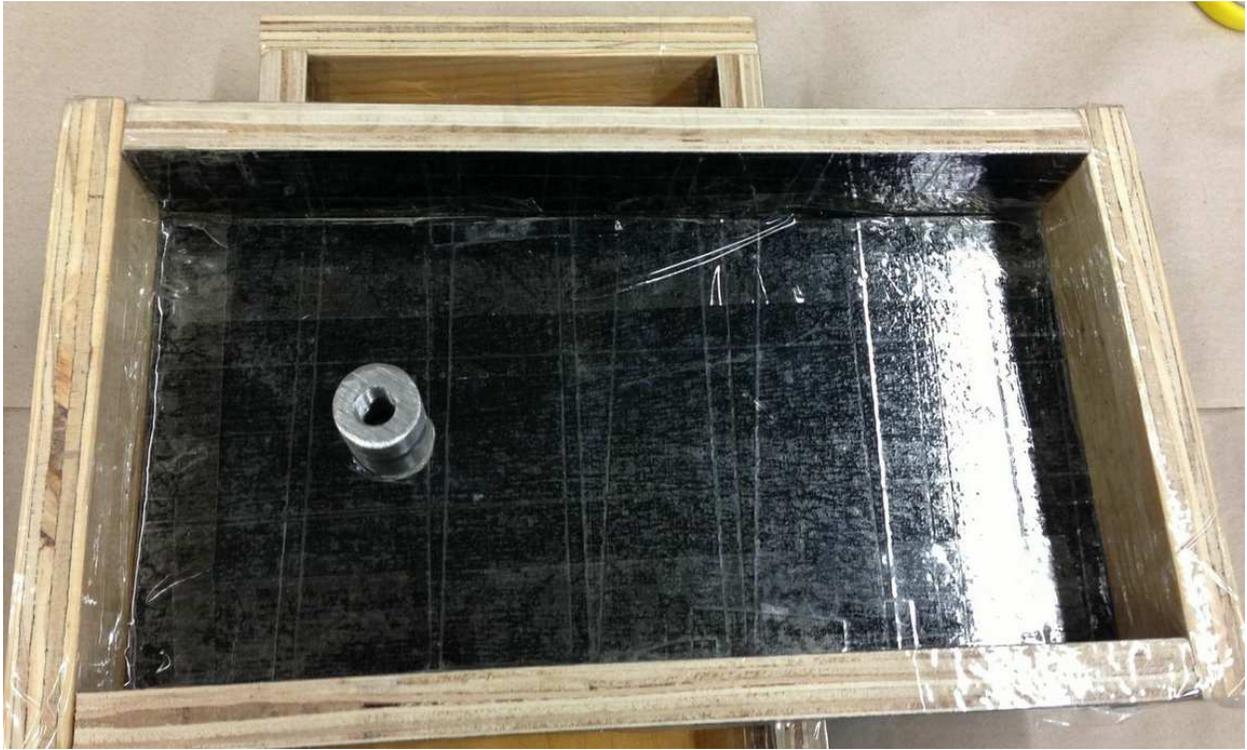
Table E 7: Mold for bearing specimen

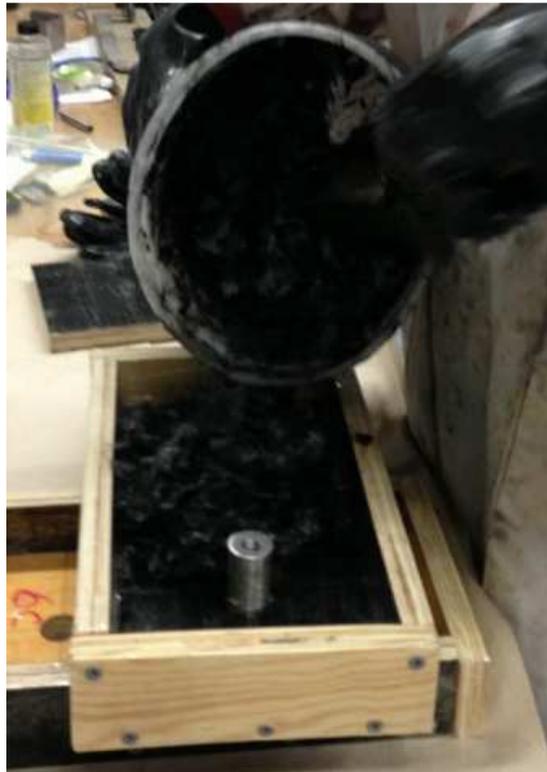
Table E 8: Casting bearing specimen

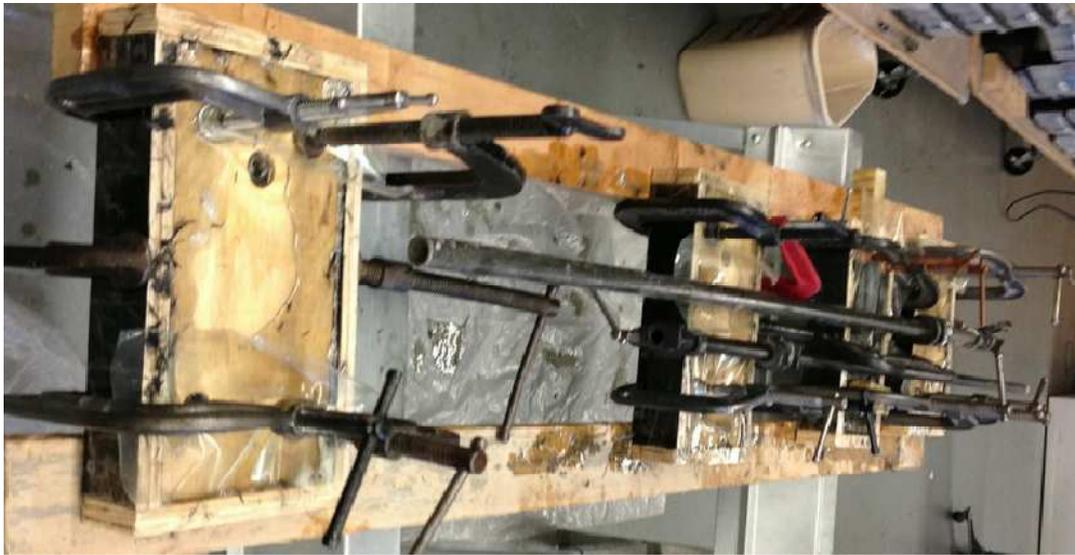
Table E 9: Bearing specimens curing

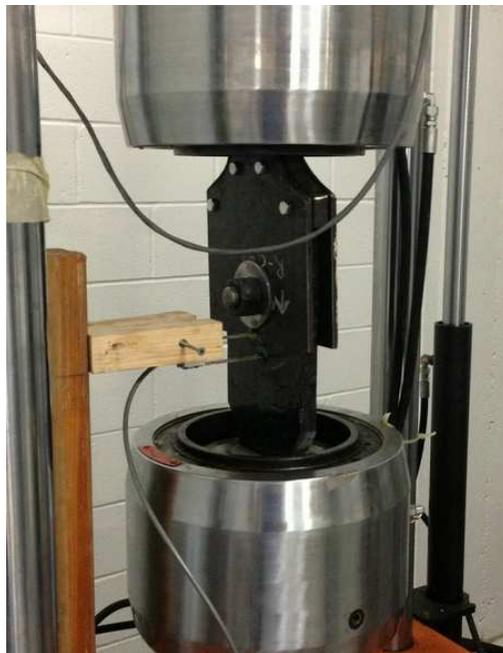
Table E 10: Test setup for bearing specimens

14.1.25 The extensometer used had arms which were spaced 24-mm (1-in.) apart. The extensometer was centered horizontally on the specimen and the lower arm of the extensometer was placed on the composite 146-mm (5 3/4-in.) from the top of the specimen. The upper arm of the extensometer was 24-mm (1-in.) above the lower arm. The extensometer had four 350 Ohm 6-mm (1/4-in) strain gages longitudinally oriented, one on each face of the two arms. They were wired in a wheat stone bridge configuration and connected to a 5V power supply and the Data acquisition system.

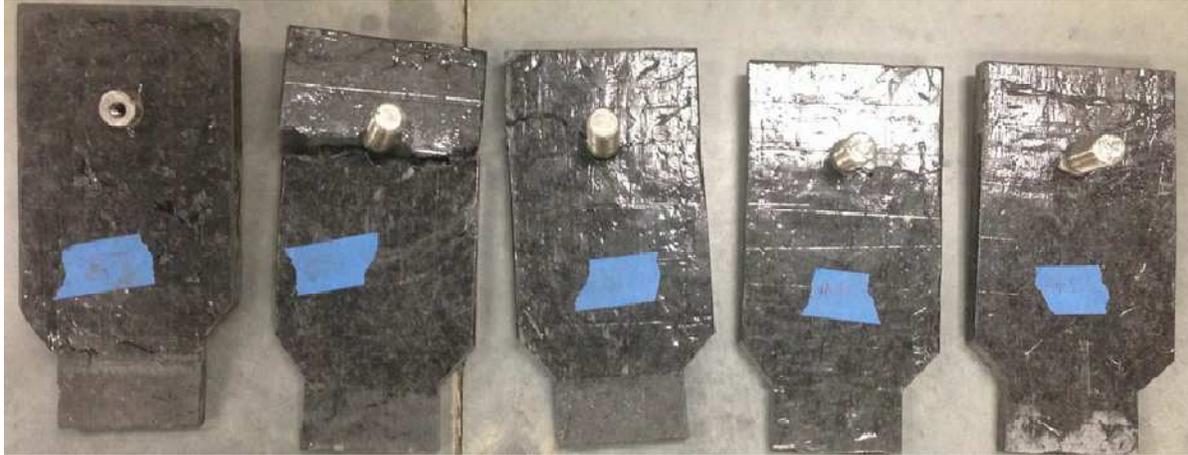
Table E 11: The tested bearing specimens

Specimen #	Failure Mode
1	L(above bottom grip)
2	LII
3	M(bl)II
4	BII
5	BII
