INTERNALLY-CURED LOW-CRACKING HIGH-PERFORMANCE CONCRETE (IC-LC-HPC) BRIDGE DECKS: DURABILITY AND CRACKING PERFORMANCE

Alireza Bahadori

Submitted to the graduate degree program in Civil Engineering and the Graduate Faculty of the University of Kansas in partial fulfillment of the requirements for the degree of Doctor of Philosophy.

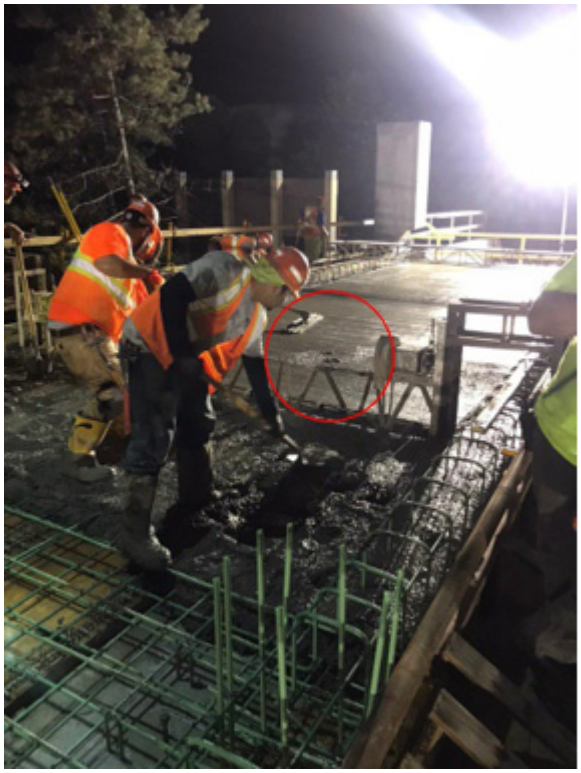
Figure 4.10: Holes in the concrete surface duo to rapid removal of the spud vibrator

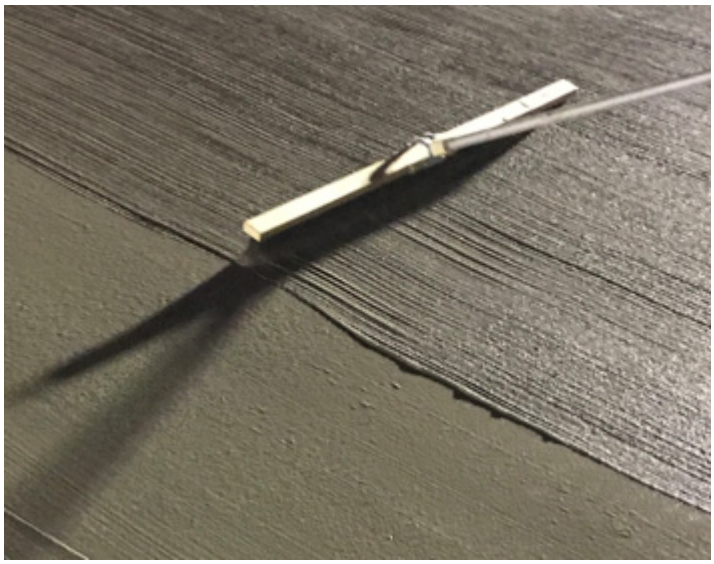
Figure 4.12: Brooming of the deck with the presence of excess water at the surface

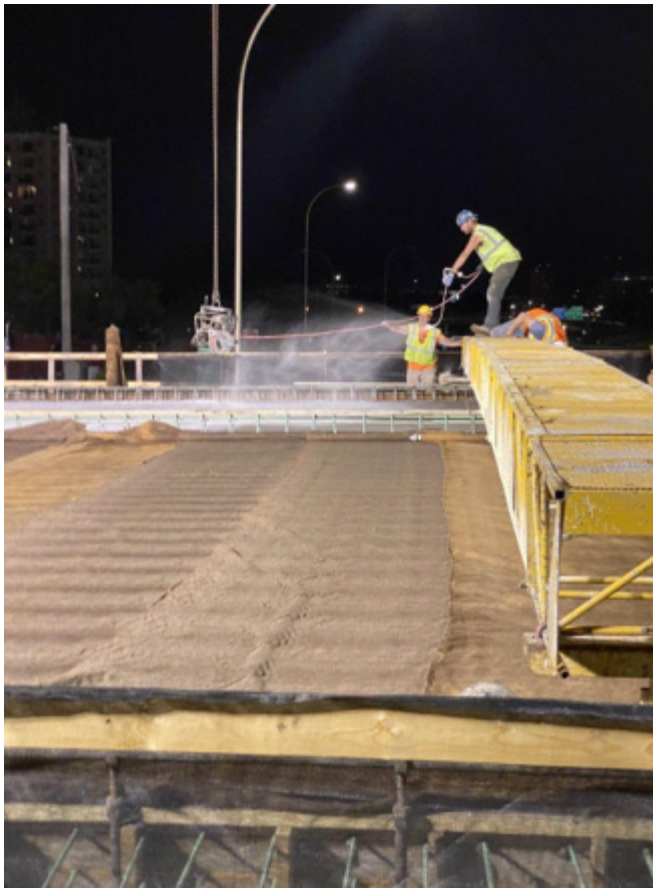
Figure 4.24: The application of curing of the MN-IC-LC-HPC-7-P1

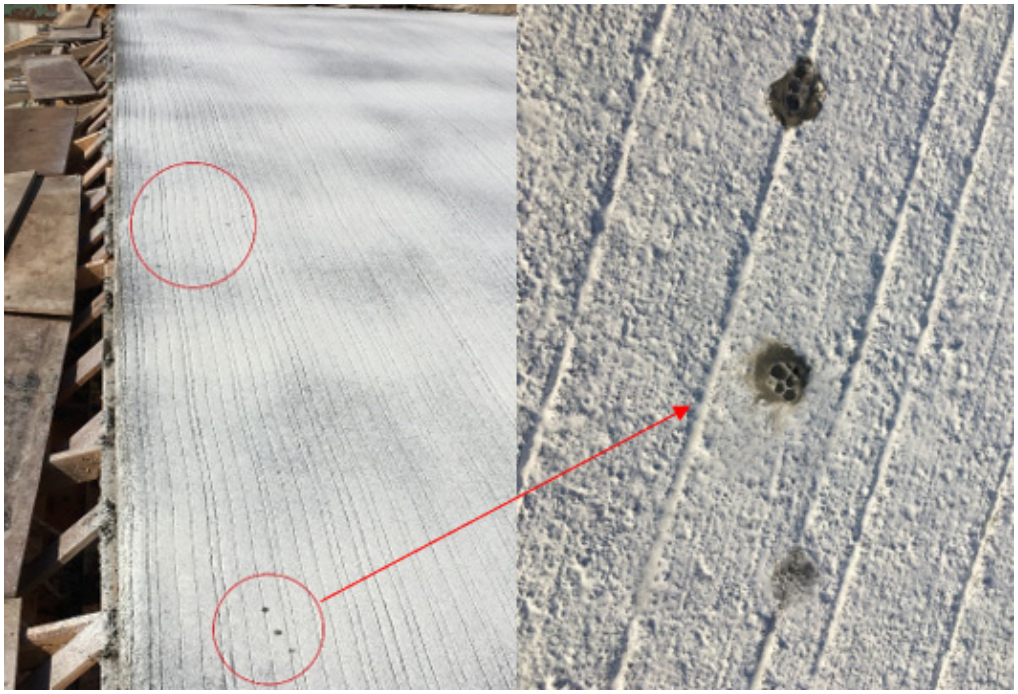
During the placement, MnDOT personnel observed trapped air pockets appearing on the finished surface of the concrete, mainly near the east end abutment, as shown in Figure 4.29.

Figure 4.29: Trapped air pockets on top of the east end abutment (a) overview; (b) close-up (image provided by MnDOT)

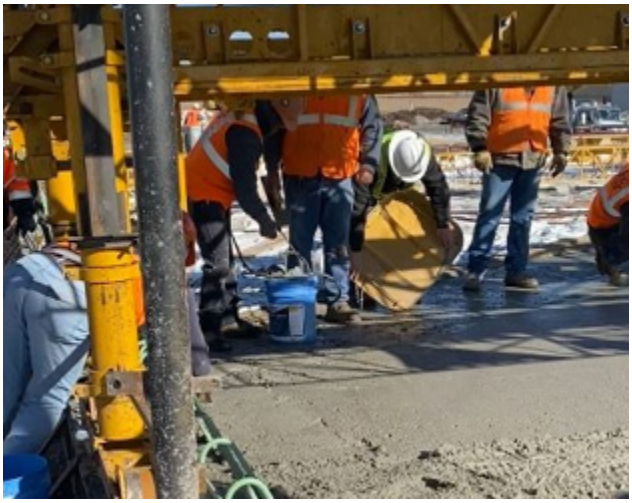
According to Kansas IC-LC-HPC specifications, no finishing aids are permitted. In spite of this, the contractor applied a finishing aid on the concrete for the entire deck, as shown in Figure 4.58. The use of the finishing aid increases the *w/cm* ratio at the surface, which may also contribute to increased scaling (Section 5.3.2.2). This shortcoming was pointed out to the contracted (non-KDOT) inspector who said that this was “not a big deal at this point.”

Figure 4.58: Applying finishing aid to the concrete surface

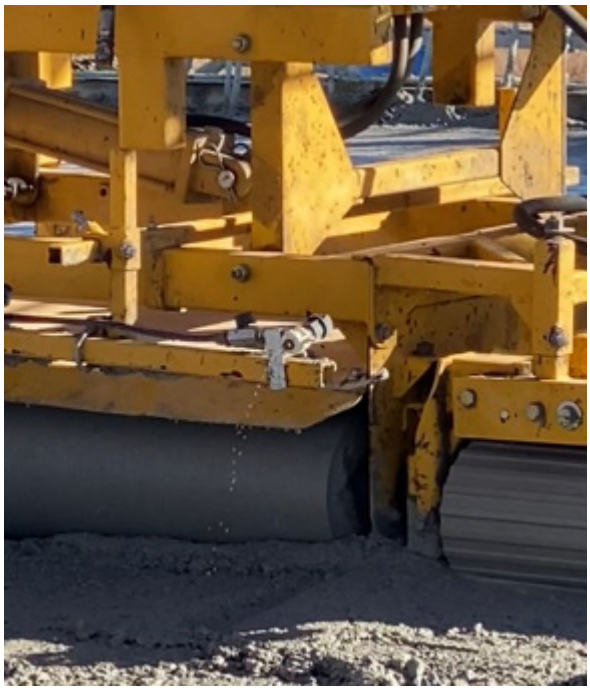
Figure 4.59: Malfunctioning of the fogging system mounted on the finishing machine

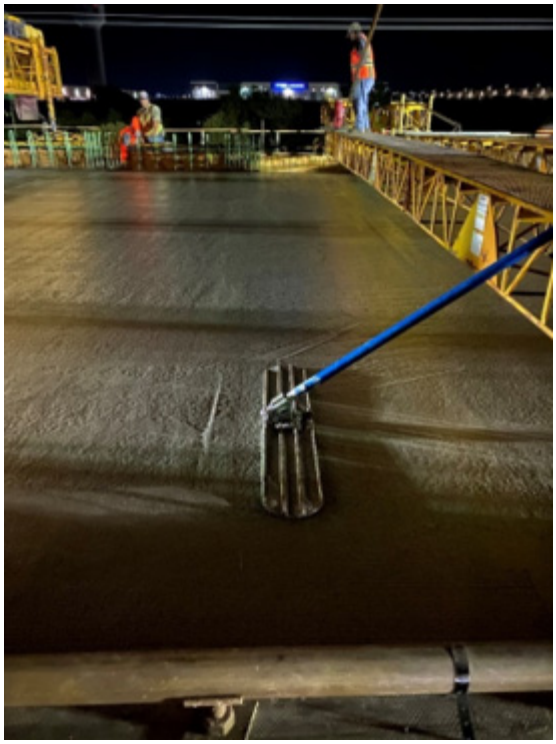
Figure 4.67: Bullfloating in the longitudinal direction along with sheen water on the surface

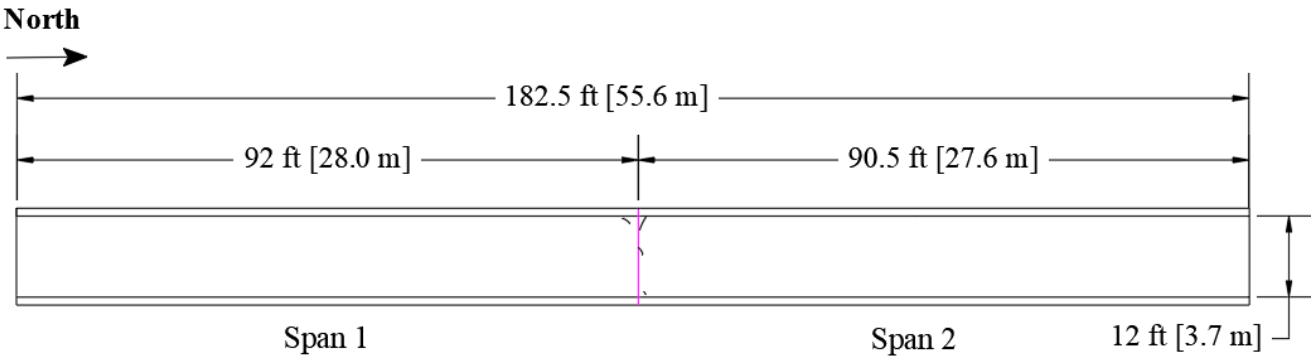
Figure 5.2: Crack map for MN-IC-LC-HPC-1 (Survey 4)

Bridge ID: MN-IC-LC-HPC-1
Bridge Number: 62892
Bridge Location: Mackubin St. over I-94, St. Paul, MN
Construction Date: 9/22/2016
Crack Survey Date: 6/22/2020

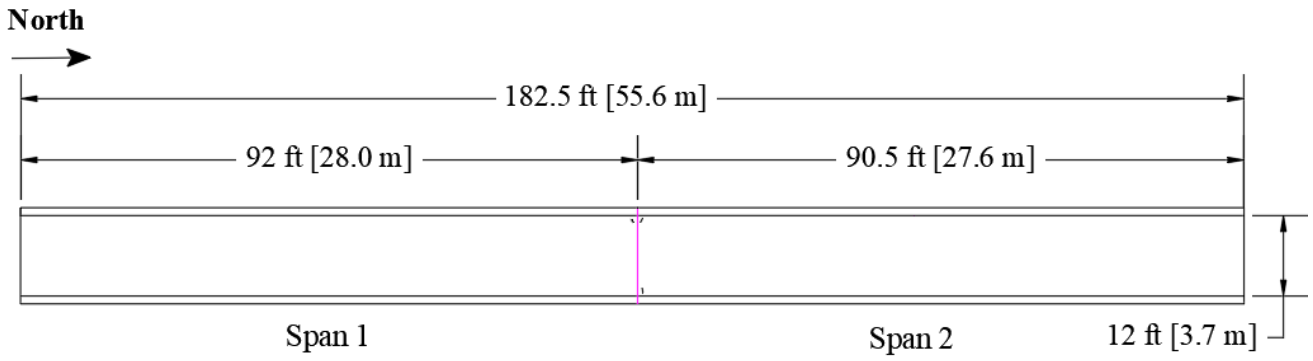
Figure 5.3: Crack map for MN-IC-LC-HPC-1 (Survey 5)

Bridge Age: 56.8 months
Crack Density: 0.003 m/m^2
Span 1: 0.002 m/m^2
Span 2: 0.004 m/m^2

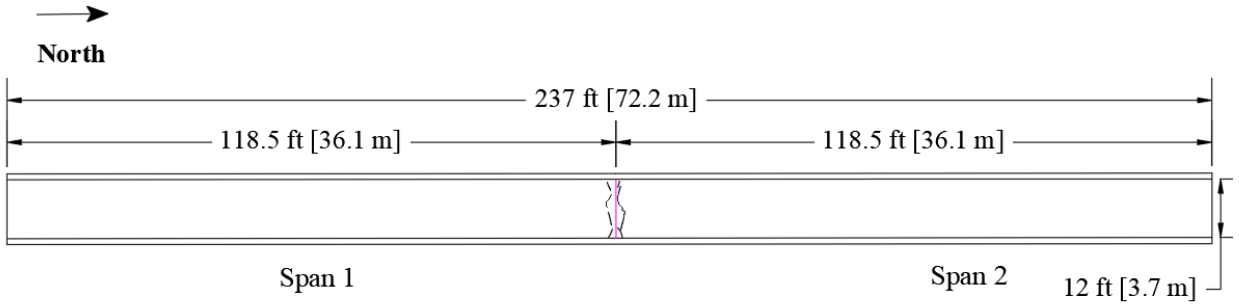
Figure 5.5: Crack map for MN-Control-1 (Survey 4)

Bridge Age: 44.8 months
Crack Density: 0.027 m/m^2
Span 1: 0.023 m/m^2
Span 2: 0.032 m/m^2

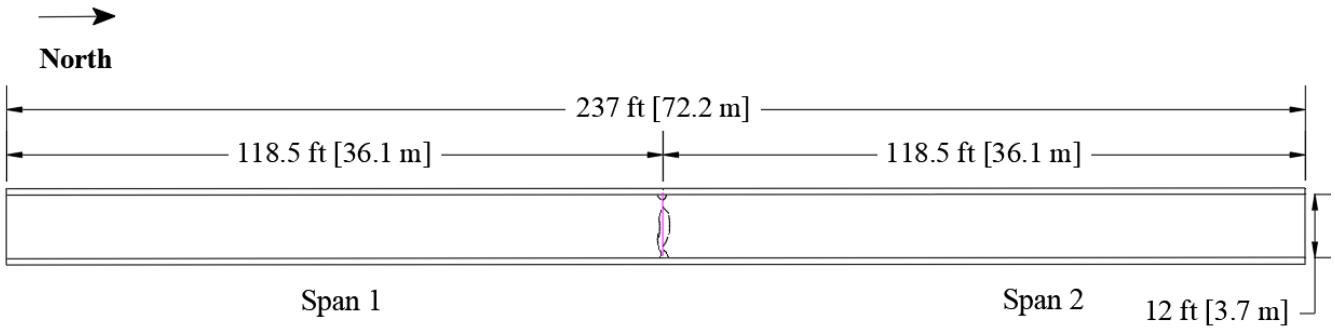
Figure 5.6: Crack map for MN-Control-1 (Survey 5)

Bridge Age: 56.6 months
Crack Density: 0.024 m/m^2
Span 1: 0.025 m/m^2
Span 2: 0.022 m/m^2

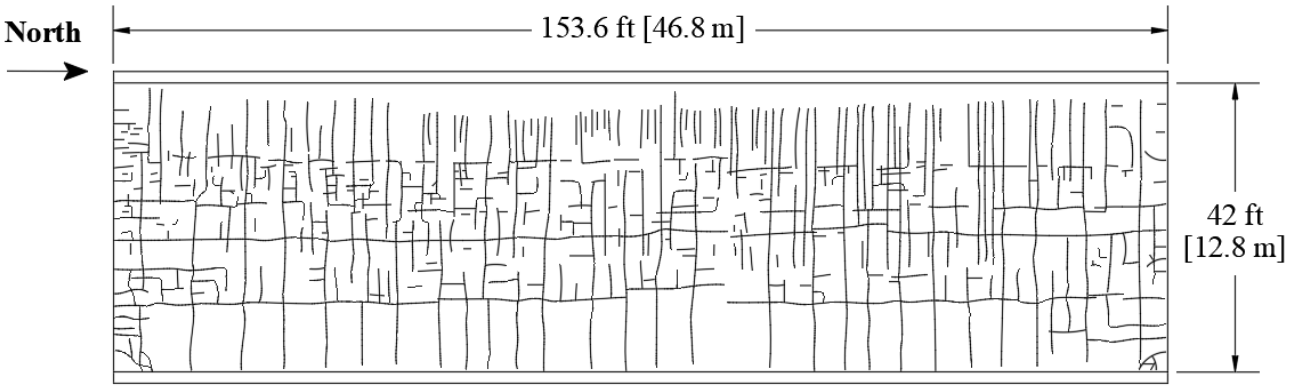
Figure 5.8: Crack map for MN-IC-LC-HPC-2 (Survey 3)

MN-IC-LC-HPC-2 is a two-lane bridge that carries southbound traffic on T.H. 52 over the Little Cannon River, near Cannon Falls. In this study, MN-IC-LC-HPC-2, MN-Control-2, and MN-IC-LC-HPC-3 are the only decks constructed with overlay placements. The substructure was constructed on July 6, 2017 and received a 2-in. (25-mm) wearing course (overlay) on July 21 and July 24, 2017, for the right lane and shoulder, and left lane and shoulder, respectively. This deck has been surveyed three times. With a crack density of 1.429 m/m^2, this bridge exhibited the highest crack density in this study. Survey 1 was performed at a deck age of 10.2 months after substructure construction or 9.6 months after overlay placement, with a crack density of 0.165 m/m^2. The cracks were mainly in the longitudinal direction and concentrated near the north and south abutments, possibly due to restraint from the abutments in the transverse direction (Schmitt and Darwin 1995, Miller and Darwin 2000). In Survey 2, performed at an age of 22.9 months after substructure construction, however, longitudinal and transverse cracks were observed along the full length of the deck, with a crack density of 0.896 m/m^2. In Survey 3, performed at an age of 36.6 months after substructure construction, significant longer transverse and longitudinal

cracking was found throughout the deck. The transverse cracks extended across the entire surveyed width along the full length of the bridge. A number of longitudinal cracks were found mainly near the centerline of the deck, with cracks ranging in length from 1 to 90 ft (0.3 to 27.4 m), 5 to 10 ft (1.5 to 3.1 m) apart along the bridge width. Crack widths in Survey 3 ranged from 0.009 to 0.016 in. (0.23 to 0.41 mm), with an average of 0.012 in. (0.31 mm). The high crack density on MN-IC-LC-HPC-2 is likely the result of the overlay, as it has been addressed in a number of studies (Miller and Darwin 2000, Lindquist et al. 2005, Pendergrass and Darwin 2014, Lafikes et al. 2020). Miller and Darwin (2000) and Lindquist et al. (2005) reported greater cracking in decks with concrete overlays than for monolithic decks (one coarse) with similar characteristics. Additionally, the MN-IC-LC-HPC-2 overlay was placed in July 2017, and one possible contributor to the especially poor cracking performance of this deck could be that the restrained drying shrinkage of the overlay was exacerbated by high air temperatures. The most recent crack map (Survey 3) is shown in Figure 5.8. Additional details associated with Surveys 1 and 2 of MN-IC-LC-HPC-2 are documented by Lafikes et al. (2020).

Bridge Age: 36.6 months
Crack Density: 1.429 m/m^2

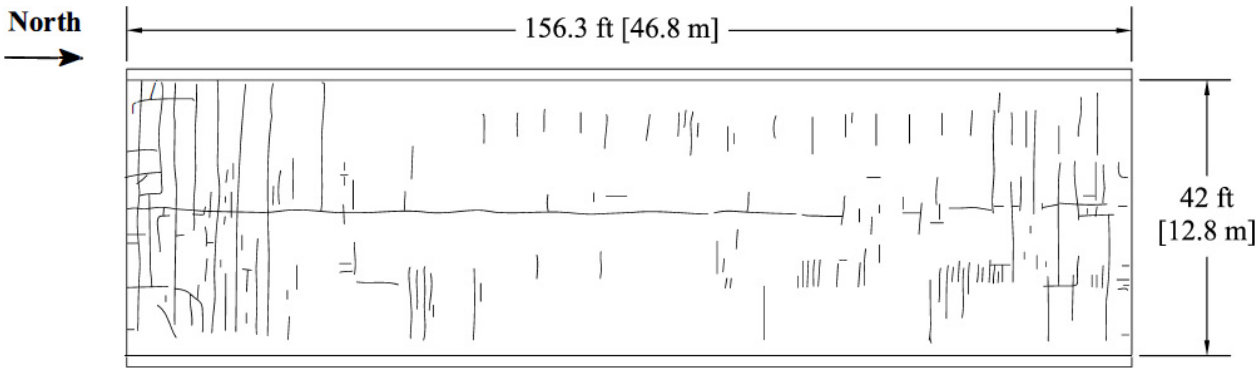
Figure 5.9: Crack map for MN-Control-2 (Survey 3)

The associated control deck for MN-IC-LC-HPC-2, MN-Control-2, is a two-lane bridge that carries northbound traffic on T.H. 52 over the Little Cannon River, near Cannon Falls. The substructure was constructed on September 15, 2017 and received a 2-in. (25-mm) wearing course (overlay) on September 28 and September 30, 2017, for the right lane and shoulder and the left lane and shoulder, respectively. This deck has been surveyed three times. Survey 1 was performed at a deck age of 7.8 months after substructure construction or 7.3 months after overlay placement, with no observable cracks. Survey 2 was performed at a deck age of 20.6 months after substructure construction, with a crack density of 0.050 m/m^2. In Survey 2, the cracks were mainly concentrated near the north and south abutments. Some longitudinal cracks extended from the south abutment. One longer transverse crack, approximately 20 ft (6.1 m) in length, had developed approximately 5 ft (1.5 m) from the south abutment. Crack widths in Survey 2 ranged from 0.003 to 0.007 in. (0.08 to 0.18 mm), with an average of 0.005 in. (0.13 mm). Survey 3 was performed at a deck age

of 34.3 months after substructure construction, with a crack density of 0.539 m/m^2. The crack density observed in Survey 3 was significant compared to 0.050 m/m^2 in Survey 2, but not unexpected since it often takes three years to establish the cracking performance of bridge decks – even decks that perform well during the first two years (Lindquist et al. 2008, Yuan et al. 2011, Pendergrass and Darwin 2014). Longer transverse cracking was found throughout the deck. The transverse cracks extended across the entire surveyed width near the south end. A longer longitudinal crack, approximately 90 ft (27.4 m) in length, had developed from the south abutment near the centerline. Crack widths in Survey 3 ranged from 0.004 to 0.020 in. (0.10 to 0.51 mm), with an average of 0.011 in. (0.28 mm). One possible reason for the better cracking performance of this deck compared to its pair (MN-IC-LC-HPC-2) could be the placement of its overlay in a milder environmental condition. The MN-Control-2 overlay was placed in September when the cooler ambient temperatures would have helped reduce rapid drying shrinkage, exacerbated by higher temperatures for the MN-IC-LC-HPC-2 overlay placed in July. Due to the placement of overlay on MN-Control-2, the effects of fibers in the substructure could not be investigated. The most recent crack map (Survey 3) is shown in Figure 5.9. Additional details associated with Surveys 1 and 2 of MN-Control-2 are documented by Lafikes et al. (2020).

Bridge Age: 34.3 months
Crack Density: 0.539 m/m^2

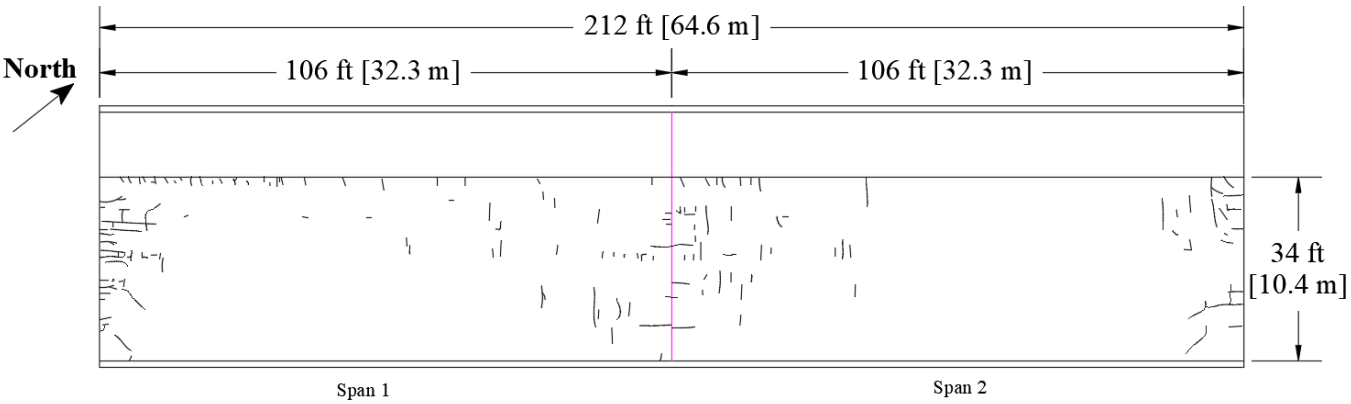
Figure 5.10: Crack map for MN-IC-LC-HPC-3 (Survey 3)

MN-IC-LC-HPC-3 is a two-way bridge that carries traffic on T.H. 58 over T.H. 52 in Zumbrota. The subdeck was constructed in one placement on June 29, 2017. The deck received a 2-in. (25-mm) wearing course (overlay) on September 7 and September 9, 2017. The 34-ft (10.4 m) wide roadway of the deck has been surveyed three times. Survey 1 was performed at a deck age of 10.4 months after substructure construction or 8.1 months after overlay placement, with no observable cracks. Survey 2 was performed at a deck age of 23.2 months after substructure construction, with a crack density of 0.042 m/m^2. In Survey 2, the cracks were mainly concentrated near the north and south abutments, as well as the center pier. Some longitudinal cracks extended from each abutment, with cracks ranging in length from 1 to 2.5 ft (0.3 to 0.8 m). Transverse cracks, between 1 and 8 ft (0.3 and 2.4 m) in length, also formed within 19 ft (5.8 m) on each side of the center pier. Crack widths in Survey 2 ranged from 0.003 to 0.006 in. (0.08 to 0.15 mm), with an average of 0.004 in. (0.10 mm). Survey 3 was performed at a deck age of 36.8 months

after substructure construction, with a crack density of 0.161 m/m^2. In Survey 3, the extent and the number of transverse and longitudinal cracks increased. Several cracks were found in the shoulder area on the west side of the deck, mainly in span 1. A number of longitudinal cracks were also formed over the piers, with cracks ranging from 1 to 7 ft (0.3 to 2.1m) in length. Some diagonal cracks were observed near each abutment, with approximately 5 ft (1.5 m) in length. Crack widths in Survey 3 ranged from 0.005 to 0.007 in. (0.13 to 0.18 mm), with an average of 0.006 in. (0.15 mm). With the overlay placed in September and cured in cooler ambient temperatures as well as incorporating IC water, MN-IC-LC-HPC-3 exhibited the lowest crack density at a given deck age compared to other overlay decks in this study. The most recent crack map (Survey 3) is shown in Figure 5.10. Additional details associated with Surveys 1 and 2 of MN-IC-LC-HPC-3 are documented by Lafikes et al. (2020).

Bridge Age: 36.8 months
Crack Density: 0.161 m/m^2
Span 1: 0.181 m/m^2
Span 2: 0.142 m/m^2

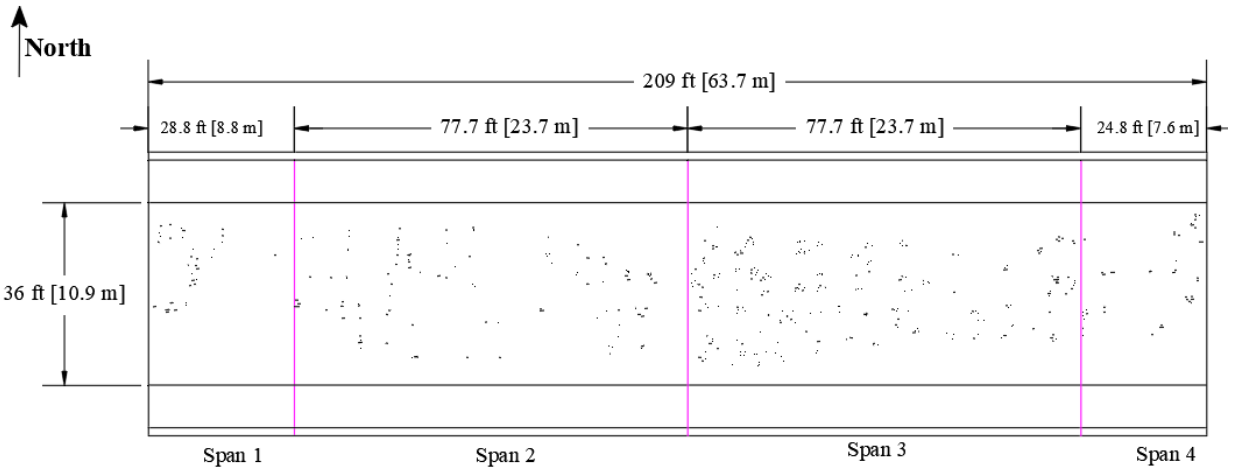
Figure 5.11: Crack map for MN-IC-LC-HPC-4 (Survey 2)

Bridge Age: 37.0 months
Crack Density: 0.045 m/m^2
Span 1: 0.033 m/m^2
Span 2: 0.034 m/m^2
Span 3: 0.061 m/m^2
Span 4: 0.046 m/m^2

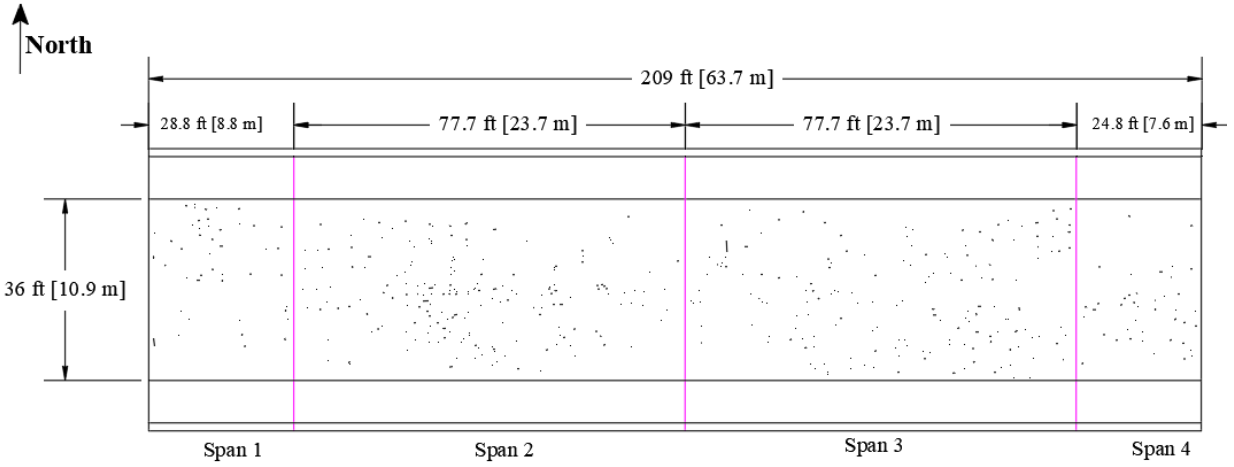
Figure 5.12: Crack map for MN-IC-LC-HPC-4 (Survey 3)

MN-IC-LC-HPC-4 is a two-way bridge that carries traffic on 38th St. over I-35W in Minneapolis. The deck was constructed in one placement on May 15, 2018. The 36-ft (11-m) wide roadway has been surveyed three times and exhibited a crack density as low as 0.046 m/m^2 at a deck age of 48.3 months. Survey 1 was performed at a deck age of 16.0 months, with a crack density of 0.005 m/m^2. In Survey 1, the majority of cracks were in the transverse direction and were distributed over spans 1 and 3 of the deck. A few longitudinal cracks were located near the middle of spans 2 and 3. No cracking was observed in span 4. The bridge deck was not surveyed in the second year after the construction. Surveys 2 and 3 were performed at ages of 37.0 and 48.3 months, respectively. The overall crack density did not noticeably change in Surveys 2 and 3, with values of 0.045 and 0.046 m/m^2, respectively. The majority of cracks in Surveys 2 and 3 were short longitudinal and transverse cracks (crack lengths below 1 ft. [305 mm]) distributed over the entire deck area with crack widths ranging from 0.002 to 0.007 in. (0.05 to 0.18 mm) and an average of 0.003 in. (0.08 mm). One larger transverse crack was also observed in span 3 with a crack length of 2 ft (0.6 m). Some surface damage was observed due to poor tining of the deck, as reported by Lafikes et al. (2020). The most recent crack maps (Surveys 2 and 3) are shown in Figures 5.11 and 5.12. Additional details associated with Survey 1 of MN-IC-LC-HPC-4 are documented by Lafikes et al. (2020).

Bridge Age: 48.7 months
Crack Density: 0.046 m/m^2
Span 1: 0.042 m/m^2
Span 2: 0.049 m/m^2
Span 3: 0.046 m/m^2
Span 4: 0.043 m/m^2

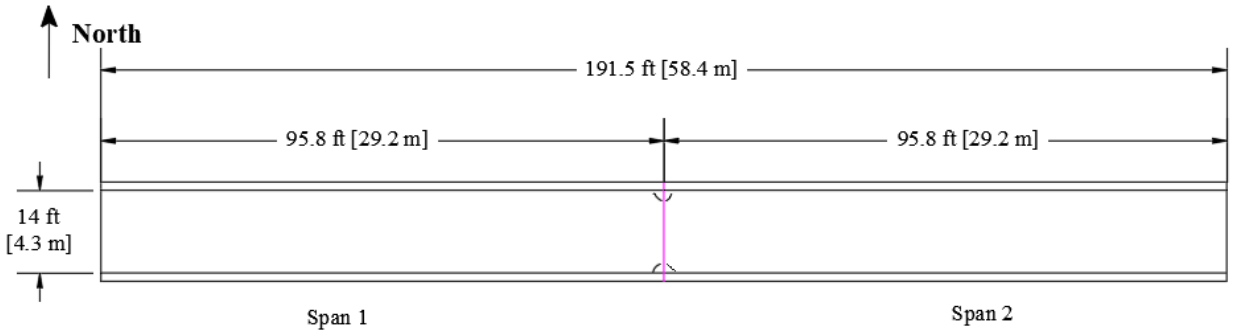
Figure 5.13: Crack map for MN-IC-LC-HPC-5 (Survey 1)

Bridge Age: 11.0 months
Crack Density: 0.009 m/m^2
Span 1: 0.009 m/m^2
Span 2: 0.009 m/m^2

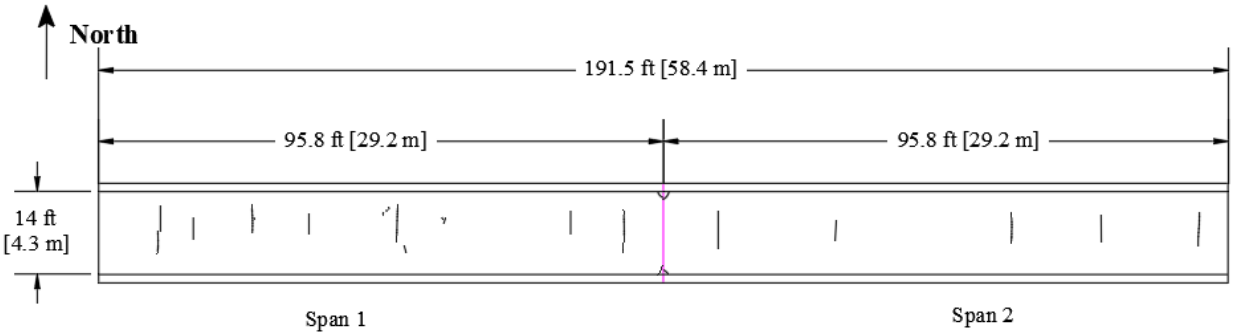
Figure 5.14: Crack map for MN-IC-LC-HPC-5 (Survey 2)

Bridge Age: 22.7 months
Crack Density: 0.091 m/m^2
Span 1: 0.112 m/m^2
Span 2: 0.069 m/m^2

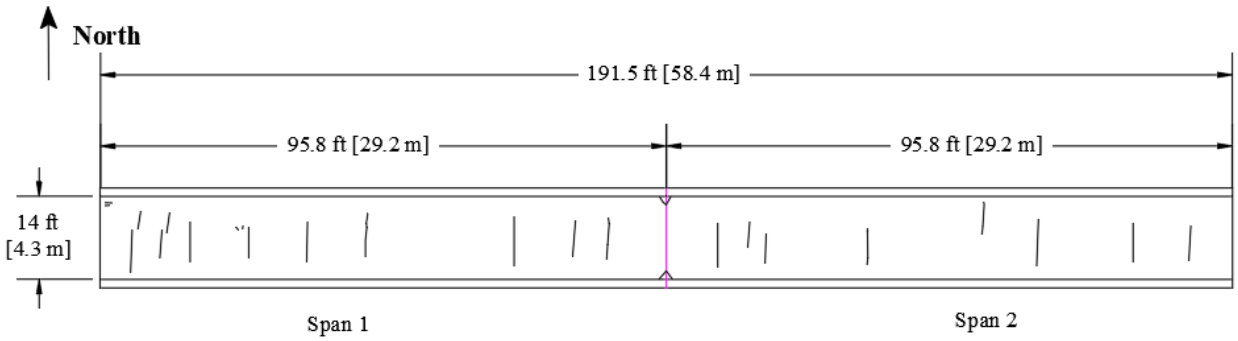
Figure 5.15: Crack map for MN-IC-LC-HPC-5 (Survey 3)

MN-IC-LC-HPC-5 is a pedestrian bridge located at 40th St. over I-35W in Minneapolis. The deck was constructed in one placement on July 23, 2019. This deck has been surveyed three times since 2019 and has exhibited the highest crack densities at a given age of the pedestrian bridge decks (MN-IC-LC-HPC-1 and MN-Control-1) constructed in this study. Survey 1 was performed at a deck age of 11.0 months, with a crack density of 0.009 m/m^2. In Survey 1, only a number of diagonal cracks were observed on either side of the contraction joint over the center pier, with crack lengths ranging from 1.5 to 2 ft (0.5 to 0.6 m). Survey 2 was performed at a deck age of 22.7 months, with a crack density of 0.091 m/m^2, an increase from the 0.009 m/m^2 density observed during Survey 1. Some long transverse cracks were observed over the entire deck, mainly with lengths of 3 to 6 ft (0.9 to 1.8 m). Crack widths in Survey 2 ranged from 0.004 to 0.007 in. (0.10 to 0.18 mm), with an average of 0.006 in. (0.152 mm). Survey 3 was conducted at a deck age of 34.1 months and had transverse cracks that extended almost one-third of the deck width, with a crack density of 0.153 m/m^2. Crack widths in Survey 3 ranged from 0.010 to 0.050 in. (0.25 to 1.27 mm), with an average of 0.019 in. (0.48 mm). The crack maps associated with Surveys 1 to 3 are shown in Figures 5.13 to 5.15, respectively. As discussed in Section 4.4.7, the cracking performance of the deck may have been affected due to inadequate consolidation, as observed during the construction. Construction personnel were observed walking through areas that had been previously vibrated, resulting in deconsolidation of the concrete. As demonstrated in multiple decks in Kansas, inadequate consolidation can result in a higher crack density (McLeod et al. 2009, Khajehdehi and Darwin 2018).

Bridge Age: 34.1 months
Crack Density: 0.153 m/m^2
Span 1: 0.179 m/m^2
Span 2: 0.127 m/m^2

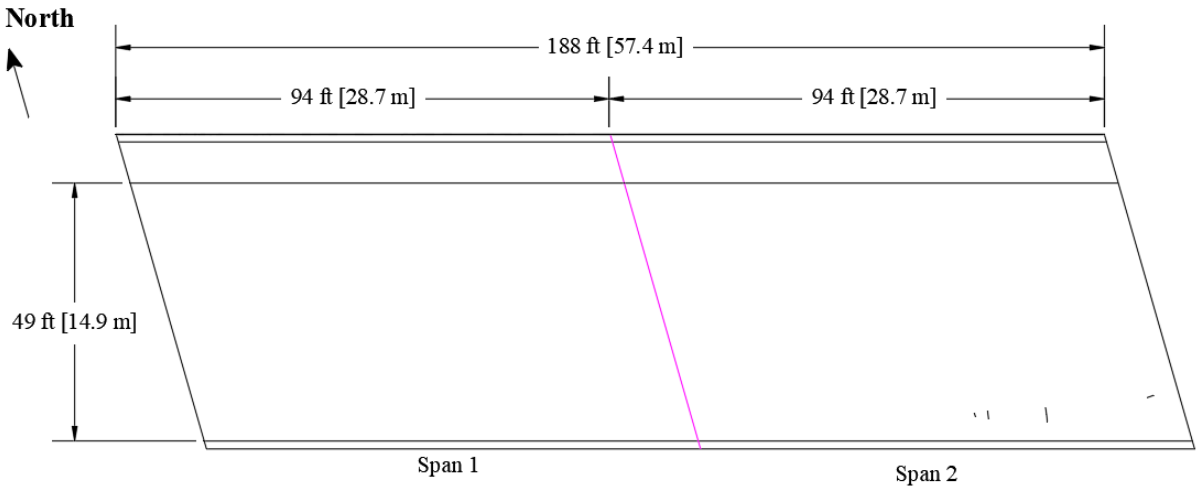
Figure 5.17: Crack map for MN-IC-LC-HPC-6 (Survey 1)

Bridge Age: 10.8 months
Crack Density: 0.002 m/m^2
Span 1: 0.000 m/m^2
Span 2: 0.005 m/m^2

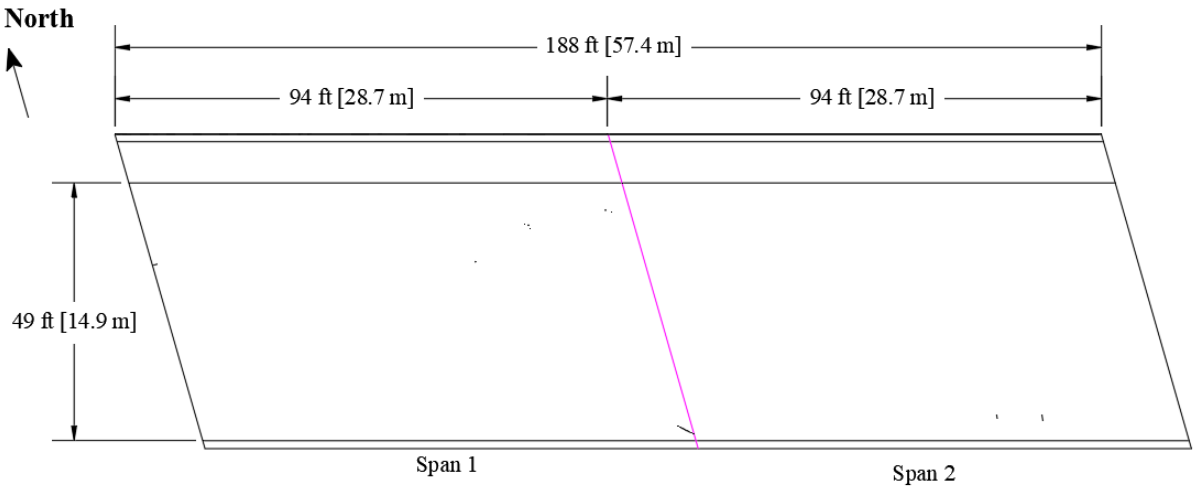
Figure 5.18: Crack map for MN-IC-LC-HPC-6 (Survey 2)

Bridge Age: 20.9 months
Crack Density: 0.003 m/m^2
Span 1: 0.004 m/m^2
Span 2: 0.001 m/m^2

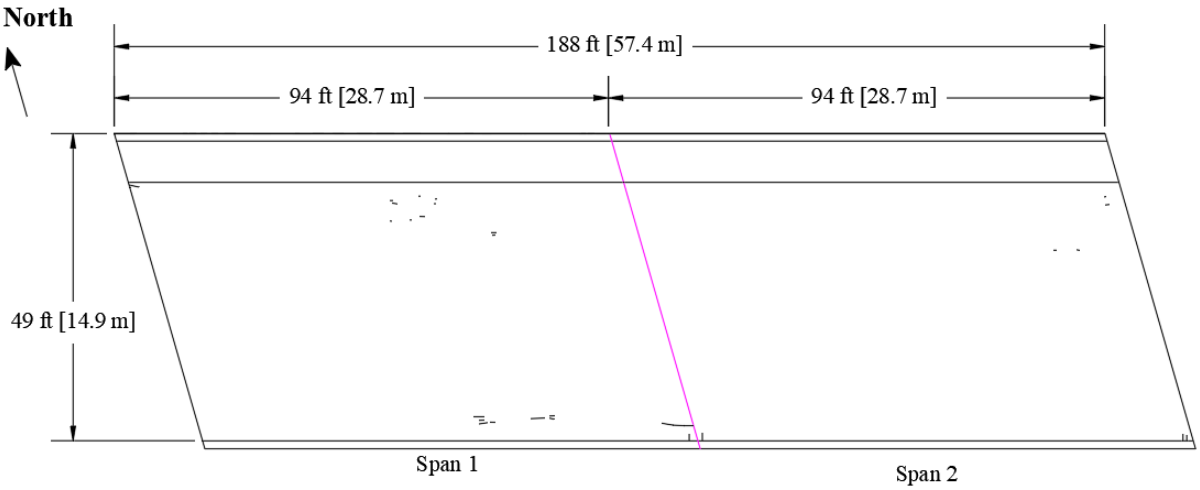
Figure 5.19: Crack map for MN-IC-LC-HPC-6 (Survey 3)

mm]). One diagonal crack was extended from the central pier, with approximately 3.5 ft (1.1 m) in length. Survey 3 was performed at a deck age of 32.2 months with a crack density of 0.011 m/m^2. Both the number and the length of cracks increased compared to Survey 2, and similar to previous years, the cracks were short and scattered at discrete locations on the deck. A number of longitudinal cracks were found, mostly on the south side of span 1, with crack lengths ranging from 1 to 6 ft (0.3 to 1.8 m). Crack widths in Survey 3 ranged from 0.003 to 0.016 in. (0.08 to 0.41 mm), with an average of 0.010 in. (0.25 mm). The crack maps associated with Surveys 1 to 3 are shown in Figures 5.17 to 5.19, respectively.

Bridge Age: 32.2 months
Crack Density: 0.011 m/m^2
Span 1: 0.017 m/m^2
Span 2: 0.004 m/m^2

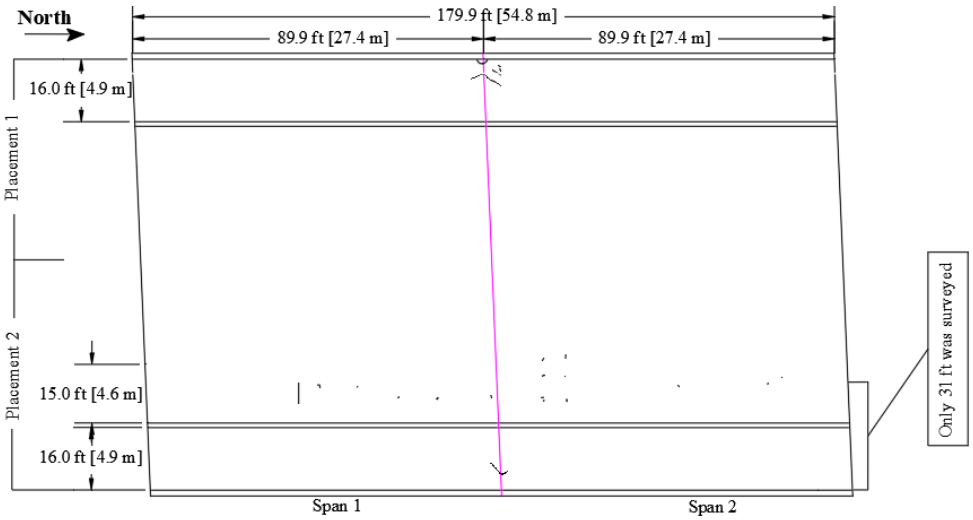
Figure 5.21: Crack map for MN-IC-LC-HPC-7 (Survey 1)

Bridge Age:
Placement 1 (West): 11.7 months
Placement 2 (East): 8.8 months
Crack Density: 0.016 m/m^2
Placement 1 (West): 0.018 m/m^2
Placement 2 (East): 0.014 m/m^2
Span 1: 0.016 m/m^2
Span 2: 0.015 m/m^2

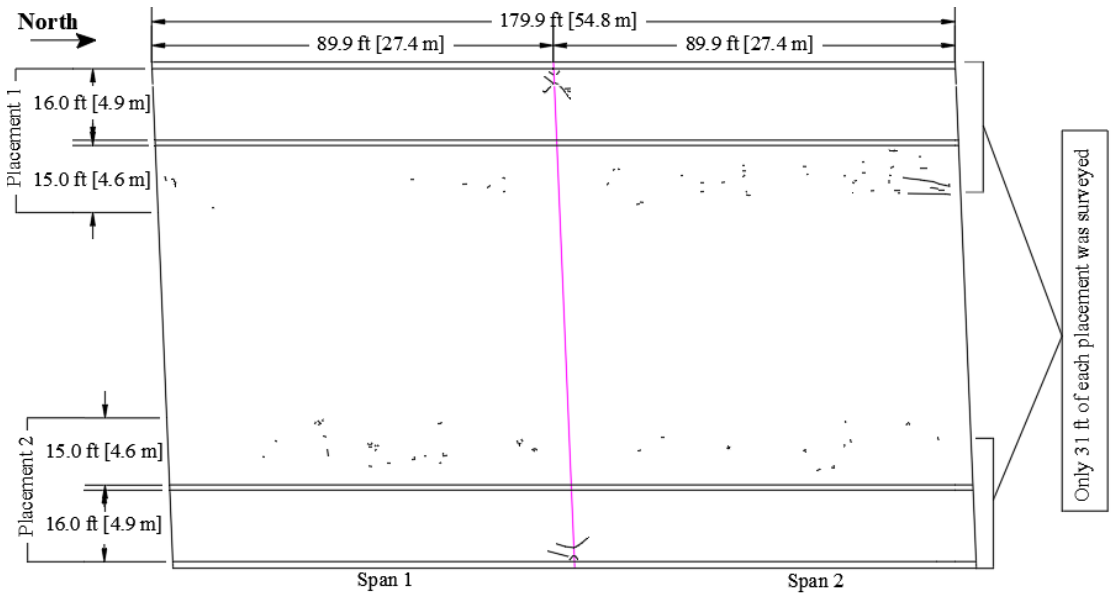
Figure 5.22: Crack map for MN-IC-LC-HPC-7 (Survey 2)

HPC-7-P2) was completed on September 22, 2020. The crack surveys covered only the sidewalks (incorporating IC water) and a portion of the roadway due to restrictions imposed by traffic control. For Survey 1, only one lane and the two sidewalks were surveyed. Survey 1 was performed at a deck age of 11.7 months for Placement 1 and 8.8 months for Placement 2. In Survey 1, the deck exhibited a low crack density (below 0.050 m/m^2), with cracks observed mainly on the sidewalks near the center pier. One single transverse crack was observed within 25 ft from the south end, with a length of about 5 ft (1.5 m). Crack widths in Survey 1 ranged from 0.002 to 0.006 in. (0.05 to 0.15 mm), with an average of 0.004 in. (0.10 mm). For Survey 2, the two sidewalks (incorporating IC water) but only one lane and a shoulder were surveyed. Survey 2 was performed at a deck age of 23.0 months for Placement 1 and 20.0 months for Placement 2. A number of diagonal cracks were observed on either side of the piers on the sidewalks. Some randomly oriented cracks were found at all spans. Two longitudinal cracks were observed near the north end, with approximately 7 ft (2.1 m) in length. Some short and narrow cracks (with crack lengths below 6 in. [152.4 mm]) were observed mostly on the roadway within 5 ft (1.5 m) from the barrier, possibly due to insufficient consolidation, observed in some locations during the construction. The crack densities for the entire deck (both placements) were 0.016 and 0.031 in Surveys 1 and 2, respectively, 0.018 and 0.037 for Placement 1; and 0.014 and 0.024 m/m^2 for Placement 2. Crack widths in Survey 2 ranged from 0.003 to 0.025 in. (0.08 to 0.64 mm), with an average of 0.007 in. (0.18 mm). The crack maps associated with Surveys 1 and 2 are shown in Figures 5.21 and 5.22, respectively.

Bridge Age:
Placement 1 (West): 23 months
Placement 2 (East): 20 months
Crack Density: 0.031 m/m^2
Placement 1 (West): 0.037 m/m^2
Placement 2 (East): 0.024 m/m^2
Span 1: 0.024 m/m^2
Span 2: 0.037 m/m^2

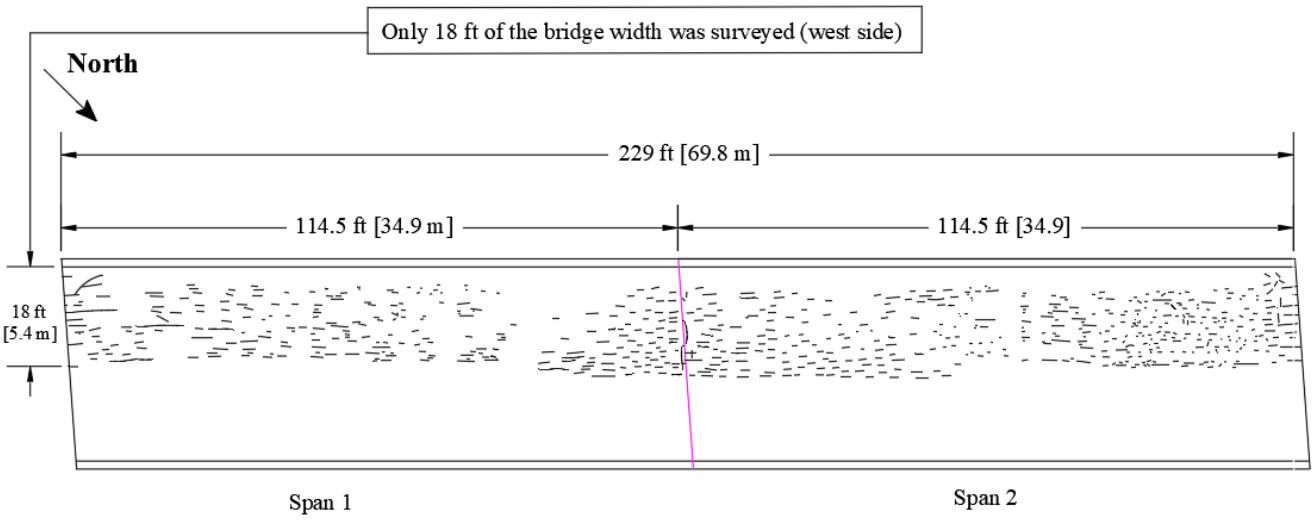
Figure 5.25: Crack map for MN-IC-LC-HPC-8 (Survey 2)

MN-IC-LC-HPC-8 is a two-lane bridge that carries traffic on C.S.A.H. 12 over I-90 in Winona. The deck was constructed in one placement on August 20, 2020. As discussed in Chapter 4, MN-IC-LC-HPC-8 is another example of a bridge deck constructed with poor construction practices. This deck has been surveyed two times, with Survey 2 exhibiting one of the highest crack densities for an IC deck placed without overlay in this study. Survey 1 was performed at a deck age of 9.9 months with a crack density of 0.013 m/m^2. In Survey 1, the majority of cracks were longitudinal cracks extending from both abutments. Some transverse cracks, approximately 3 ft (0.9 m) in length, had developed near the center pier of the bridge. Crack widths in Survey 1 ranged from 0.004 to 0.025 in. (0.10 to 0.64 mm), with an average of 0.009 in. (0.23 mm). Due to high crack density, in Survey 2 only one lane and a shoulder of MN-IC-LC-HPC-8 were surveyed (18 ft (5.5) of the west side). Survey 2 was performed at a deck age of 21.2 months with a crack density of 0.671 m/m^2, considerably higher than Survey 1. As shown in Figure 5.23, a notable amount of map cracking was found during Survey 2, especially near the center pier and in the middle of Spans 1 and 2. The crack maps associated with Surveys 1 and 2 are shown in Figures 5.24 and 5.25, respectively. As discussed in Section 5.2.1, map cracking is not totally clear in Figure 5.24 due to the scale of the image. As discussed in Section 4.4.10, one possible cause of the poor cracking performance of decks is non-uniform distribution of curing compound applied during construction, leading to plastic shrinkage. It was also indicated by MnDOT personnel that the cracking may have resulted from increased traffic from heavy vehicles from a truck parking lot located 0.3 miles (0.482 km) south of the bridge, which could have increased tensile stresses in the deck. While most cracks were longitudinal and distributed over the entire deck area, several larger longitudinal and transverse cracks were found near the abutments and center pier,

respectively. Crack widths in Survey 2 ranged from 0.003 to 0.060 in. (0.08 to 1.52 mm), with an average of 0.018 in. (0.46 mm).

Bridge Age: 21.2 months
Crack Density: 0.671 m/m^2
Span 1: 0.641 m/m^2
Span 2: 0.700 m/m^2

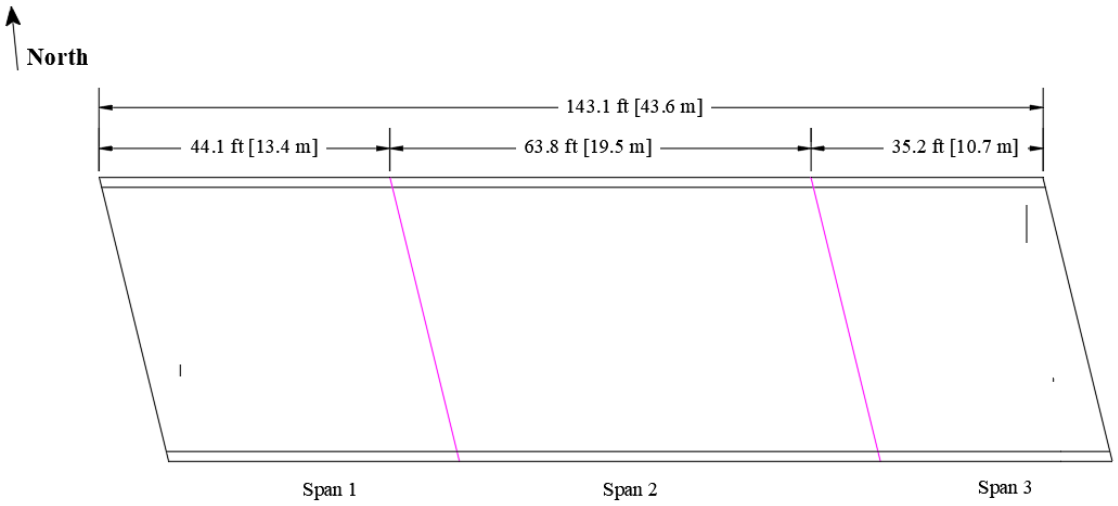
Figure 5.27: Crack map for MN-IC-LC-HPC-9 (Survey 1)

Bridge Age: 9.5 months
Crack Density: 0.004 m/m^2
Span 1: 0.003 m/m^2
Span 2: 0.000 m/m^2
Span 3: 0.008 m/m^2

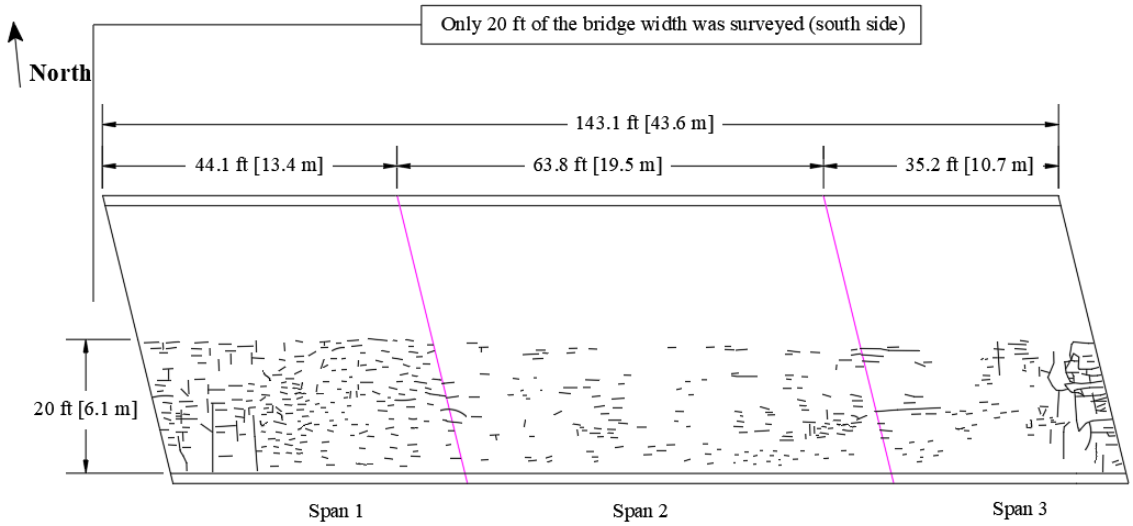
Figure 5.28: Crack map for MN-IC-LC-HPC-9 (Survey 2)

surveyed (20 ft (6.1 m) of the south side). Survey 2 was performed at a deck age of 20.6 months with a crack density of 0.788 m/m^2, considerably higher than Survey 1. As shown in Figure 5.26, a notable amount of map cracking was found during Survey 2, especially in the middle of spans 1 and 3. The crack maps associated with Surveys 1 and 2 are shown in Figures 5.27 and 5.28, respectively. Again, as discussed in Section 5.2.1, map cracking is not totally clear in Figure 5.28 due to the scale of the image. The majority of cracks were longitudinal (lengths of 2 ft [0.6 m] or less) distributed over the entire deck area. The underside of the deck, however, did not appear to reflect these cracks, as shown in Figure 5.29. Some longitudinal cracks extended from the east abutment. Two longer longitudinal cracks, approximately 9 ft (2.7 m) in length, had developed from the pier between spans 2 and 3. A number of transverse cracks were observed within 15 ft (4.6 m) of the west abutment and within 5 ft (1.5 m) of the east abutment. Crack widths in Survey 2 ranged from 0.007 to 0.025 in. (0.18 to 0.64 mm), with an average of 0.011 in. (0.28 mm). The reason for the poor cracking performance of the deck of MN-IC-LC-HPC-9 is similar to that discussed for MN-IC-LC-HPC-8, including non-uniform distribution of curing compound.

Bridge Age: 20.6 months
Crack Density: 0.788 m/m^2
Span 1: 1.110 m/m^2
Span 2: 0.451 m/m^2
Span 3: 0.991 m/m^2

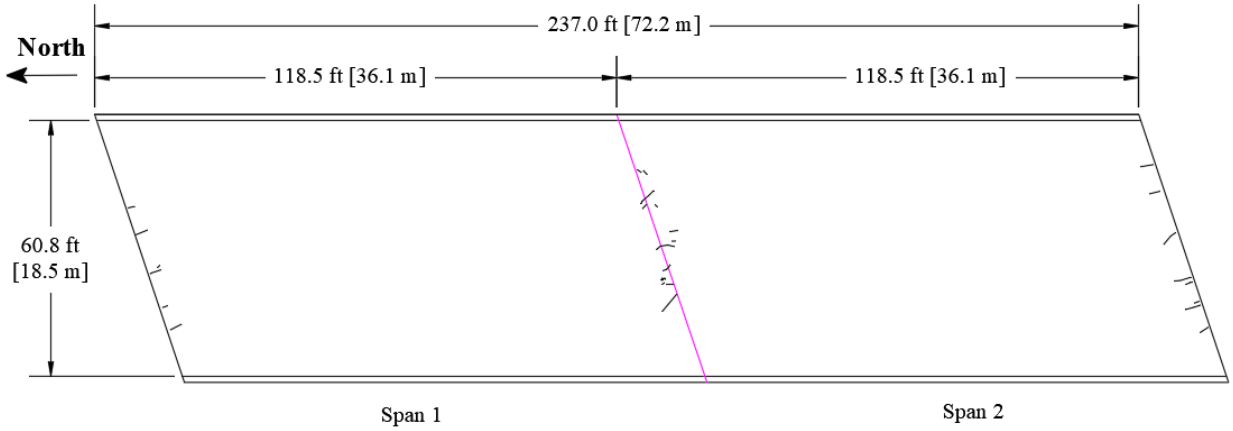
Figure 5.30: Crack map for KS-IC-LC-HPC-1 (Survey 1)

November 26, 2019. This deck has been surveyed two times and exhibited a crack density of 0.019 m/m^2 at a deck age of 30.9 months. The deck was not surveyed in the first year after the construction. Survey 1 was performed at a deck age of 19.8 months, with a crack density of 0.015 m/m^2. In Survey 1, the majority of cracks were located on either side of the piers, normal to the end of the deck. Some cracks were also observed perpendicular to the skew of the deck at both abutments. Crack widths in Survey 1 ranged from 0.003 to 0.025 in. (0.08 to 0.64 mm), with an average of 0.015 in. (0.38 mm). Survey 2 was performed at a deck age of 30.9 months, with a crack density of 0.019 m/m^2. In Survey 2, the number and length of cracks increased compared to Survey 1, mostly observed near the same locations. Crack widths in Survey 2 ranged from 0.013 to 0.020 in. (0.33 to 0.51 mm), with an average of 0.016 in. (0.41 mm). The crack maps associated with Surveys 1 and 2 are shown in Figures 5.30 and 5.31, respectively. During the crack surveys, some scaling was also observed, mainly near the shoulders, as shown in Figure 5.32. The scaling may have occurred because the concrete had air contents as low as 5.5%, as discussed in Section 4.7.1. Overall, air contents ranged from 5.5 to 7.6%, with an average of 6.3%, which compares with the LC-HPC specifications that require individual air content reading to be between 6.5 and 9.5%. Lafikes et al. (2020) recommended requiring air contents above 7% to improve freeze-thaw durability and scaling resistance of concrete mixtures incorporating IC water. KS-IC-LC-HPC-1 (Sunflower Rd.) bridge deck was constructed in late November (and therefore cured in cold ambient temperatures). Furthermore, on the day of placement the air temperature ranged from 38 to 49 °F with an average of 43 °F, which may have also increased the potential of concrete durability problems.

Bridge Age: 19.8 months
Crack Density: 0.015 m/m^2
Span 1: 0.011 m/m^2
Span 2: 0.018 m/m^2

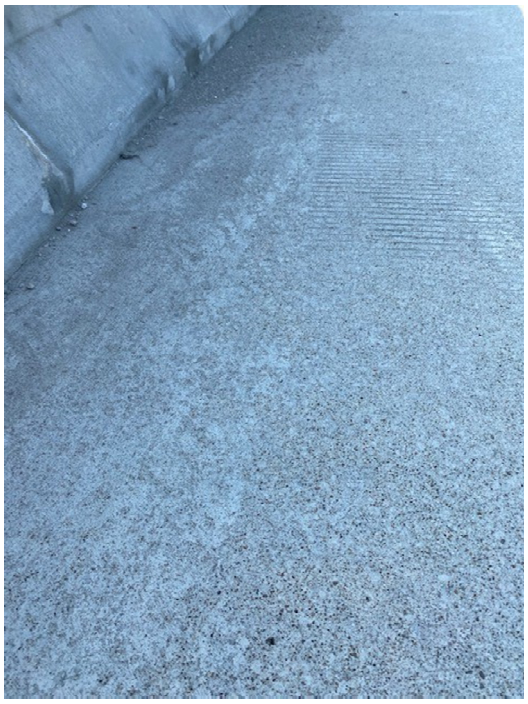
Figure 5.32: Scaling damage observed near the shoulders of KS-IC-LC-HPC-1

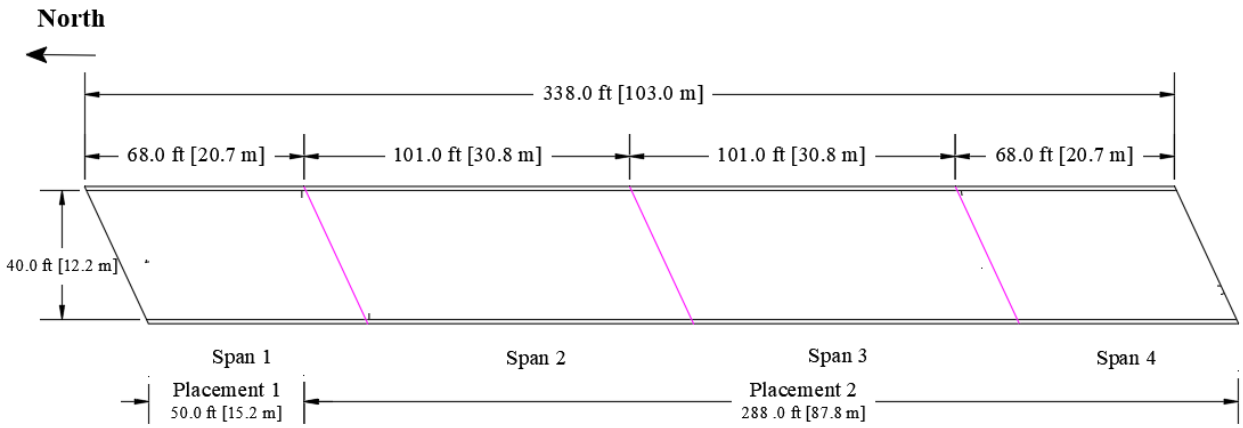
Figure 5.34: Crack map for KS-IC-LC-HPC-2 (Survey 1)

Survey 2 was performed at a deck age of 19.7 months for Placement 1 and 19.4 months for Placement 2, also exhibiting very low crack densities (below 0.02 m/m^2). Some randomly oriented cracks were found at all spans. A few cracks were observed near the pier between spans 1 and 2, and near the pier between spans 3 and 4. Crack widths in Survey 2 ranged from 0.002 to 0.005 in. (0.05 to 0.13 mm), with an average of 0.003 in. (0.08 mm). The crack densities for the entire deck (both placements) were 0.002 and 0.003 in Surveys 1 and 2, respectively, 0.004 and 0.004 for Placement 1; and 0.002 and 0.003 m/m^2 for Placement 2. The crack maps associated with Surveys 1 and 2 are shown in Figures 5.34 and 5.35, respectively.

Bridge Age:
Placement 1: 8.6 months
Placement 2: 8.4 months
Crack Density: 0.002 m/m^2
Span 1: 0.005 m/m^2
Span 2: 0.001 m/m^2
Span 3: 0.000 m/m^2
Span 4: 0.003 m/m^2
Placement 1:0.004 m/m^2
Placement 2:0.002 m/m^2
