INTERNALLY-CURED LOW-CRACKING HIGH-PERFORMANCE CONCRETE (IC-LC-HPC) BRIDGE DECKS: DURABILITY AND CRACKING PERFORMANCE

Alireza Bahadori

Submitted to the graduate degree program in Civil Engineering and the Graduate Faculty of the University of Kansas in partial fulfillment of the requirements for the degree of Doctor of Philosophy.

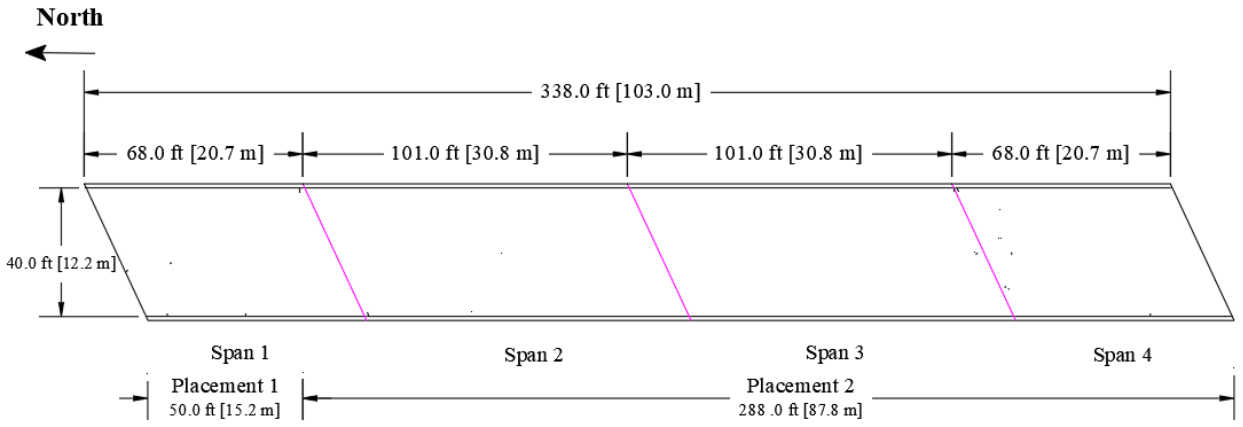
Figure 5.35: Crack map for KS-IC-LC-HPC-2 (Survey 2)

Survey 2 was performed at a deck age of 19.7 months for Placement 1 and 19.4 months for Placement 2, also exhibiting very low crack densities (below 0.02 m/m^2). Some randomly oriented cracks were found at all spans. A few cracks were observed near the pier between spans 1 and 2, and near the pier between spans 3 and 4. Crack widths in Survey 2 ranged from 0.002 to 0.005 in. (0.05 to 0.13 mm), with an average of 0.003 in. (0.08 mm). The crack densities for the entire deck (both placements) were 0.002 and 0.003 in Surveys 1 and 2, respectively, 0.004 and 0.004 for Placement 1; and 0.002 and 0.003 m/m^2 for Placement 2. The crack maps associated with Surveys 1 and 2 are shown in Figures 5.34 and 5.35, respectively.

Bridge Age:
Placement 1: 19.7 months
Placement 2: 19.4 months
Crack Density: 0.003 m/m^2
Span 1: 0.005 m/m^2
Span 2: 0.002 m/m^2
Span 3: 0.002 m/m^2
Span 4: 0.001 m/m^2
Placement 1:0.004 m/m^2
Placement 2:0.003 m/m^2

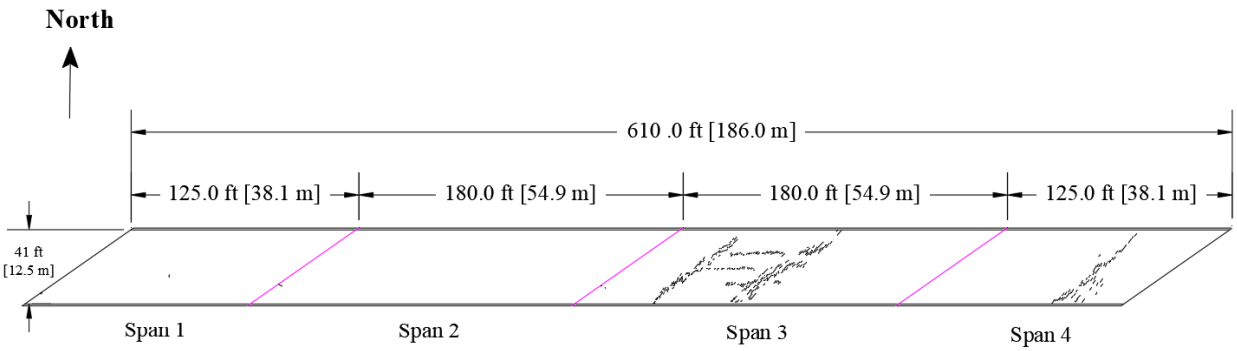
Figure 5.37: Crack map for KS-IC-LC-HPC-3 (Survey 1)

KS-IC-LC-HPC-3 is a two-lane bridge that carries traffic on 199th St. over I-35 in Edgerton, Kansas. The deck was constructed in one placement on September 16, 2021. The deck has been surveyed one time. The survey showed a crack density of 0.061 m/m^2. The cracks were primarily located 60 ft (18.3) and 200 ft (70 m) from the east end of the deck, as shown in the crack map in Figure 5.37. Some scaling damage was also observed on the deck. Crack widths ranged from 0.003 to 0.020 in. (0.08 to 0.51 mm), with an average of 0.013 in. (0.33 mm). The cracks and scaling damage observed in those portions of the deck could be the result of multiple factors that occurred during the construction, as discussed in Section 4.7.3. Malfunctioning fogging equipment was observed spraying excess water directly onto the deck surface, especially in spans 3 and 4. The excess water was later worked back into the surface by the contractors when bullfloating the deck, which resulted in a thin paste layer with a high *w/cm* at the concrete surface, causing high cracks in those areas. Although not permitted by the IC-LC-HPC specifications, a finishing aid was also used on the first half of the deck. The finishing aid increases the *w/cm* ratio at the surface, which may contribute to increased scaling damage. The use of the finishing aid, however, was discontinued after it was pointed out to KDOT and contractor personnel. Additionally, a bullfloat was repeatedly used in the longitudinal direction while the excess water was visible on the surface. The scaling damage is shown in Figure 5.38.

Bridge Age: 9.2 months
Crack Density: 0.061 m/m^2
Span 1: 0.002 m/m^2
Span 2: 0.001 m/m^2
Span 3: 0.160 m/m^2
Span 4: 0.066 m/m^2

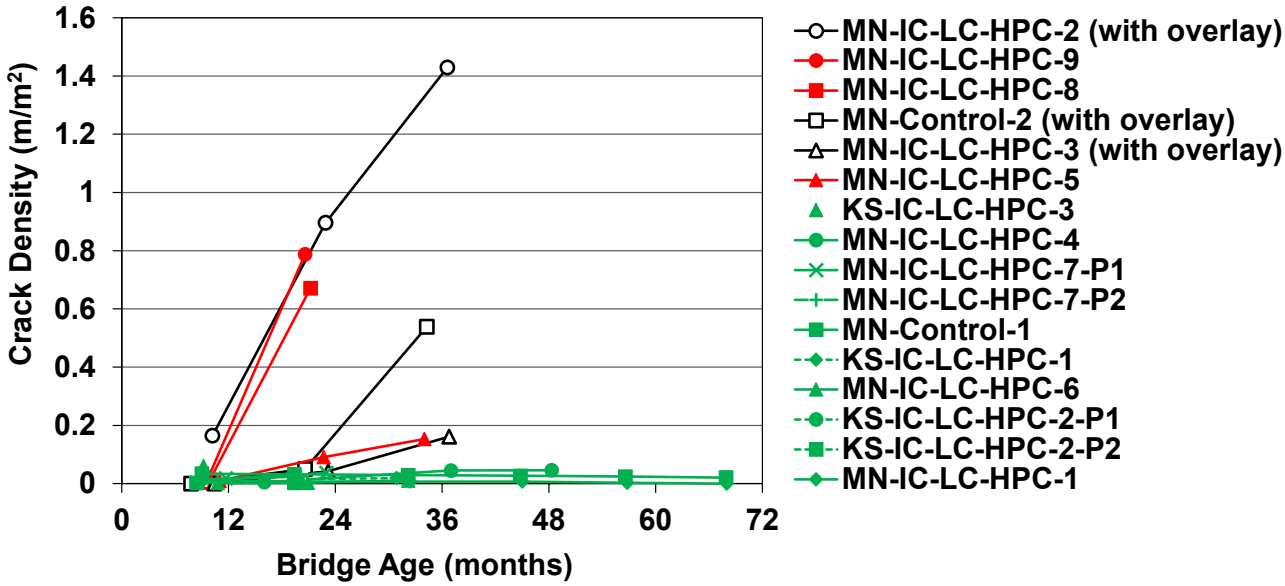
Figure 5.39: Crack density as a function of age for IC-LC-HPC and Control decks

Figure 5.39 shows crack density as a function of age for IC-LC-HPC and Control decks surveyed from 2017 to 2022 in Minnesota and Kansas.

The crack surveys have shown that the majority of the IC-LC-HPC decks constructed in Minnesota and Kansas exhibited low crack densities (below 0.05 m/m^2, shown in green) during the first two or three years (and longer for some decks) after the construction. For decks without overlays, the use of IC and SCMs reduced bridge deck cracking compared to Control decks. No improvement, however, was noted for the two IC bridge decks with an overlay where higher amounts of cracking were observed. The use of overlays can increase bridge deck cracking and decks with concrete overlays are also susceptible to map cracking (Miller and Darwin 2000, Lindquist et al. 2005). The construction issues during placement of MN-IC-LC-HPC-5, -8, and -9 likely contributed to increased crack densities. When proper construction practices are not followed–as was the case for the three MN decks, where overfinishing, excess water worked into the surface, and inadequate curing were observed–bridge decks can exhibit noticeable cracking. To date, the Kansas IC-LC-HPC decks have exhibited low crack densities. The tendency to exhibit cracking over the long term, however, usually becomes apparent only after 36 months (Lindquist et al. 2008, Yuan et al. 2011, Pendergrass and Darwin 2014). Therefore, future surveys will provide a better indicator of long-term cracking performance. Factors that affect bridge deck cracking, including internal curing, paste content, and construction procedures, are discussed in Chapter 6.

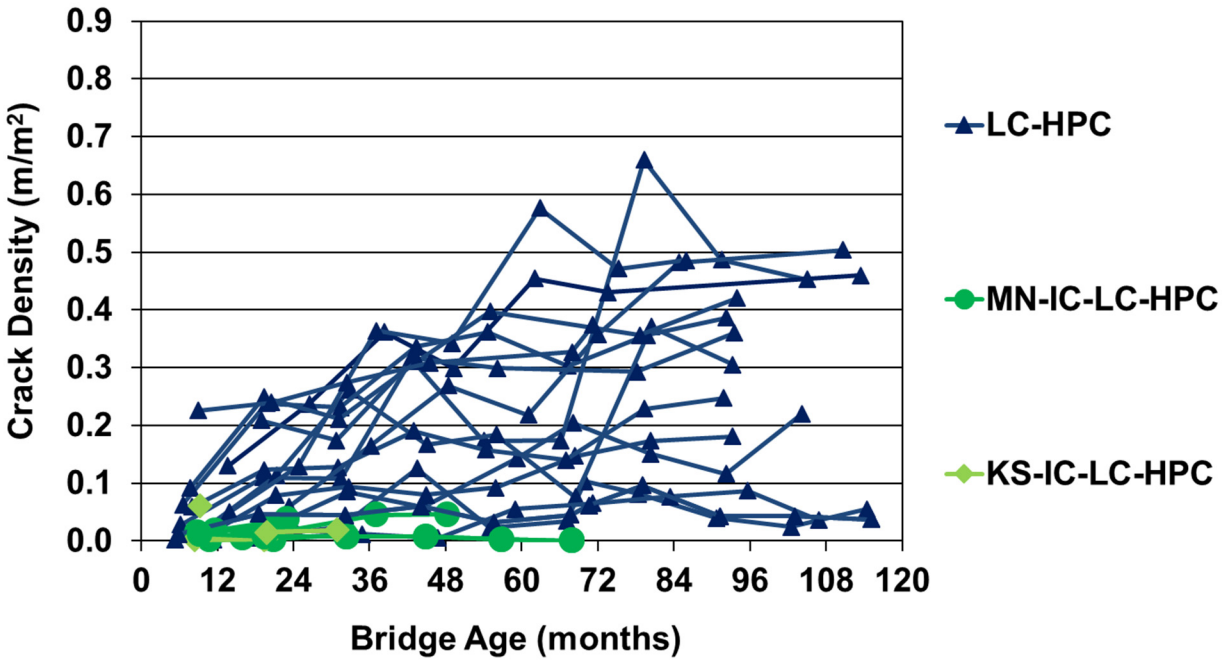
Figure 5.40: Crack densities versus deck age for monolithic LC-HPC decks, Minnesota, and Kansas IC-LC-HPC decks with good construction practices. All had paste contents of 26% or less

Figure 5.40 compares the cracking performance of the IC-LC-HPC monolithic decks with cracking in LC-HPC bridge decks in Kansas (Darwin et al. 2016). Bridge decks for which the contractor followed poor construction practices and decks with overlays are excluded from the figures. A single monolithic deck in Minnesota without internal curing water (MN-Control-1) is not shown in the figure because the study focuses on the effects of internal curing and SCMs on bridge deck cracking. As described in Chapter 1, LC-HPC decks were constructed between 2005 and 2011 in Kansas. LC-HPC mixtures have low paste contents (below 24.6%) to reduce shrinkage and all had crack densities below 0.4 m/m^2 through 48 months. Annual crack surveys performed on the LC-HPC decks demonstrated their improved cracking performance in comparison with Control decks (Lindquist et al. 2008, McLeod et al. 2009, Yuan et al. 2011, Pendergrass and Darwin 2014, Alhmood et al. 2015, Darwin et al. 2016).

included 27 to 30% mass replacement of cement with slag cement and a paste content ranging from 25.4 to 26%; the Kansas IC-LC-HPC decks contained either a binary cementitious system that included a 30% mass replacement of cement with slag cement and a paste content of 24.2%, or a ternary cementitious system that included 30% mass replacement of cement with slag cement and 2 or 3% mass replacement of cement with silica fume and a paste content of either 24.4 or 24.6%. As described in Chapter 1, given that decks with low paste contents exhibit low cracking, the low cracking of the IC-LC-HPC decks is not unexpected. As shown in Figure 5.40, the IC-LC-HPC decks exhibited better cracking performance (below 0.07 m/m^2 between 9 and 68 months after placement) than the LC-HPC decks.

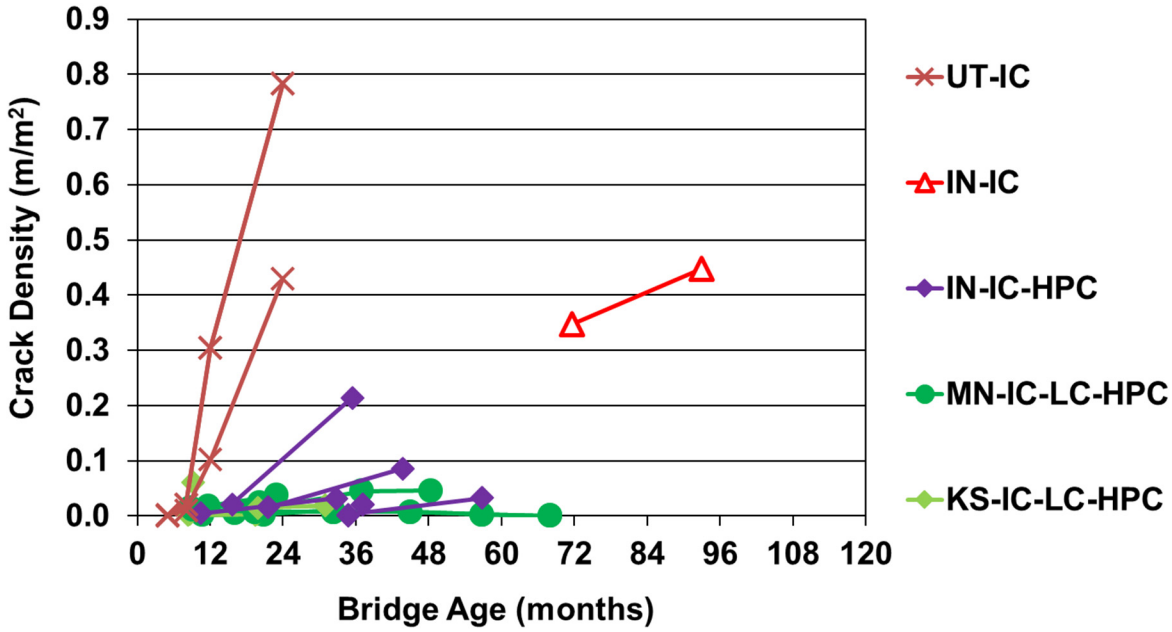
Figure 5.41: Crack densities versus deck age for Utah, Indiana, Minnesota, and Kansas IC decks

Figure 5.41 compares the cracking performance of the IC-LC-HPC decks surveyed in this study (MN-IC-LC-HPC and KS-IC-LC-HPC) with cracking in internally-cured decks in Utah and Indiana. As described in Chapter 1, the results of two crack surveys are available for two IC decks in Utah (identified here as UT-IC), supported by prestressed girders with partial-depth precast concrete deck panels. The concrete for the decks had a *w/cm* ratio of 0.44 and a binary cementitious material system (with partial replacements of portland cement with fly ash), but the paste content was 28%. The concrete for the UT-IC decks was proportioned to provide a nominal IC water content of 7% by the weight of binder (Bitnoff 2014). Additionally, one IC deck containing portland cement as the only binder (identified as IN-IC) was constructed in 2010 in Indiana. This deck had a *w/cm* ratio of 0.39 and a paste content of 27.6%. The nominal quantity of IC water was 7.2% by the cement weight (Di Bella et al. 2012). In addition to these decks, four IC decks containing a ternary binder system (identified as IN-IC-HPC, with partial replacements of portland cement with either slag cement and silica fume or fly ash and silica fume) were constructed between 2013 and 2015 in Indiana. These decks had *w/cm* ratios ranging from 0.40 to 0.43 and lower paste contents than IN-IC, between 24.6 and 26.0%. They had IC water contents ranging from 8.5 to 12.0% by total weight of binder (Barrett et al. 2015). As shown in Figure 5.41, the IC-LC-HPC decks, all with paste contents below 27.2%, exhibited noticeably less cracking at similar ages than the internally-cured Utah and Indiana decks (UT-IC and IN-IC) with paste contents greater than 27.2%.

In most cases, the IC-LC-HPC decks in this study, that had IC water contents ranging from 5.2 to 8% (by the weight of binder), exhibited lower crack densities at 36 months than the IN-IC-HPC decks (0.000 to 0.046 vs. 0.000 to 0.214 m/m^2) at similar ages. These observations suggest

that there is no apparent reduction in cracking when IC water is increased above 8% (by total weight of binder). Based on Figures 5.40 and 5.41, it can be concluded that IC and SCMs contributed noticeably to a reduction in cracking when the paste content is below 27.2%; for decks with paste contents greater than 27.2%, the addition of IC and SCMs cannot overcome the negative effects of high paste contents, resulting in high crack densities as is the case for UT-IC and IN-IC decks at similar ages to IN-IC-LC-HPC, MN-IC-LC-HPC, and KS-IC-LC-HPC decks.

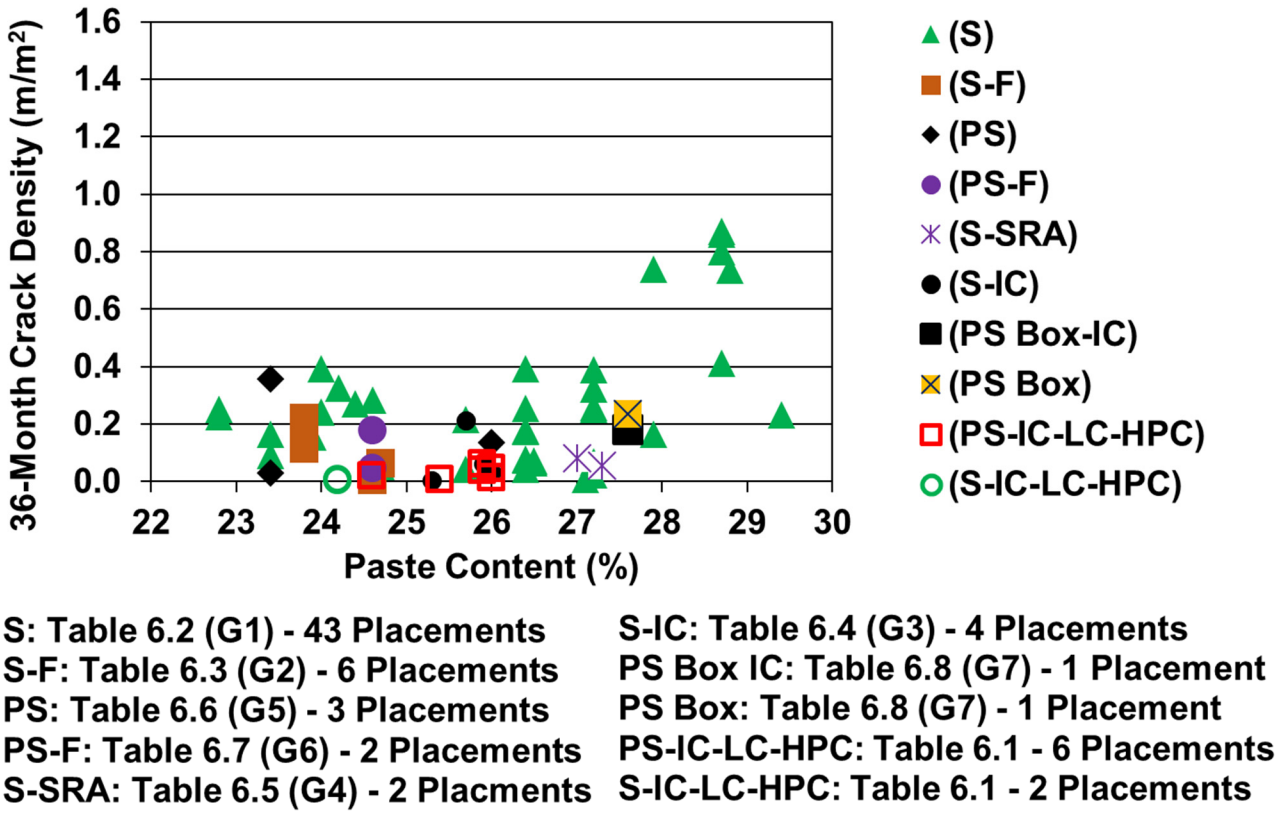
Figure 6.1: Paste content versus 36-month crack density for decks with good construction practices-Decks described in Tables 6.1 to 6.8

Figure 6.1 shows the 36-month crack density of the six PS-IC-LC-HPC and two S-IC-LC-HPC bridge decks (with good construction practices in Table 6.1) surveyed in this study and those with good construction practices that are used for comparison (in Tables 6.2 to 6.8), as a function of the paste content. As shown in the figure, 35 of the decks with paste contents below 27.2% had crack densities below 0.2 m/m^2 and 18 decks had crack densities between 0.3 to 0.4 m/m^2 at 36 months. The PS-IC-LC-HPC and S-IC-LC-HPC decks surveyed in this study, with paste contents ranging from 24.2 to 26%, had crack densities ranging from just 0.004 to 0.059 m/m^2 at 36 months, well below 0.2 m/m^2. As a general observation, the cracking of bridge decks incorporating crack-reducing technologies such as fibers, SRAs, or IC are comparable to those of the decks without

crack-reducing technologies. Once the paste content exceeds 27.2%, cracking tends to increase. Of the nine decks with a paste content greater than 27.2%, seven decks have crack densities above 0.2 m/m^2 at 36 months.

Among the six PS-IC-LC-HPC decks (with good construction) included in Figure 6.1 (Table 6.1) deck MN-IC-LC-HPC-7-P1, with a paste content of 25.9%, exhibited the highest crack density, with a value of 0.059 m/m^2 and deck KS-IC-LC-HPC-2 with a paste content of 24.2%, exhibited the lowest crack density, with a value of 0.004 m/m^2, at an age of 36 months.

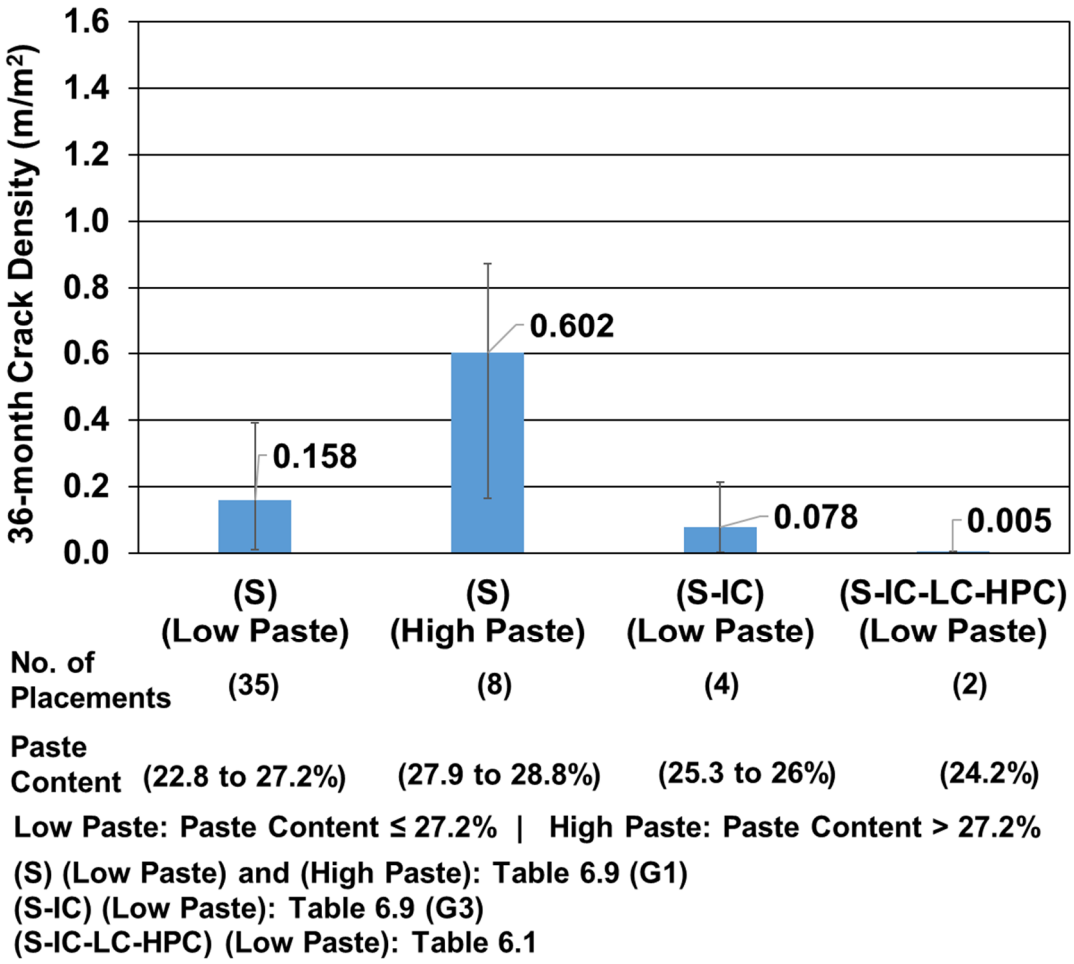
Figure 6.2: Average 36-month crack densities of decks supported by steel girders with and without IC

Figure 6.2 and Table 6.11 show that on average, the bridge decks with high paste contents (> 27.2%) supported by steel girders exhibit noticeably higher crack densities at 36 months than those with paste contents ≤ 27.2%, with differences that are statistically significant. In decks supported by steel girders, the average 36-month crack densities of decks with low paste contents range from 0.005 for the two S-IC-LC-HPC placements to 0.158 m/m^2 for the 35 S placements, while the average 36-month crack density for the eight S placements with high paste content is 0.602 m/m^2. The difference between the average crack density of decks with high paste contents (average of 0.602 m/m^2) and that of the decks with low paste contents with (0.078 and 0.005 m/m^2)

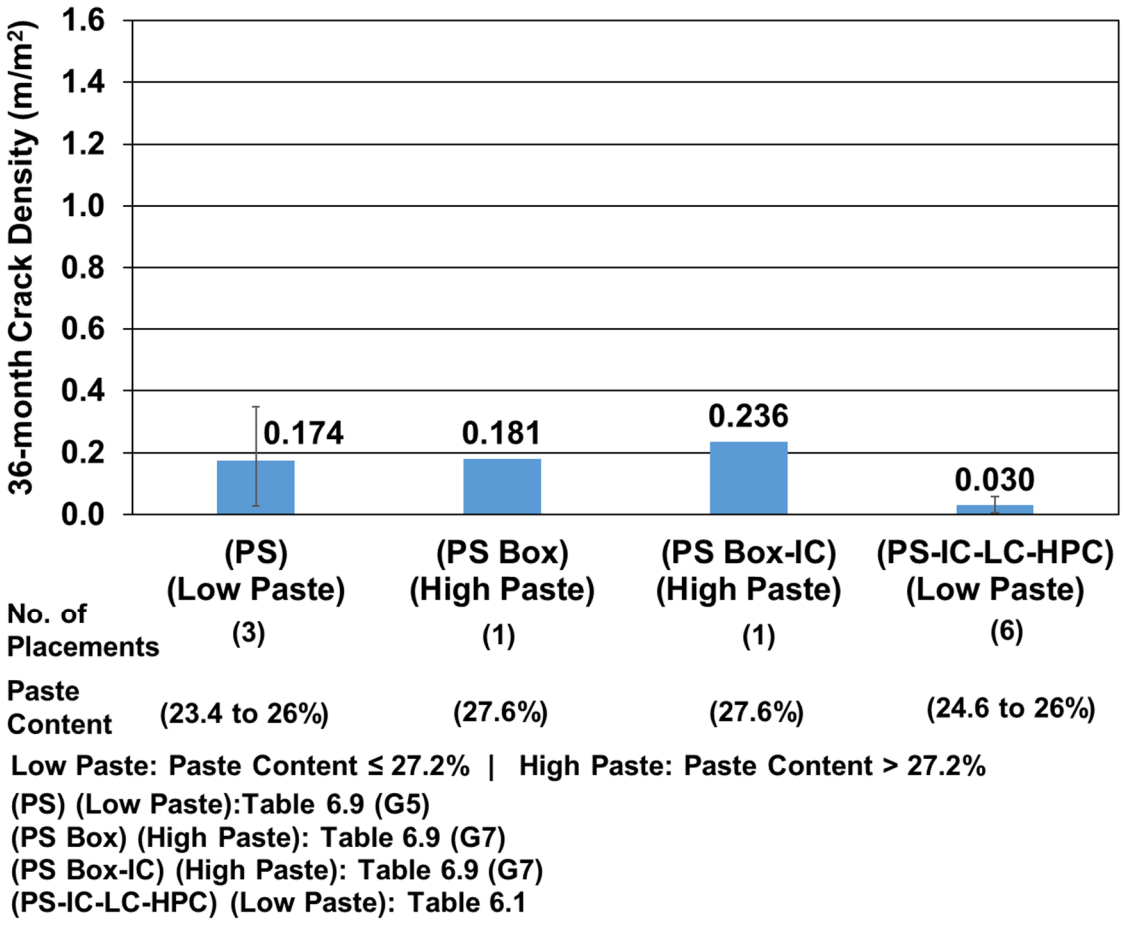
Figure 6.3: Average 36-month crack densities of decks supported by prestressed precast concrete and prestressed box girders with and without IC

As shown in Figure 6.3, in decks supported by either prestressed precast concrete girders or prestressed box girders, the average 36-month crack densities of decks with low paste contents ranged from 0.030 for the six PS-IC-LC-HPC placements to 0.174 m/m^2 for the three PS placements (without IC), while the average 36-month crack density for the two PS Box placements (with or without IC) with high paste content is either 0.181 or 0.236 m/m^2. The p-value obtained in Student's t-test indicates that in decks supported by prestressed precast concrete girders with low paste contents, the difference between the cracking of decks with IC and that of the deck without IC, is not statistically significant. (p = 0.060).

Similar observations can be made for the effects of IC on cracking of decks supported by prestressed precast concrete girders. Although the difference between the average 36-month crack density for the three PS and the six PS-IC-LC-HPC deck placements is not significant ($p = 0.060$), the PS-IC-LC-HPC decks also consistently exhibited lower cracking than the three PS deck placements (mean value of 0.030 vs. 0.174 m/m^2). The range of crack densities for the PS placements (without IC) is much greater in data for PS-IC-LC-HPC placements (between 0.029 to 0.358 m/m^2 vs. 0.007 to 0.059 m/m^2). Therefore, the results shown in Figures 6.2 and 6.3, indicate that the combination of low paste, internal curing, and good construction procedures can provide for a reduction in crack density; the high consistency of lower cracking on the low paste IC-LC-HPC deck placements indicates that the differences shown in Tables 6.11 and 6.12 can be statistically significant and is deserving of further study.

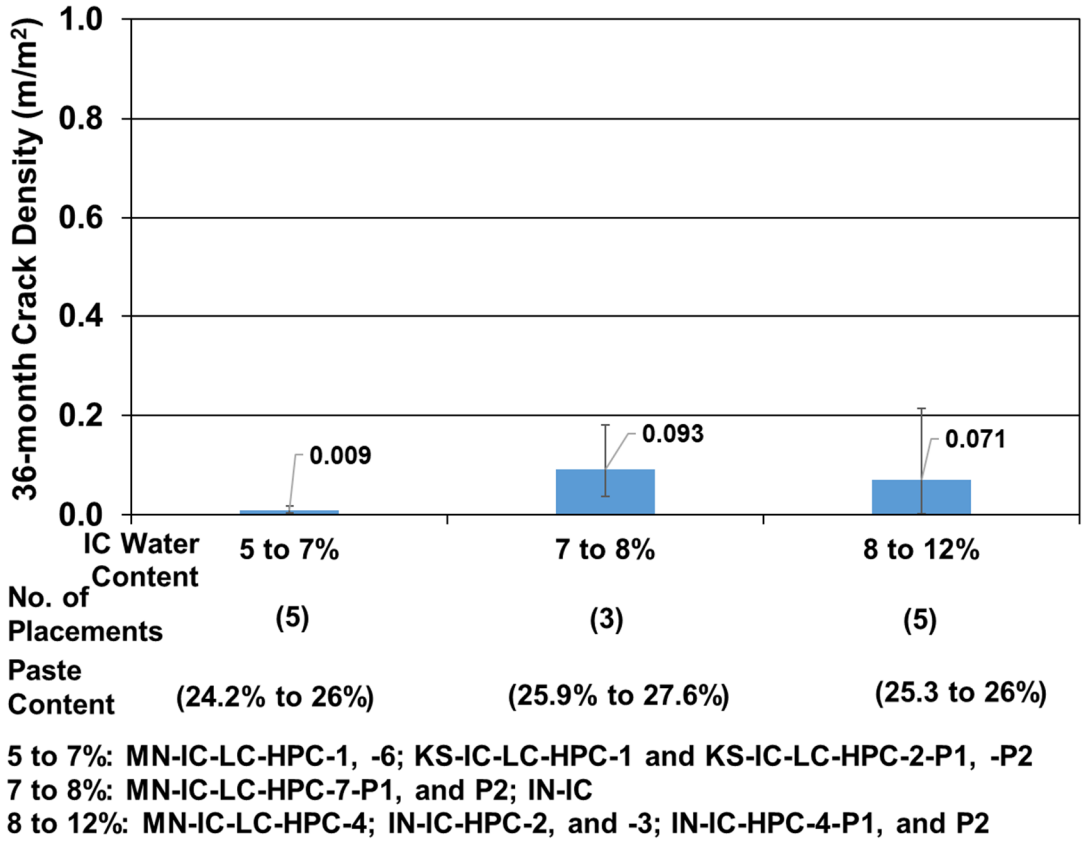
Figure 6.4: 36-month crack densities of IC decks versus IC water contents

Using the results shown in Tables 4.7, 4.38, 6.4, and 6.8, a comparison in terms of 36-month crack density can also be made as a function of the IC water content, using three ranges of IC water content: 5 to 7%, 7 to 8%, and 8 to 12%. All the decks, except for one (IN-IC), had low paste contents (below 27.2%). As shown in Figure 6.4, the average 36-month crack densities of decks with IC water contents from 5 to 12% (by the weight of binder) range from 0.009 to 0.093

m/m^2, well below 0.4 m/m^2. Table 6.13 shows the Student's t-test results comparing the average 36-month crack densities of IC monolithic decks shown in Figure 6.4. Given that decks with high quantities of IC water typically exhibit lower crack densities, higher cracking of the decks with 7 to 8% or 8 to 12% IC water contents (average of 0.093 and 0.071 m/m^2, respectively) compared to the decks with 5 to 7% IC water contents (with an average crack density of 0.009 m/m^2), is not expected, even though the difference is statistically significant (p = 0.044). Further research is required to obtain more data detailing the impact of IC water quantities on crack density across a variety of ranges.

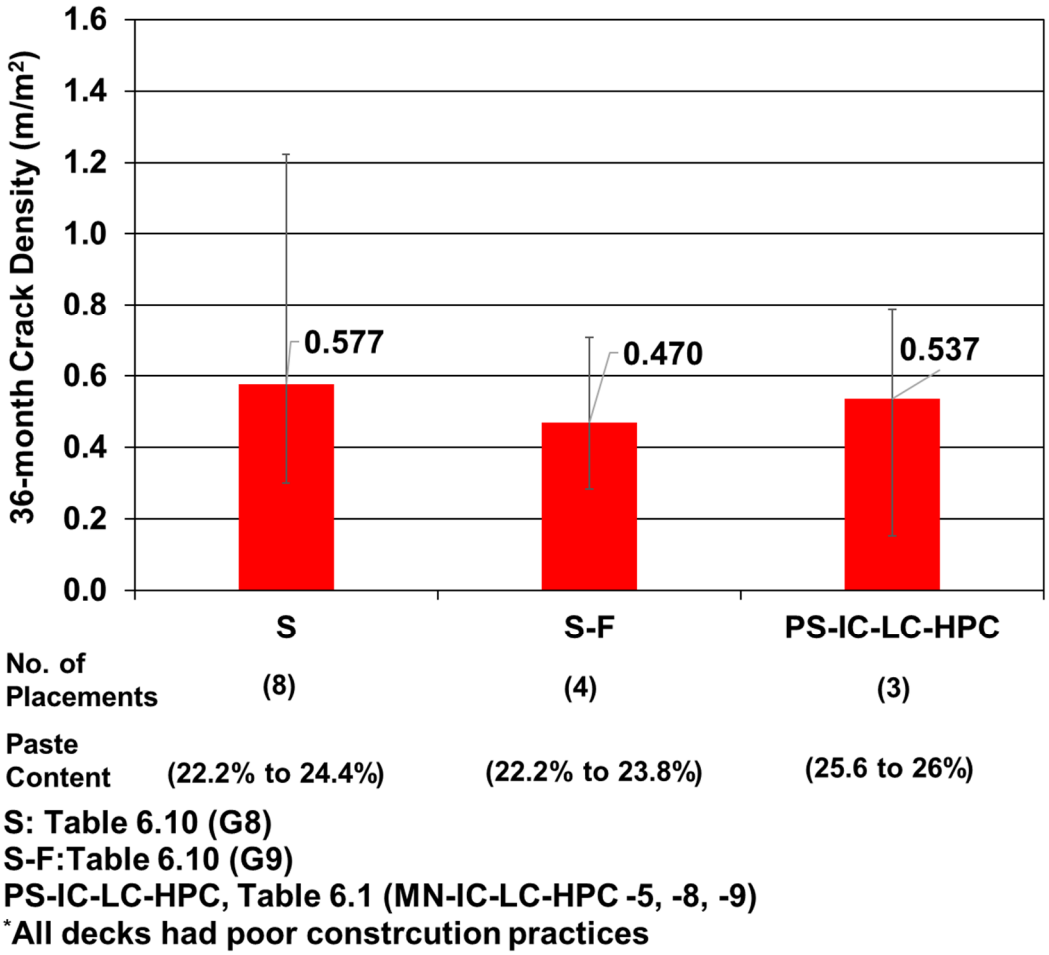
Figure 6.5: Comparing the 36-month crack densities of decks with construction issues

As shown in Figure 6.5, the average 36-month crack densities of the three PS-IC-LC-HPC decks (Table 6.1) surveyed in this study are similar to most of the decks (eight S placements and four S-F placements shown in Table 6.10) that had poor construction practices (such as insufficient consolidation or overfinishing). As shown in the figure, the average 36-month crack densities of decks with construction issues were 0.470 m/m^2 and above, even when low paste content concretes were used; the average 36-month crack density of the three PS-IC-LC-HPC decks (MN-IC-LC-HPC-5, -8, and -9) containing IC water, shown in Figure 6.5, is 0.537 m/m^2, and that of the decks without crack reducing technology or with fibers is either 0.577 or 0.470 m/m^2, respectively. The results of Student's t-test results provided in Table 6.14 show that with the paste contents ranging from 22.2 to 26%, the differences in crack density of the poorly constructed decks documented in Section 6.3.2 with fibers or without crack-reducing technology (averages of 0.470 or 0.577 m/m^2, respectively) and the three PS-IC-LC-HPC decks (0.537 m/m^2) are not statistically significant (p = 0.743 and 0.856, respectively).

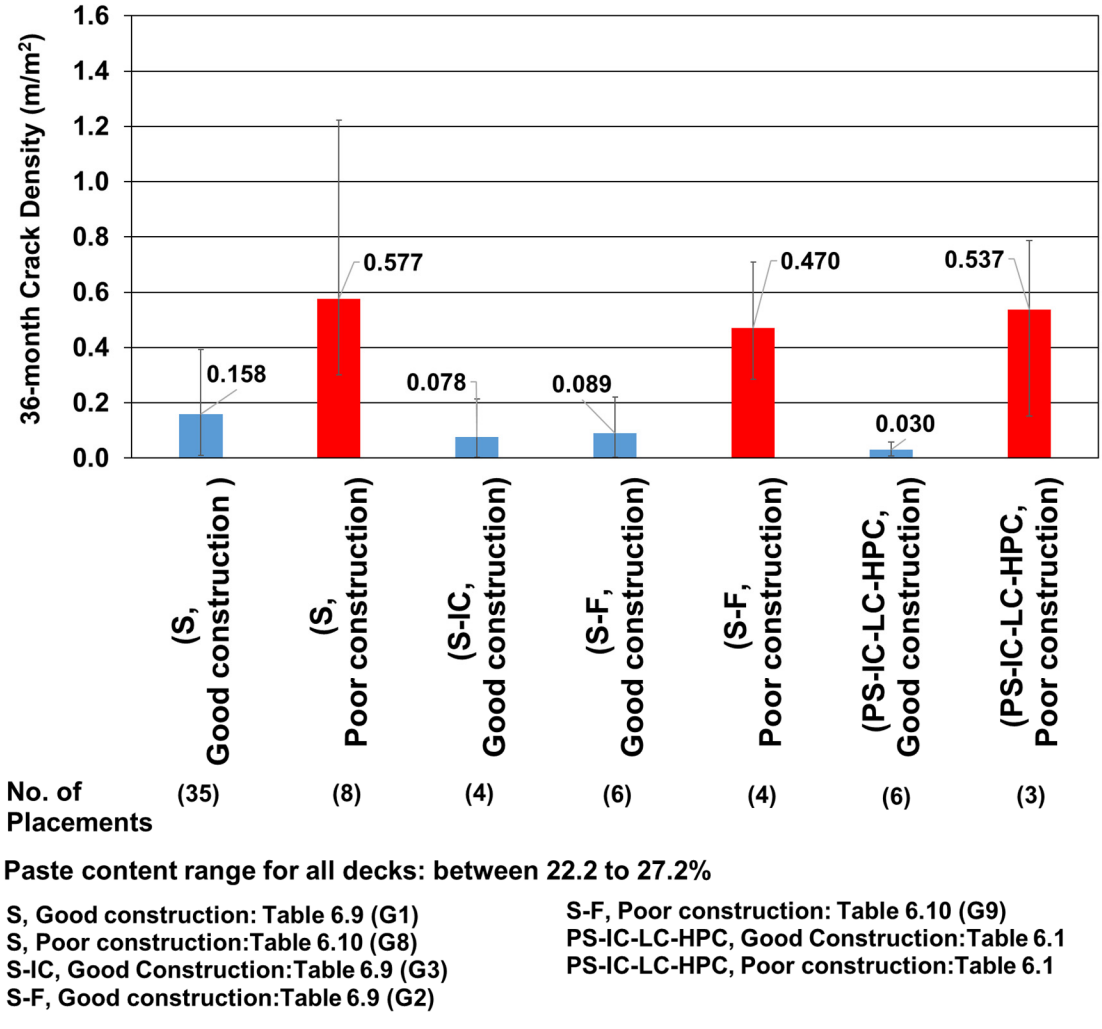
Figure 6.6: Comparing the 36-month crack densities of decks with good vs. poor construction practices

The adverse effects of poor construction practices in bridge deck cracking are illustrated in Figure 6.6 by a comparison between poor construction practices and good construction practices in low paste (22.2 to 27.2%) concrete decks supported by prestressed precast concrete and steel

girders with or without crack-reducing technologies. The results of Student's t-test results are provided in Table 6.15. As shown in the figure, the average 36-month crack densities of decks that followed poor construction practices, which range from 0.470 to 0.577 m/m^2, are at least three times higher than those that followed good construction practices, which range from 0.030 to 0.158 m/m^2, with differences that are statistically significant (p values ranging 1.9×10^{-7} to 0.045). Additionally, although the use of crack-reducing technologies such as fibers and IC-LC-HPC resulted in a reduction in cracking (0.089 and 0.030 vs. 0.158 m/m^2) their use cannot overcome the negative effects of poor construction practices (0.470 and 0.537 vs. 0.158 m/m^2).

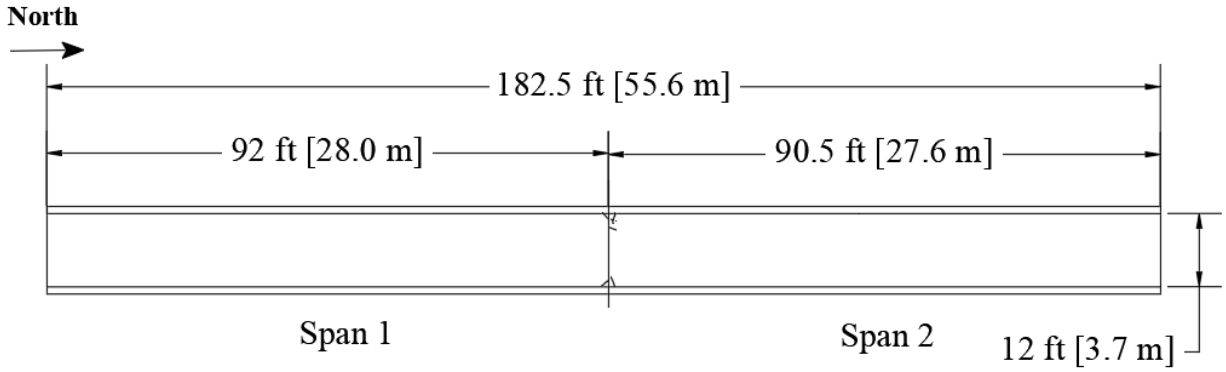
Figure G.1: Crack Map for MN-IC-LC-HPC-1 (Survey 1)

Bridge Age: 9.2 months
Crack Density: 0.013 m/m^2
Span 1: 0.010 m/m^2
Span 2: 0.016 m/m^2

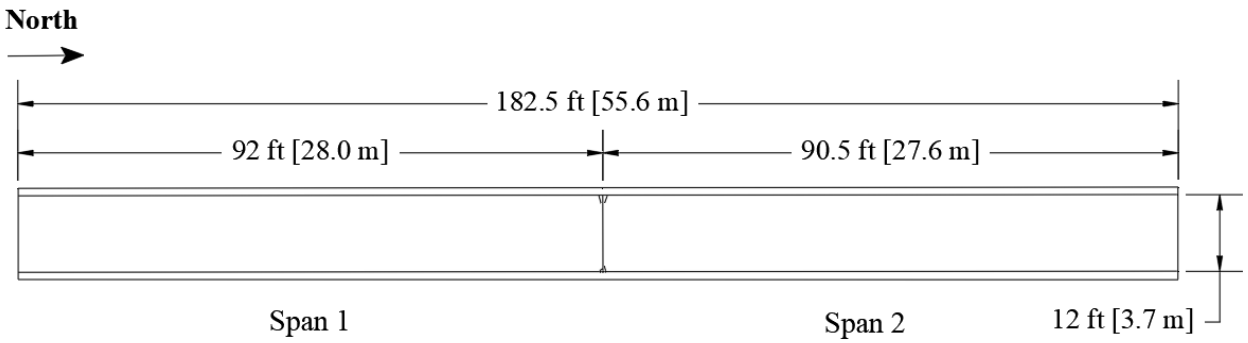
Figure G.3: Crack Map for MN-IC-LC-HPC-1 (Survey 3)

Bridge ID: MN-IC-LC-HPC-1
Bridge Number: 62892
Bridge Location: Mackubin St. over I-94
Construction Date: 9/21/2016
Crack Survey Date: 6/3/2019

Bridge Age: 32.4 months
Crack Density: 0.007 m/m^2
Span 1: 0.007 m/m^2
Span 2: 0.007 m/m^2

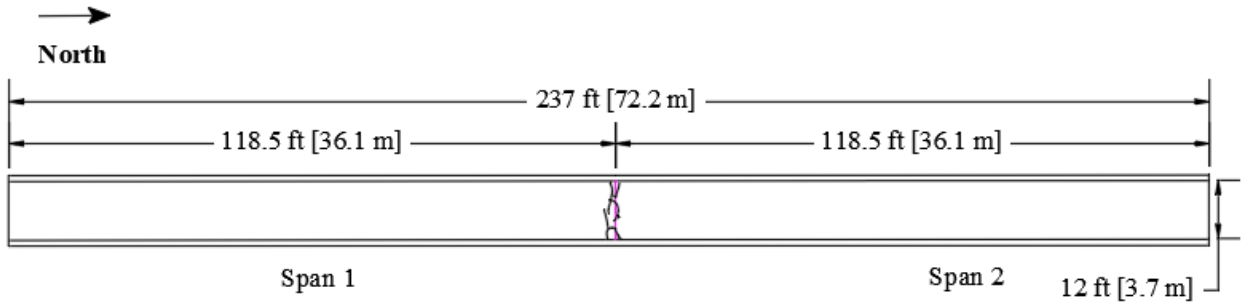
Figure G.4: Crack Map for MN-Control-1 (Survey 1)

Bridge ID: MN-Control-1
Bridge Number: 62800
Bridge Location: Grotto St. over I-94, St. Paul, MN
Construction Date: 9/28/2016
Crack Survey Date: 6/27/2017

Bridge Age: 9.0 months
Crack Density: 0.034 m/m^2
Span 1: 0.037 m/m^2
Span 2: 0.030 m/m^2

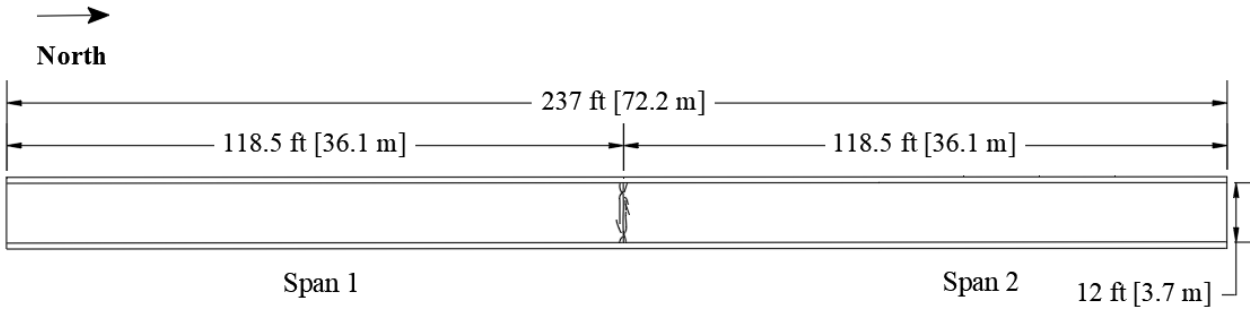
Figure G.5: Crack Map for MN-Control-1 (Survey 2)

Bridge ID: MN-Control-1
Bridge Number: 62800
Bridge Location: Grotto St. over I-94
Construction Date: 9/28/2016
Crack Survey Date: 5/8//2018

Bridge Age: 19.4 months
Crack Density: 0.032 m/m^2
Span 1: 0.031 m/m^2
Span 2: 0.034 m/m^2
Crack Length: 28.1 ft
Span 1: 13.5 ft
Span 2: 14.6 ft

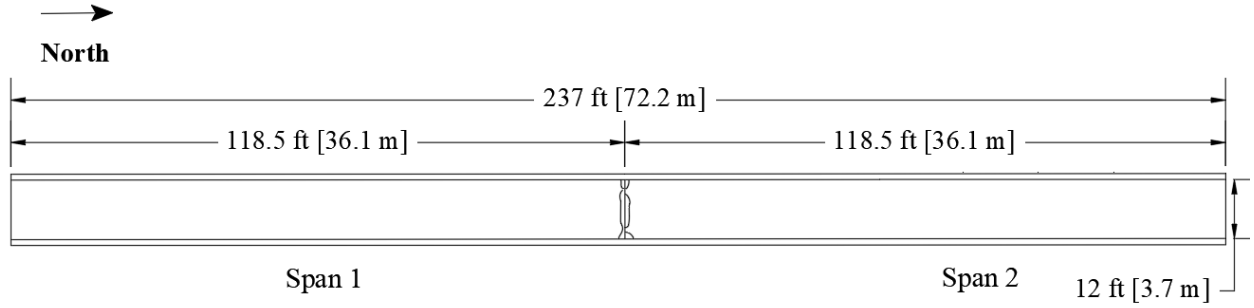
Figure G.6: Crack Map for MN-Control-1 (Survey 3)

Bridge ID: MN-Control-1
Bridge Number: 62800
Bridge Location: Grotto St. over I-94
Construction Date: 9/28/2016
Crack Survey Date: 6/3/2019

Bridge Age: 32.2 months
Crack Density: 0.029 m/m^2
Span 1: 0.029 m/m^2
Span 2: 0.028 m/m^2

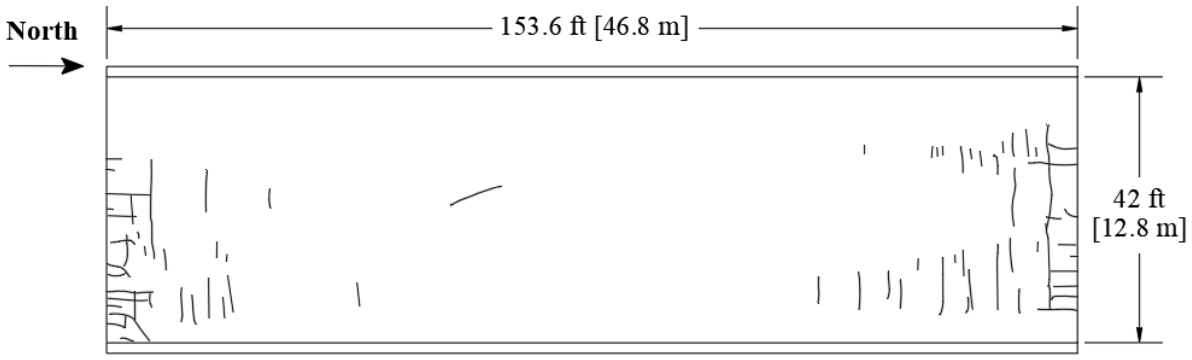
Figure G.7: Crack Map for MN-IC-LC-HPC-2 (Survey 1)

Bridge ID: MN-IC-LC-HPC-2
Bridge Number: 25036
Bridge Location: S.B TH 52 over Little Cannon River
Construction Date: 7/6/2017
Crack Survey Date: 5/10/2018

Bridge Age: 10.2 months
Crack Density: 0.165 m/m^2

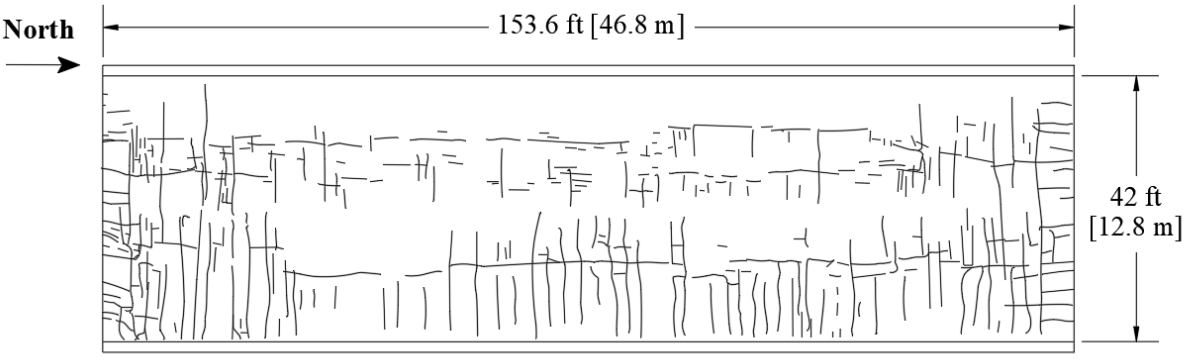
Figure G.8: Crack Map for MN-IC-LC-HPC-2 (Survey 2)

Bridge ID: MN-IC-LC-HPC-2
Bridge Number: 25036
Bridge Location: S.B TH 52 over Little Cannon River
Construction Date: 7/6/2017
Crack Survey Date: 6/3/2019

Bridge Age: 22.9 months
Crack Density: 0.896 m/m^2

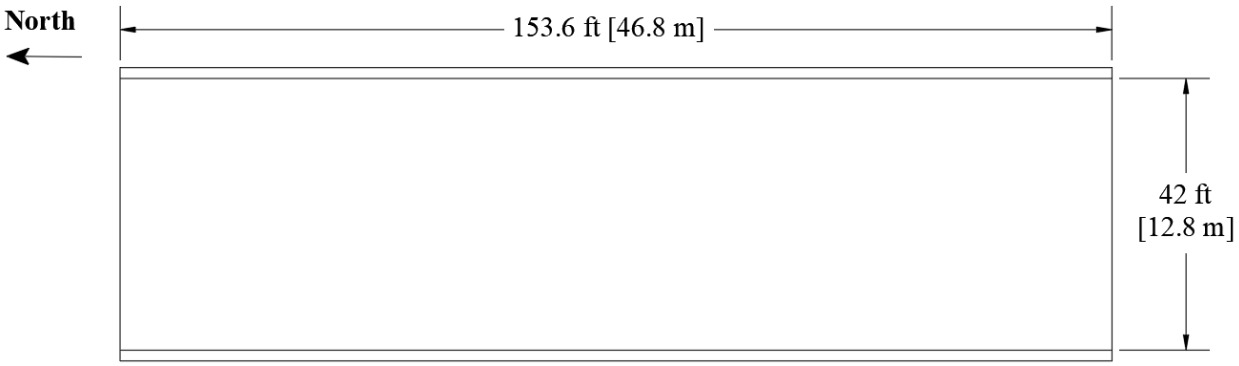
Figure G.9: Crack Map for MN-Control-2 (Survey 1)

Bridge ID: MN-Control-2
Bridge Number: 25032
Bridge Location: N.B TH 52 over Little Cannon River
Construction Date: 9/15/2017
Crack Survey Date: 5/10/2018

Bridge Age: 7.8 months
Crack Density: 0 m/m^2
Crack Length: 0 ft

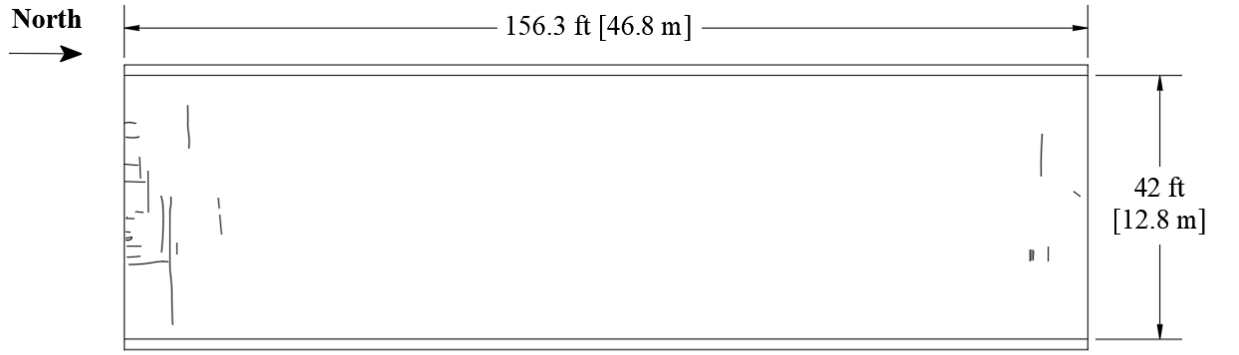
Figure G.10: Crack Map for MN-Control-2 (Survey 2)

Bridge ID: MN-Control-2
Bridge Number: 25032
Bridge Location: S.B TH 52 over Little Cannon River
Construction Date: 9/15/2017
Crack Survey Date: 6/3/2019

Bridge Age: 20.6 months
Crack Density: 0.050 m/m^2
Crack Length: 98.4 ft

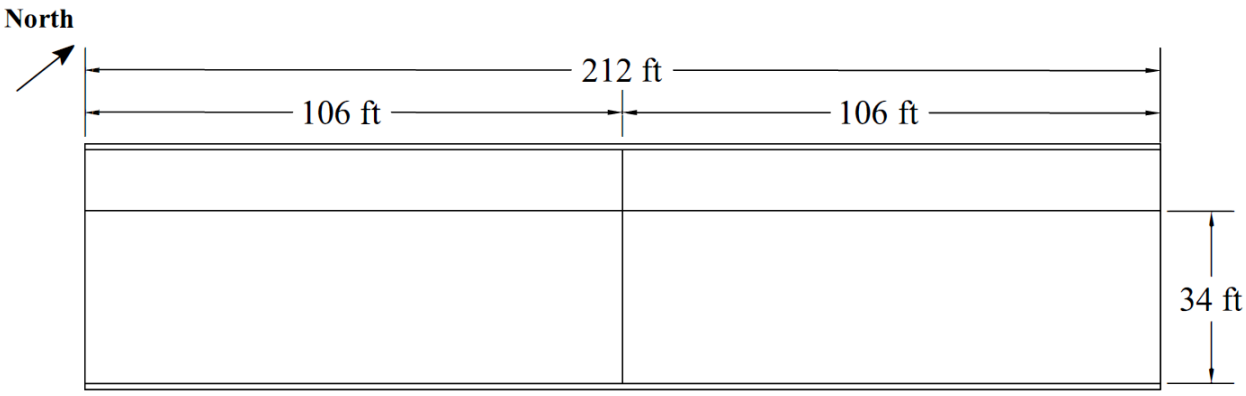
Figure G.11: Crack Map for MN-IC-LC-HPC-1 (Survey 1)

Bridge IC: MN-IC-LC-HPC-3
Bridge Number: 25037
Bridge Location: T.H. 58 over T.H. 52
Construction Date: 6/29/2017
Crack Survey Date: 5/10/2018

Bridge Age: 10.4 months
Crack Density: 0 m/m^2

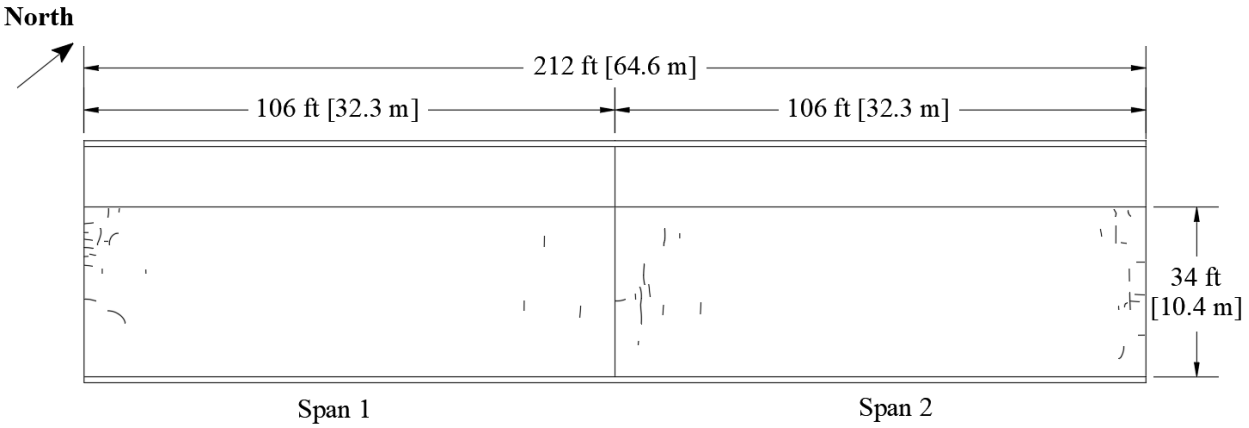
Figure G.12: Crack Map for MN-IC-LC-HPC-3 (Survey 2)

Bridge ID: MN-IC-LC-HPC-3
Bridge Number: 25037
Bridge Location: T.H. 58 over T.H. 52
Construction Date: 6/29/2017
Crack Survey Date: 6/3/2019

Bridge Age: 23.2 months
Crack Density: 0.042 m/m^2
Span 1: 0.033 m/m^2
Span 2: 0.050 m/m^2
Crack Length: 92.0 ft
Span 1: 36.7 ft
Span 2: 55.3 ft

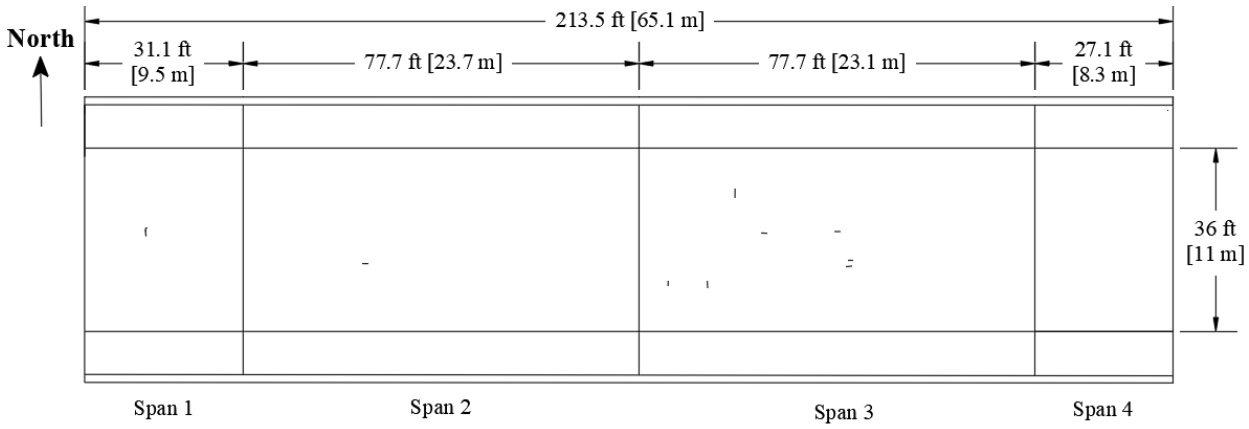
Figure G.13: Crack Map for MN-IC-LC-HPC-4 (Survey 1)

Bridge Number: MN-IC-LC-HPC-4
Bridge Number: 9619
Bridge Location: 38th St. over I-35W
Construction Date: 5/16/2018
Crack Survey Date: 9/16/2019

Bridge Age: 16.0 months
Crack Density: 0.005 m/m^2
Span 1: 0.005 m/m^2
Span 2: 0.001 m/m^2
Span 3: 0.009 m/m^2
Span 4: 0.000 m/m^2
