Utilizing Fiber-Reinforced Polymers to Retrofit Steel Bridge Girders Damaged by Fatigue Loading.

Submitted to the graduate degree program in Civil Engineering and the Graduate Faculty of the University of Kansas in partial fulfillment of the requirements for the degree of Masters of Science.

Keywords: Bridge, Girder, Steel, Retrofit, Composite, FRP, Kevlar, Fatigue, Fracture, Stiffen
Connection

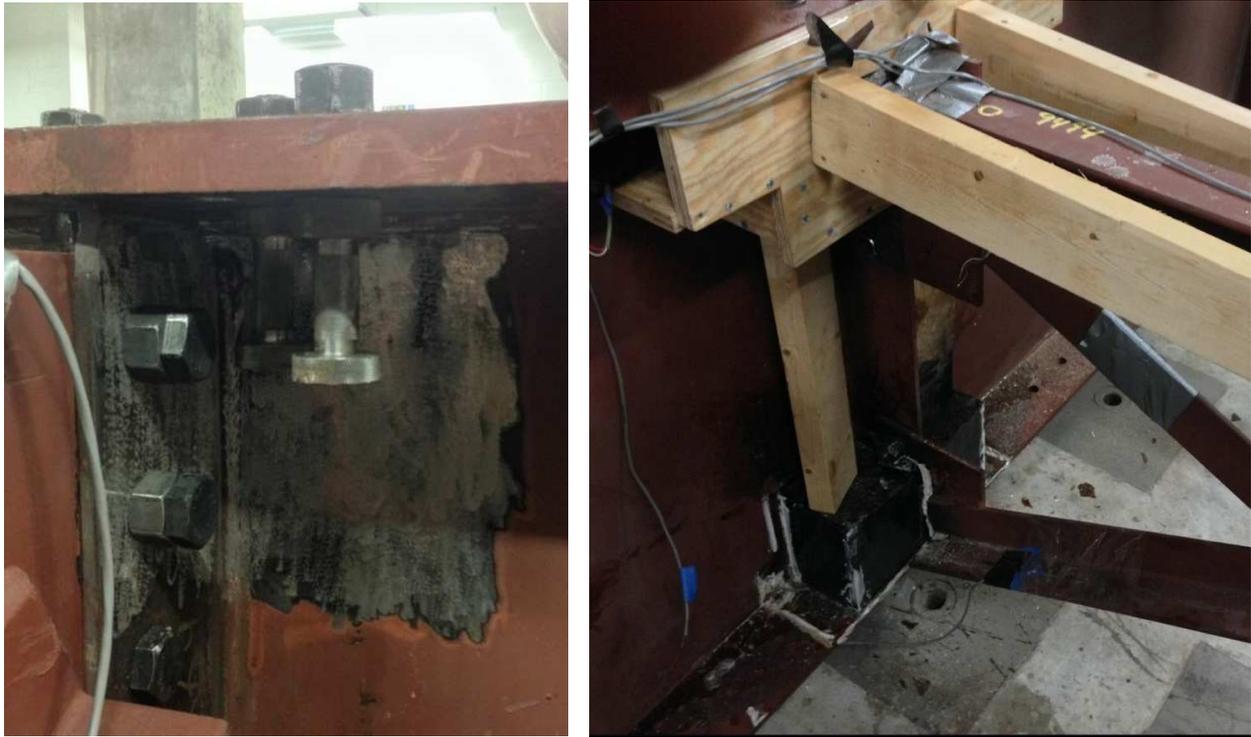
Figure F 2: Upper web-gap region composite block retrofit preparation

After the holes were drilled the surface was then prepared for the retrofit to be installed. This involved using a grinder to grind all of the paint off the specimen in the region where the retrofit would be installed. The two bolts closest to the top flange which attach the cross frame's tab plate to the connection stiffener were removed. Bolts 25-mm (1-in.) longer replaced the two bolts which were removed and a nut with the treads drilled out was placed between the head of the bolt and the connection stiffener. The Bonet Studs were then bolted to the top flange, the bolts were fully tightened as indicated by TurnaSure Direct Tension Indicator washers. The entire region was then cleaned with Acetone. Figure F 2 shows the upper web-gap region with the surface prepared and the Bonet Studs installed.

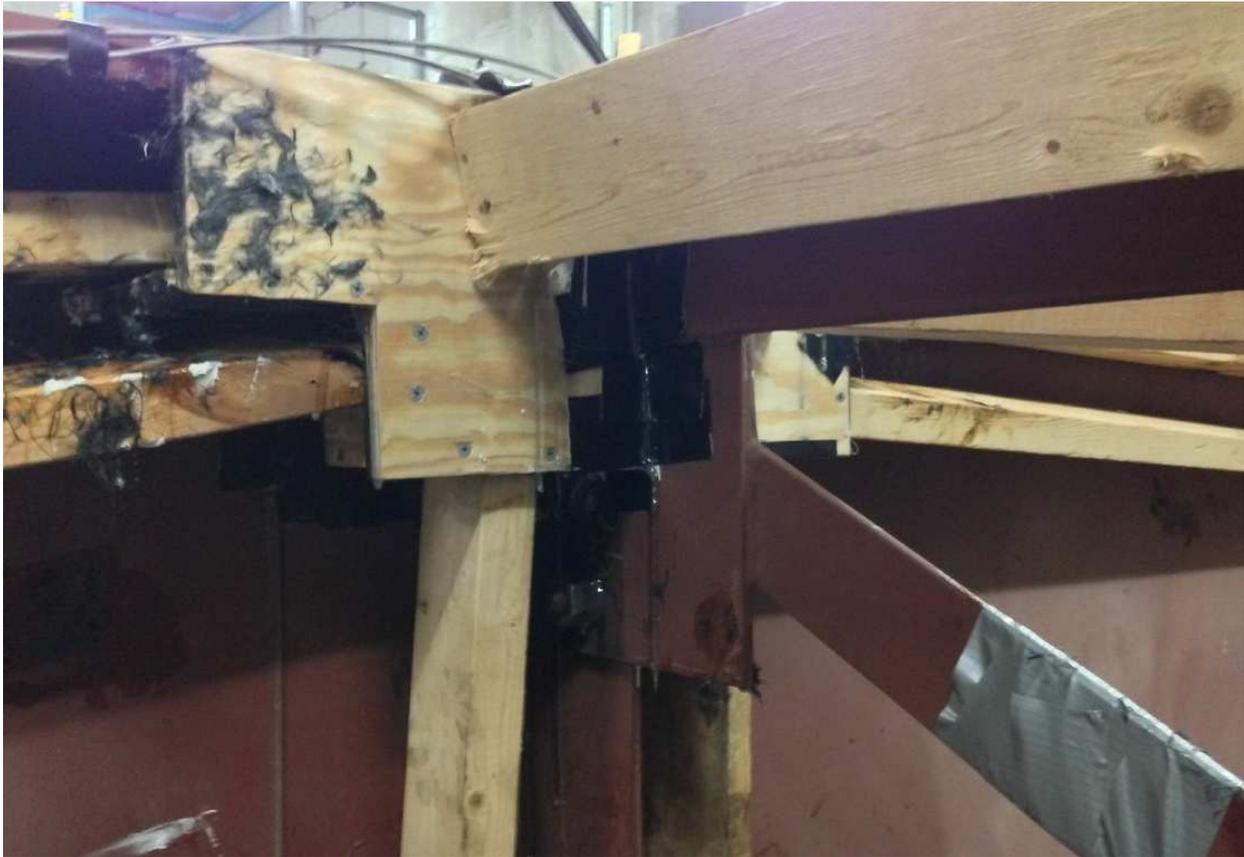
Figure F 3: Upper composite block retrofit curing in the form.

stiffener and the 127x102-mm (5x4-in.) piece of 16-mm (5/8-in.) thick plywood. This 51x102-mm (2x4-in.) was used to push the plywood piece in the tunnel of the box further into the form, in order to compact the composite and insure there wouldn't be any air pockets present in the block. Clear epoxy then began to leak through the form insuring that the block was under pressure as shown in Figure F 3. The temperature in the lab when the block was casted was 24.3-C° (75.7-F°).

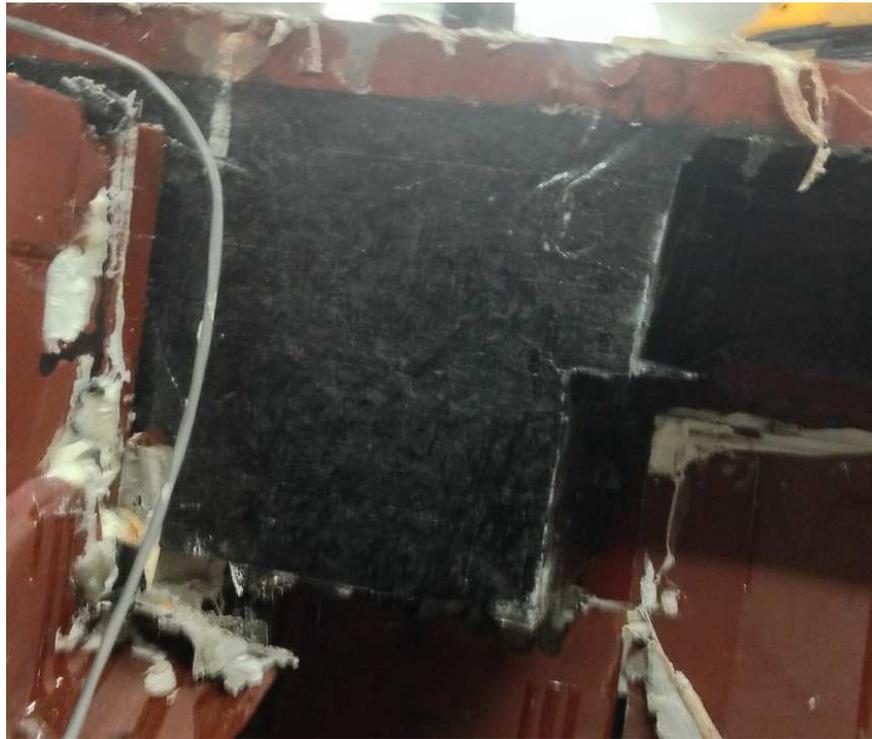
Figure F 4: Fully cured upper composite block retrofit

The composite was given nine full days to cure. On the 10th day of curing the plywood mold was removed. A crowbar and hammer was used to remove the mold from around the block. Figure F 4 shows one of the fully cured blocks installed in the upper web-gap region. Testing of the upper composite block retrofit commenced shortly after the mold was removed and the lab space was cleaned.

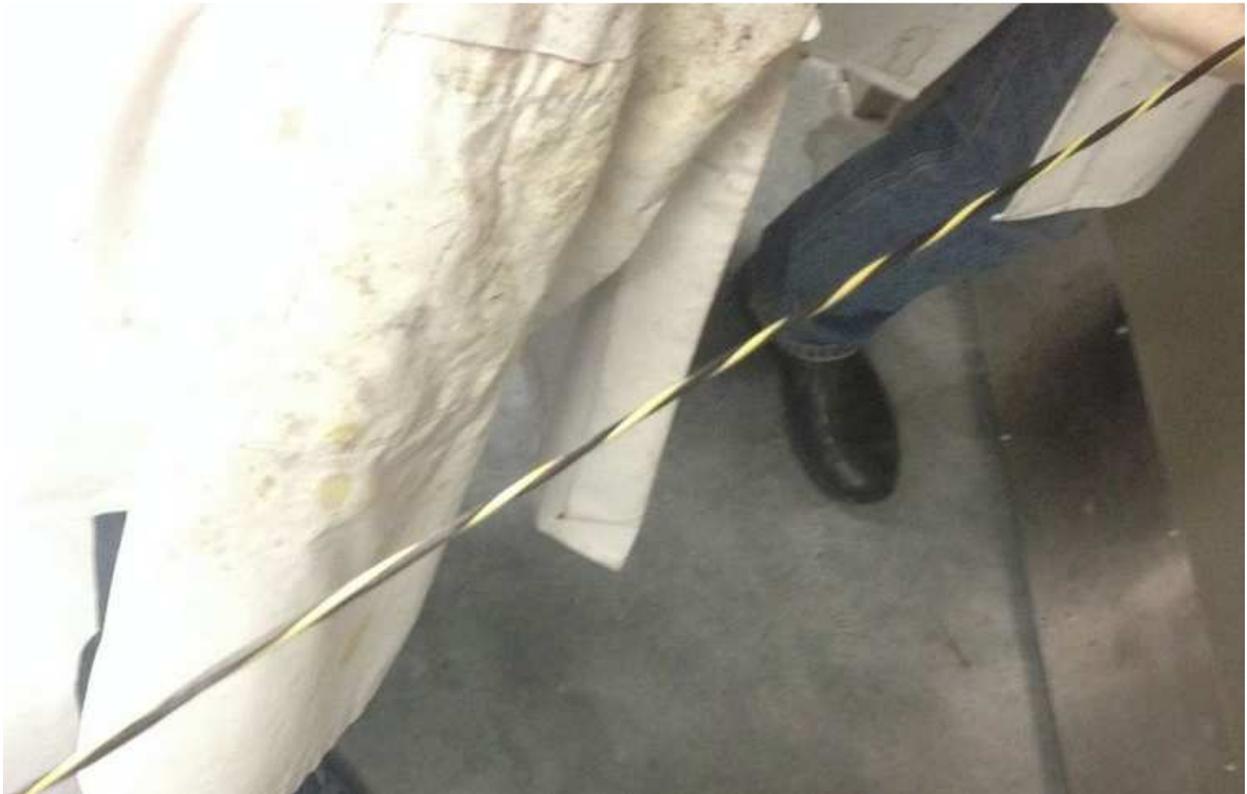
Figure G 1: 12k Carbon Fiber and Aramid Yarn spun together

Originally, the stitching was going to combine the 12k Carbon Fiber and the Aramid Yarn. The two materials were going to be spun together as shown in Figure G 1. After one attempt at spinning the two threads together it proved to be much too difficult and time consuming. The Carbon Fiber threads were too brittle and kept breaking. It was then decided to use only the Aramid Yarn in the stitching retrofit. The Aramid yarn was unraveled in a 3.7m (12-ft.) section and folded back on itself 32 times, so there were 64 total

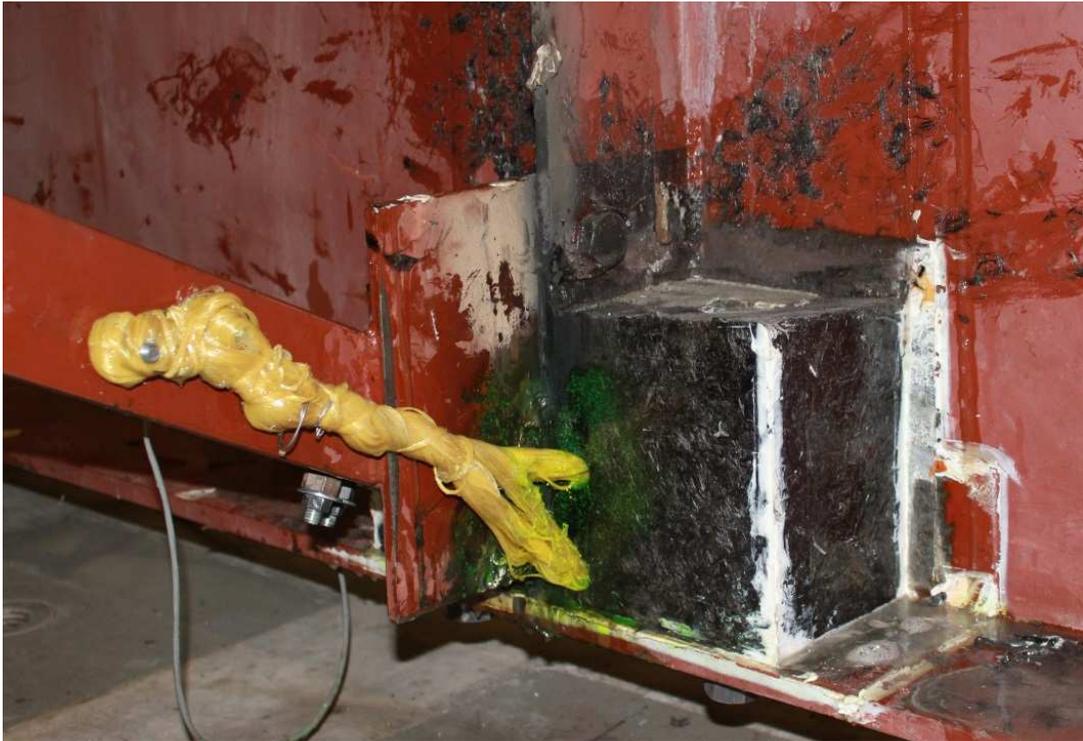
Figure G 2: Kevlar stitching retrofit north stiffener side

The MTS actuator was powered on and a compressive load of (1kip) was applied to the cross frame. This successfully created a post tensioning affect. After the retrofit was installed and the compressive actuator load was removed. The threads were then stitched through the predrilled holes in the composite block and web using a metal clothes hanger which was taken apart and made into a giant sewing needle. The threads passed through the top hole, were wrapped around one of the bolts and were then passed through the bottom hole. This procedure continued until approximately 0.3m (1-ft.) of the stitch was left. This 0.3m (1-ft.) section was then tightly wrapped around the stitching on the stiffener side as shown in Figure G 2, the thin piece of metal which can be seen sticking out of the stitch is the clothes hanger. This processed was repeated for the other side of the cross frame until there were two separate stitches on either side of the angle on the cross frame. The stitching on the fascia side of the girder was then tied together with a small piece of Aramid Yarn. The remaining epoxy which was mixed earlier was then coated on the exposed stitches.

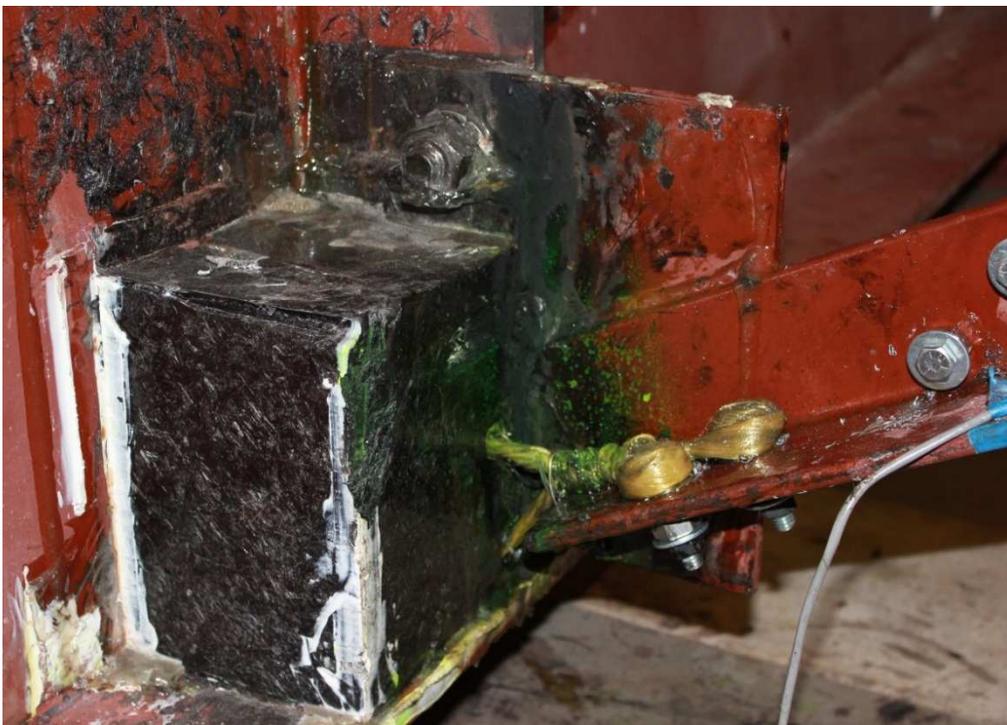
Figure G 3: Kevlar stitching retrofit south stiffener side

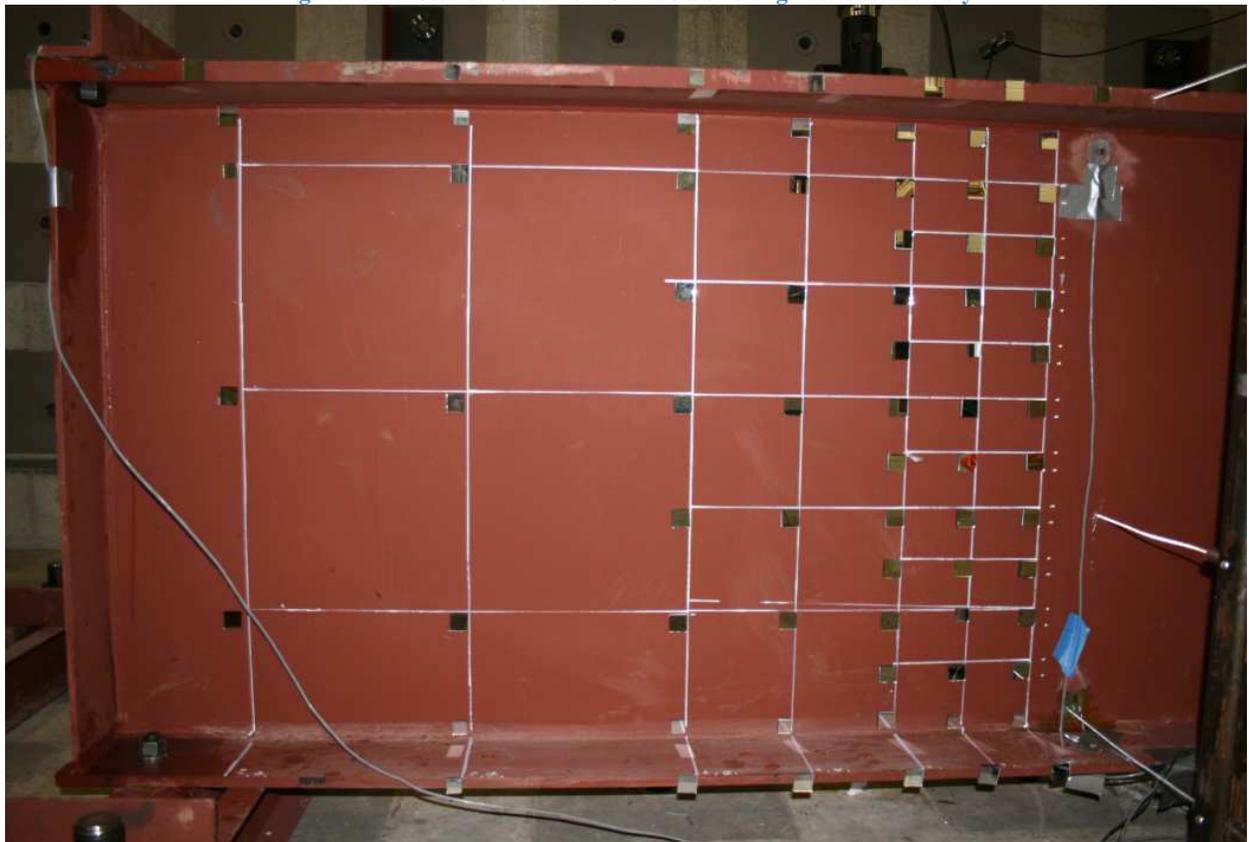
Figure H 2: Assembled mirror array

A simple, cost effective and accurate way to measure specimen rotation at a given location is through the use of an array of mirrors and a laser. This is done by reflecting a laser off of a rotating object and measuring the displacement of the laser in both the horizontal and vertical direction. The displacement of the laser is then used to calculate the rotation of the object. This procedure was performed on the 2.82-meter (9.25-ft.) subassembly tested in the Fracture and Fatigue lab in M2SEC to accurately observe how the stiffness of the specimen changed when any variable on the specimen was altered.

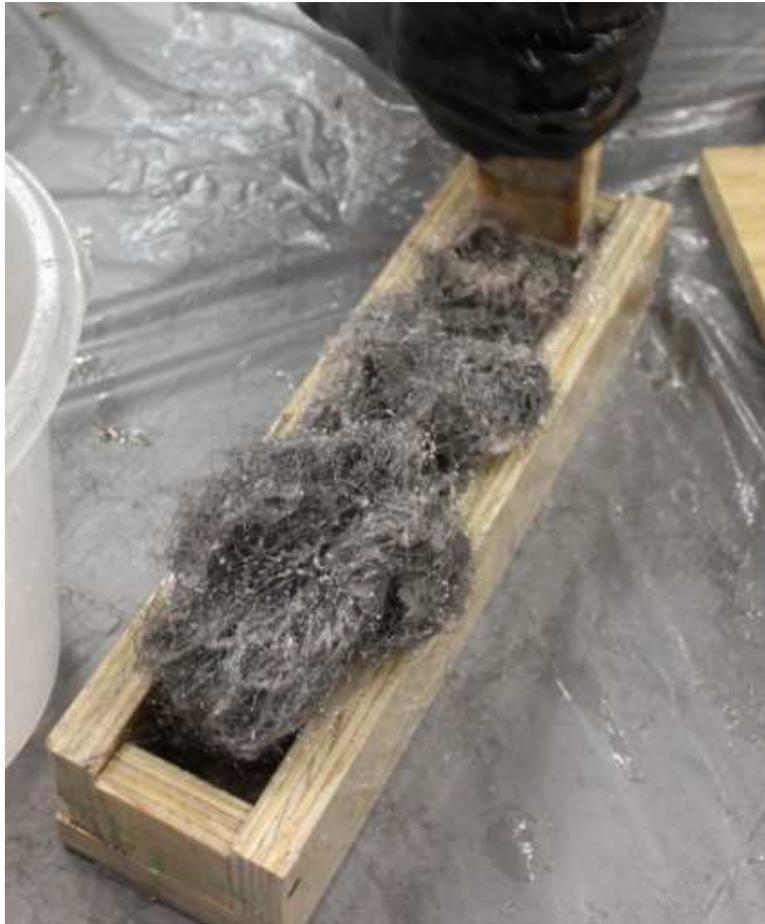
Figure J 1: Compacting steel wool and epoxy into 25x51x305 mm (1x2x12 in) mold

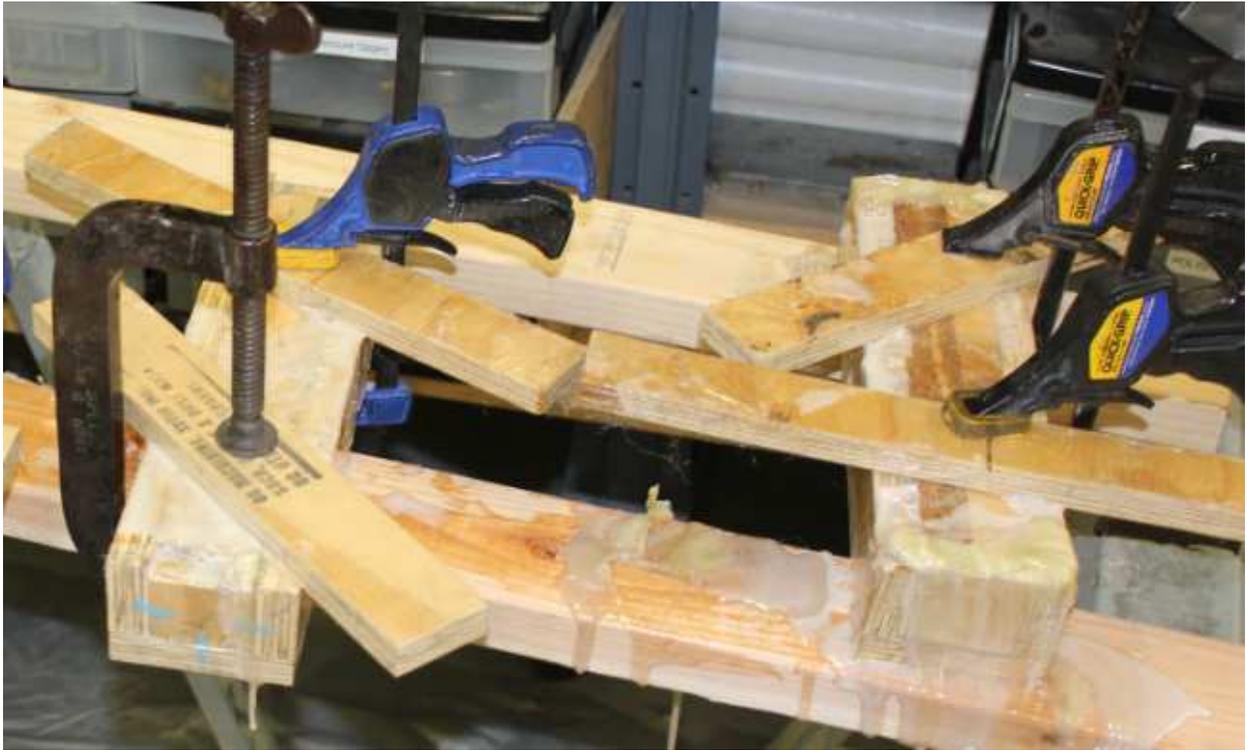
Figure J 2: Steel wool tension specimens curing

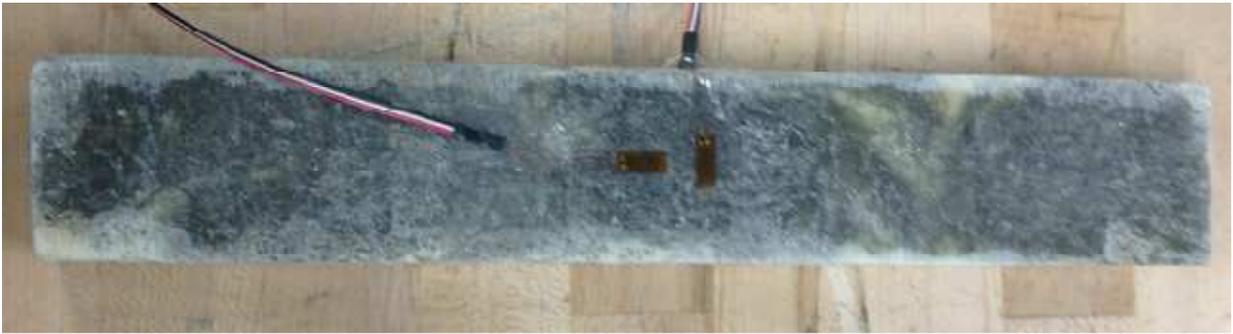
Figure J 3: Steel wool tension specimen with strain gages attached

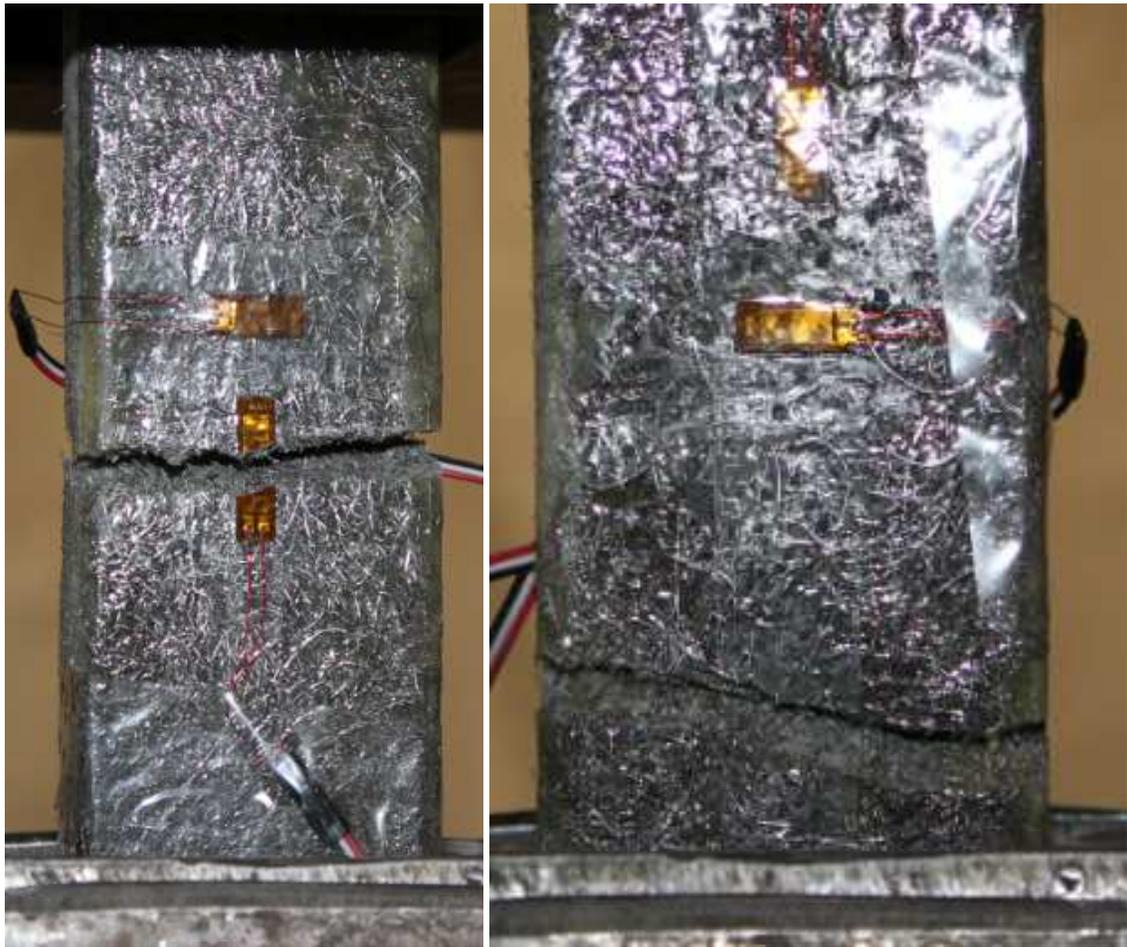
Figure J 4: Failure of steel wool tension specimen 1 left and 3 right

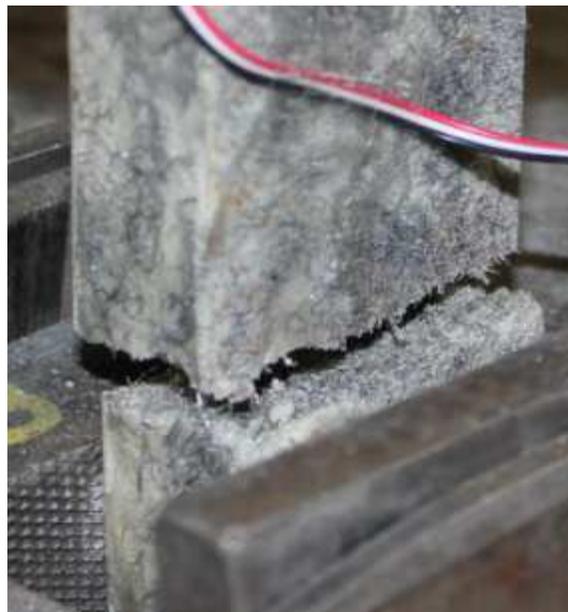
Figure J 5: Failure of steel wool tension specimen 2 occurred at lower grip

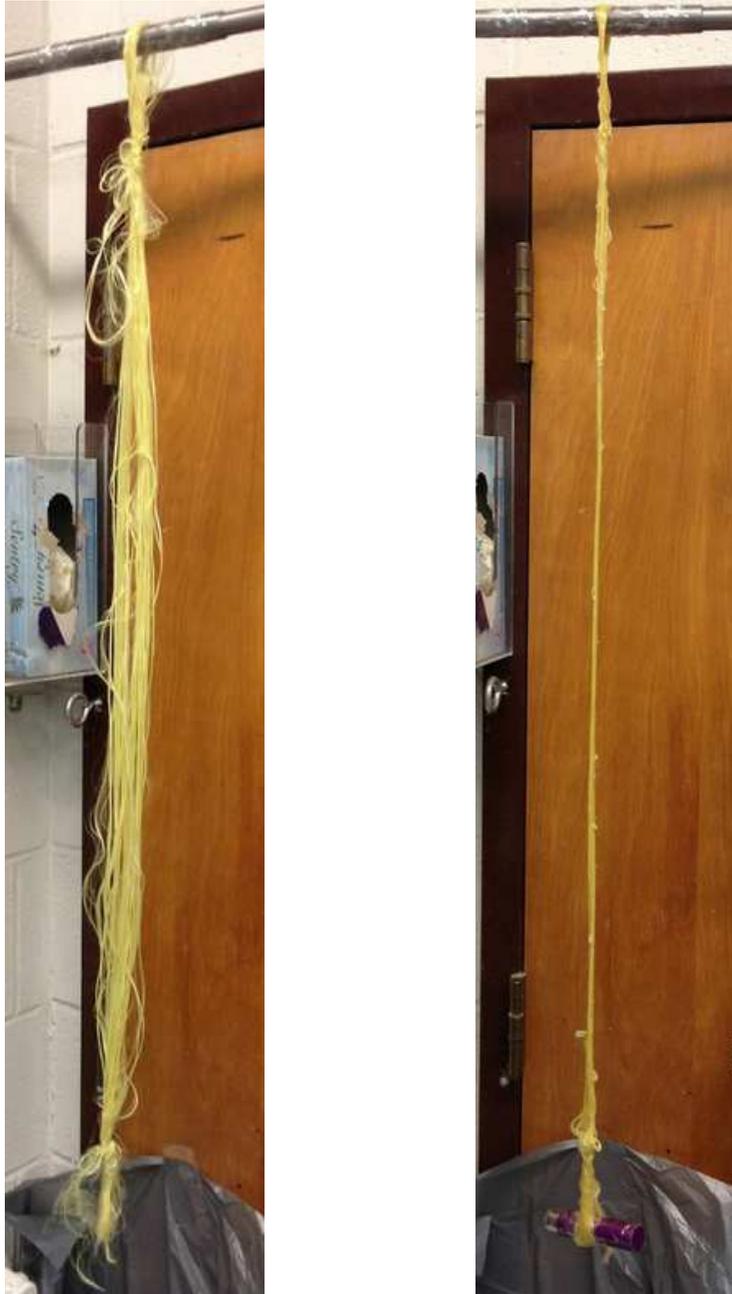
The first Aramid (Kevlar) Yarn tension specimen was constructed by creating a loop of Kevlar using 32 strands. At both ends of the loop an overhand knot was tied approximately 76mm (3-in.) from the ends. The specimens were tested in the MTS testing machine using pin grips with a pin diameter of 25-mm (1-in.). The specimens had to be casted with 25-mm (1-in.) holes on either end so they would fit in the testing machine. Figure K 1 shows the Aramid (Kevlar) Yarn hanging from a 25-mm (1-in.) diameter rod before and after it was coated in epoxy. Once the specimen was hung and coated in epoxy it was left to cure for 24 hours.

Figure K 1: Fabricating the first Kevlar Tension Specimen (left pre epoxy coating, right after epoxy coating)

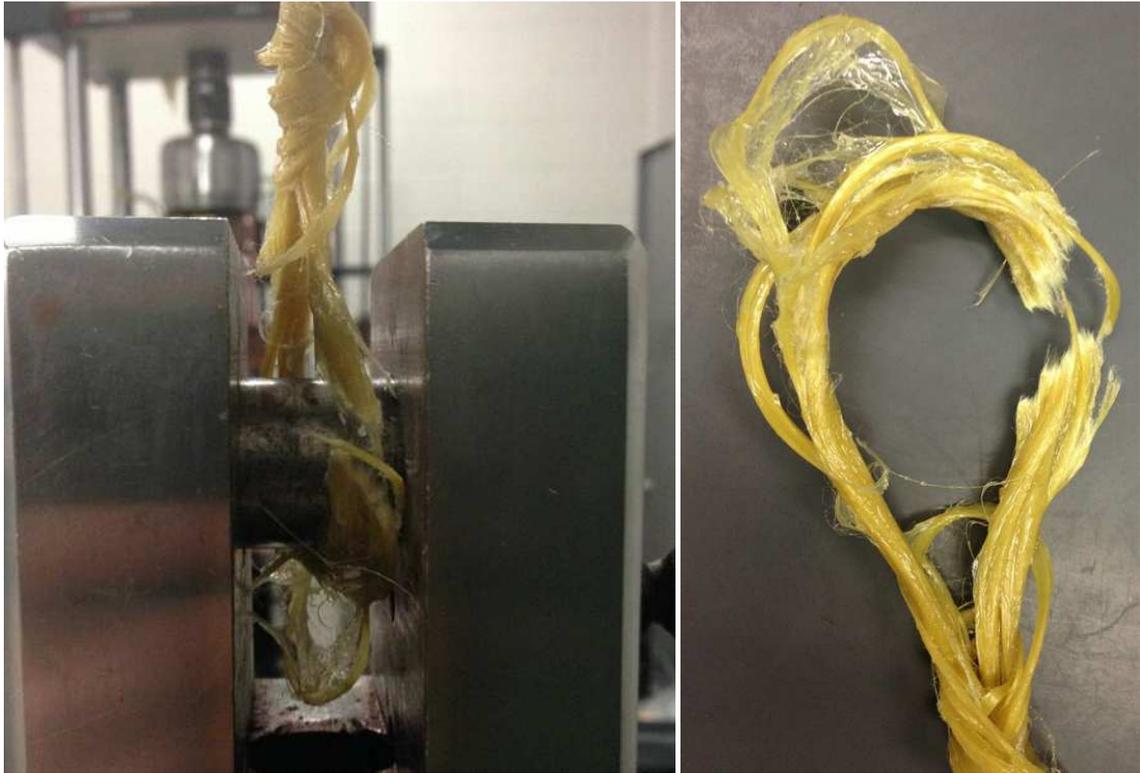
Figure K 2: Failure of Specimen 1 at the grips

The specimen was placed in the MTS testing machine and the machine was set to manual displacement control. Displacement was increased at a rate of 2.5mm/minute (0.1-in/minute). The specimen failed suddenly at a load of 4.7kN (1.05-kips) and elongated 11.4-mm (0.45-in.). The failure of the specimen occurred at the grips as shown in Figure K 2.

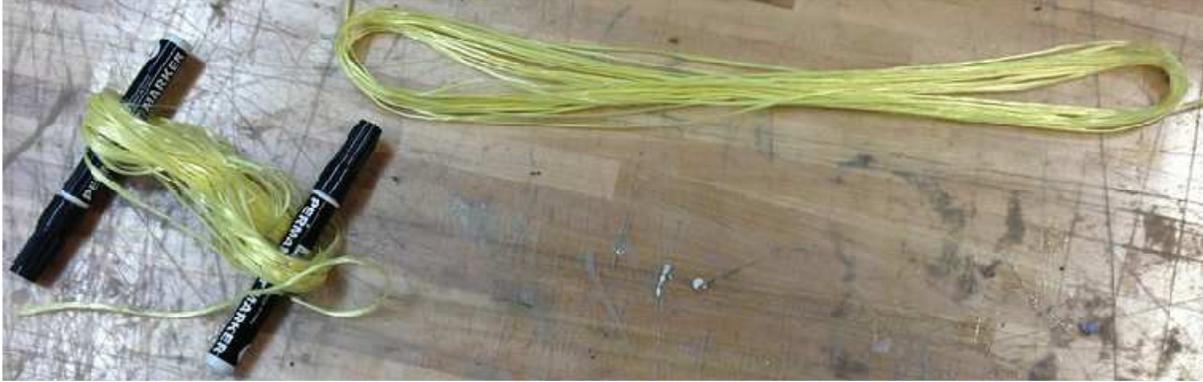
Figure K 3: Strands of Kevlar for tension specimen 2

The second Aramid (Kevlar) Yarn tension specimen was constructed with twice the material at the grip locations in an attempt to prevent grip failure. Two small loops approximately 152 mm (6-in.) long were constructed with 64 strands per loop. A second loop approximately 457 mm (18-in.) was constructed with 32 strands. Figure K 3 shows one of the small loops and the large loop which was used to construct tension specimen 2. The two small loops were placed through the ends of the large loop and folded back on themselves, thereby doubling the strand count at the ends. The specimen was hung from the same 25-mm (1-in.) diameter rod which was used for the first specimen, coated in epoxy and left to cure for 24 hours. Figure K 4 shows the specimen curing and the fully cured specimen.

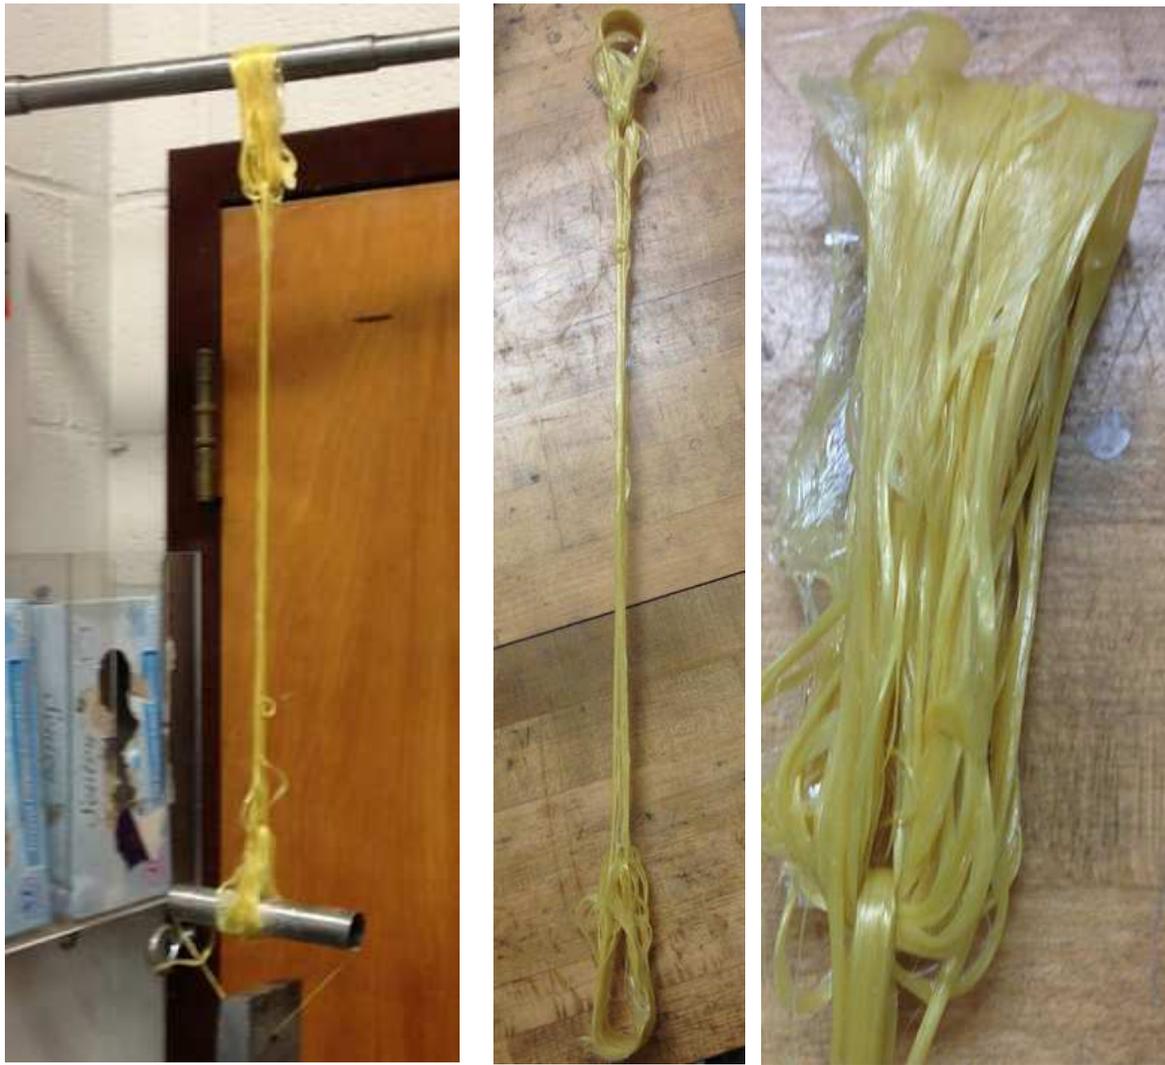
Figure K 4: Kevlar Tension Specimen 2 (left curing, center fully cured, right fully cured grip location)

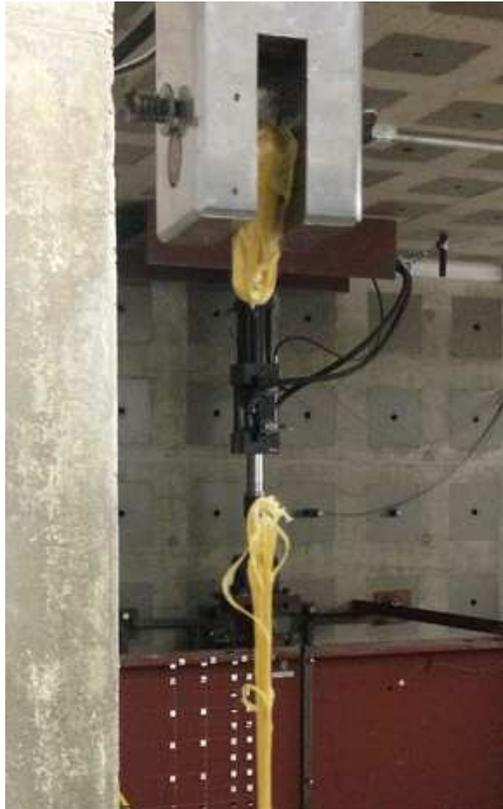
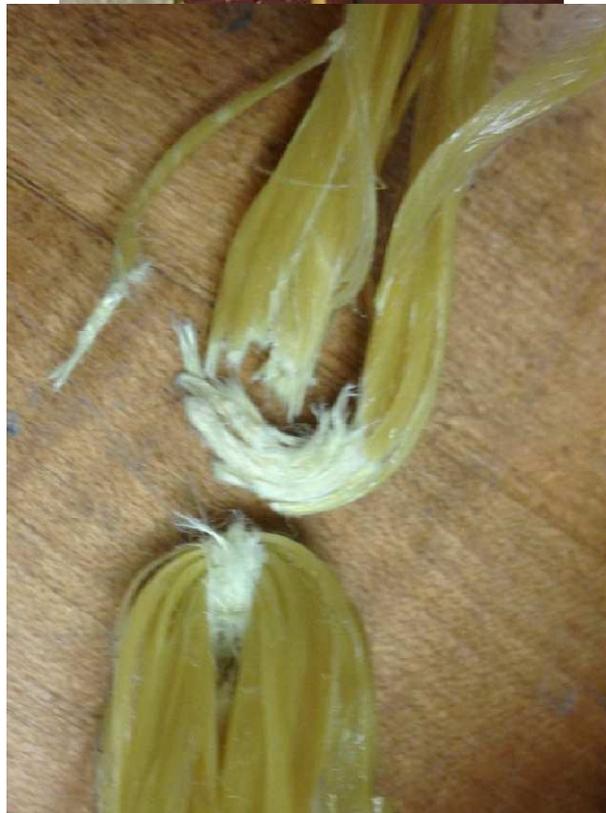
Figure K 6: Failure location of second Kevlar tension test specimen

The second specimen was placed in the MTS testing machine and the machine was set to manual displacement control. Displacement was increased at a rate of 2.5mm/minute (0.1-in/minute). **Error! Reference source not found.** Figure K 5 plots load verses displacement for the second Kevlar tension specimen. During testing cracking was heard, the cracking was strands of Kevlar breaking. All of the sudden drops of load correspond to when cracking of the specimen was heard. At 9.3kN (2.1kips) a loud crack was heard and load suddenly decreased to 8kN (1.8kips). The specimen failed at a load of 10.2kN (2.3 kips) and had an elongation of 68.6mm (2.7-in.). The failure occurred at the upper to center loop connection as shown in Figure K 6.

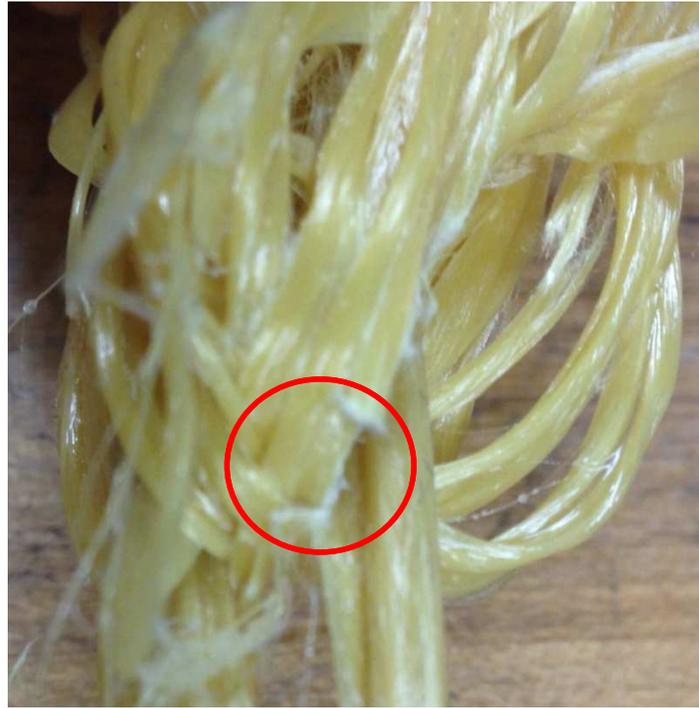
Figure K 7: View of torn Kevlar strand

After the specimen was removed from the testing machine and examined a small strand of Kevlar which was approximately 2 mm (0.08-in.) in length was found broken at the lower to center loop connection. Figure K 7 shows the torn Kevlar circled in red. This was the only visible tear found in the Kevlar specimen, other than the one which caused specimen failure. It is believed that this tear is what caused the large drop of force which occurred at 9.3 kN (2.1 kips). Testing of Kevlar coated in epoxy showed that failures are most likely to occur at connection locations.

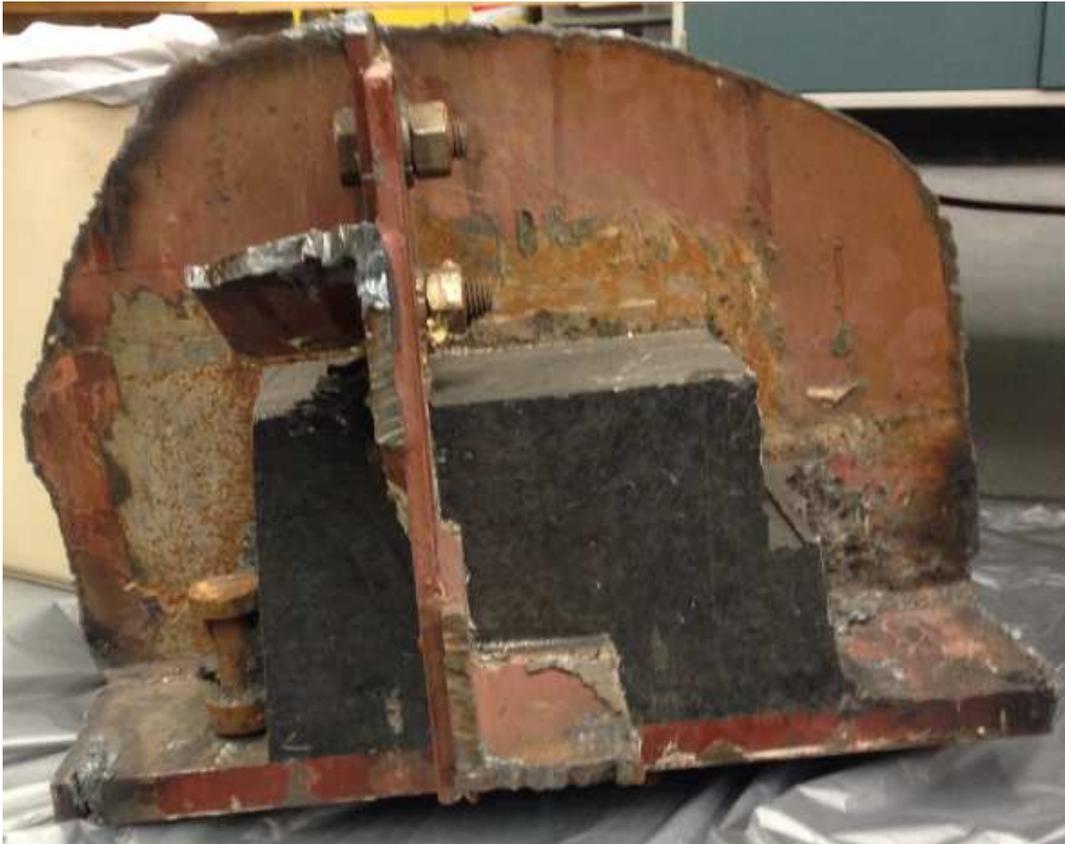
Figure L 1: Upper web-gap region removed from girder subassembly

The composite block which was applied in the upper web-gap region was plasma cut from the girder subassembly once testing concluded as shown in Figure L 1. The Bonet stud is visible on the right because that portion of the composite block was removed prior to plasma cutting the upper web-gap region. Due to the high heat given off during plasma cutting the 25mm (1-in.) top flange the block debonded from the steel and a small gap formed along the composite block to steel flange interface. This gap would allow the salt solution to easily penetrate between the block and steel. To combat this epoxy was poured along all of the composite block to steel edges, successfully eliminating this gap. The epoxy used was a five parts West Systems 105 resin to one part West Systems 206 hardener mixed in a 240 ml (8-oz.) plastic cup for approximately one minute prior to pouring. After the epoxy had cured for 48 hours the specimen was placed into an 85Liter (22 gallon) plastic Rubbermaid® container. 38Liters (10 gallons) of salt water solution was then poured into the plastic container as shown in Figure L 2. The specimen was left in the container for 14 days and was then removed and left to dry for 24 hours.

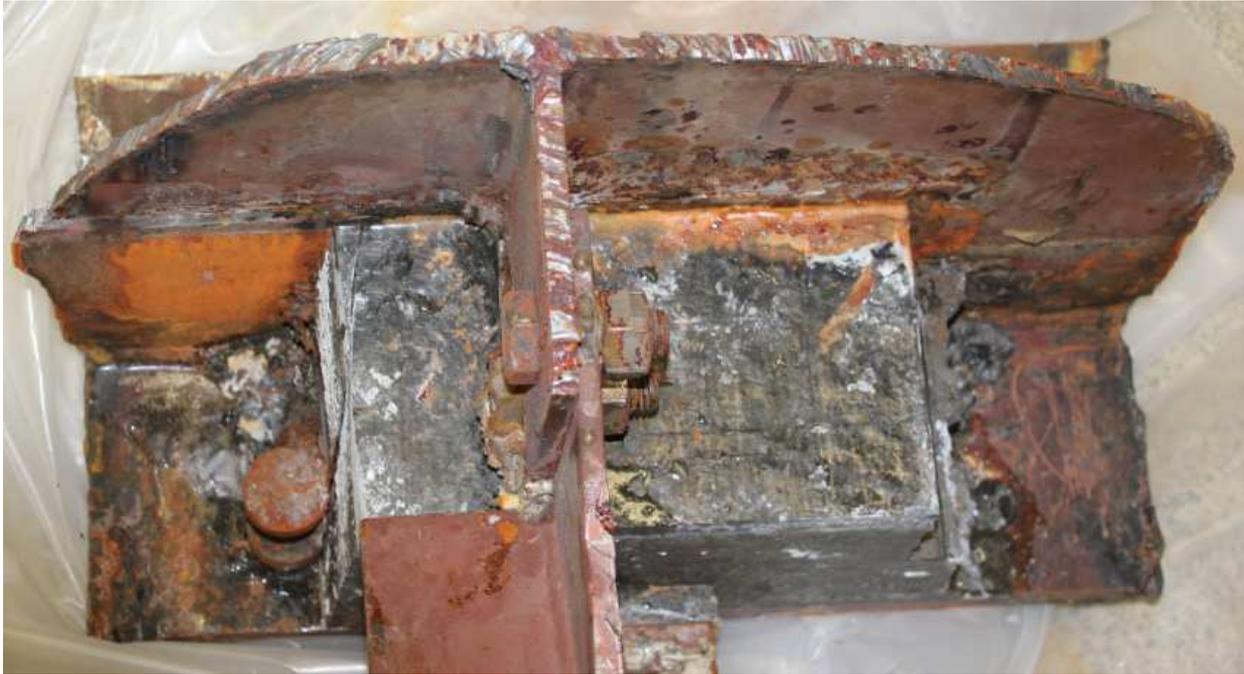
Figure L 3: Upper web-gap region after 14 days in salt solution

Heavy rust formed on the specimen in any location where there was bare steel without paint. Rust also formed along many of the composite block to steel edges. Figure L 3 shows the upper web-gap region after being removed from the salt solution for 24 hours. From visible inspection it didn't appear that any of the salt solution was able to break the bond between the epoxy and steel to cause internal corrosion. To confirm this, a cross section of the block was cut so the internal steel to CFRP connection could be examined. The cross section can be seen in Figure L 4 and was cut utilizing a 355mm (14-in.) chop saw with a metal chop saw blade. Once the cross section was cut it was visibly apparent that rust did not occur on any steel face which was covered in the CFRP.

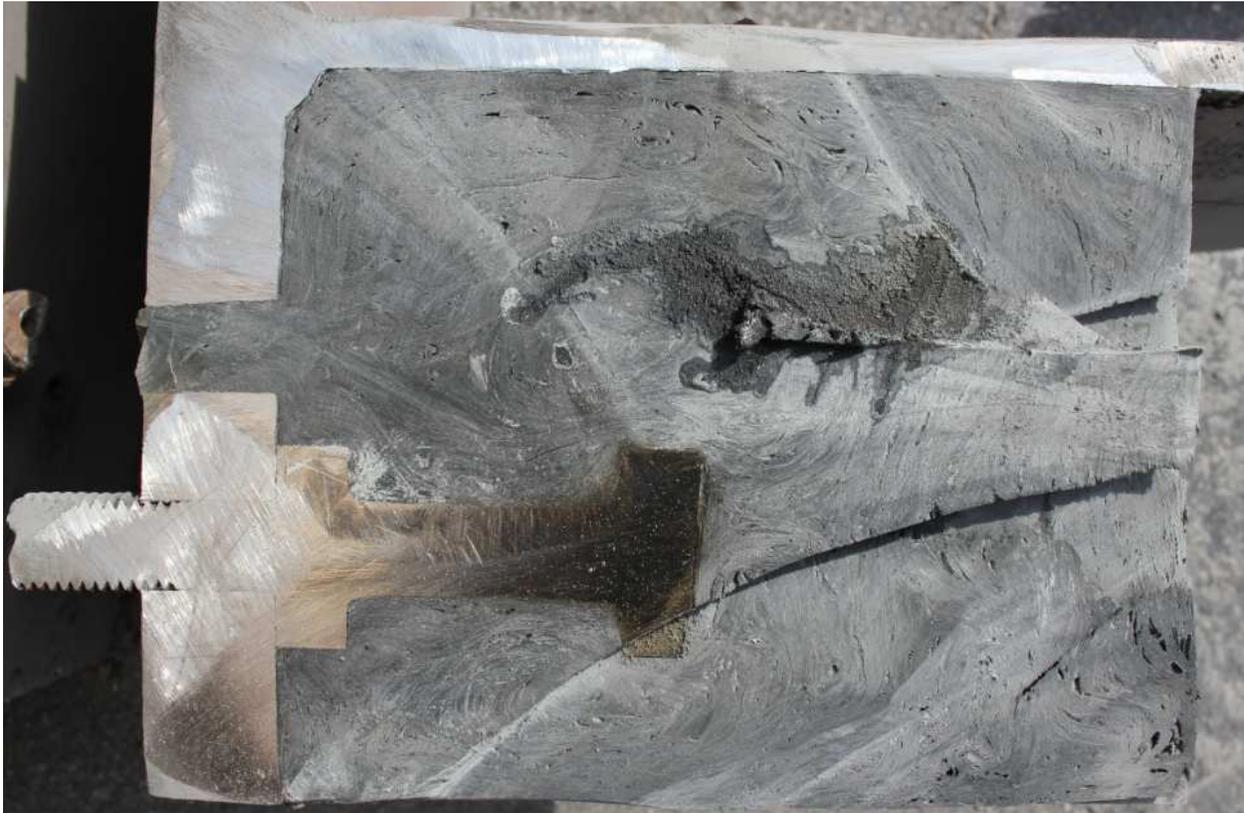
Figure L 4: Cross section of the upper web-gap region after two weeks in salt solution

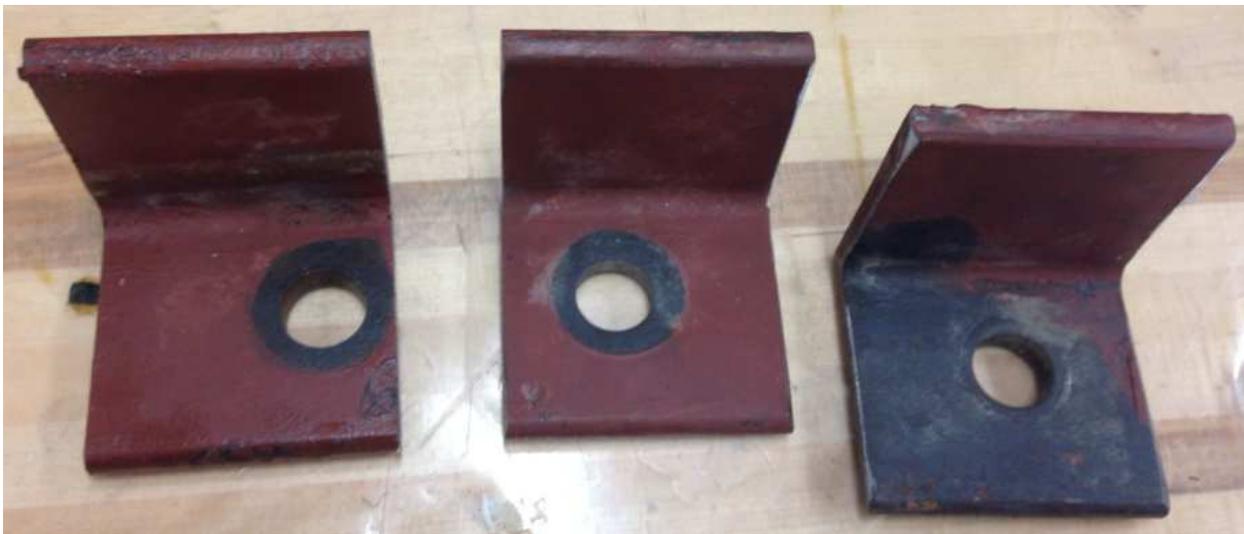
Figure L 5: Corrosion specimens with bolts before bolts are applied

There were three specimens with bolts, all of these specimens had the paint left on them. One specimen was placed in the chamber as the control with no composite applied the other two specimens had the CFRP composite applied to their surface. Figure L 5 shows the specimens after they were cut off of the cross frame and before the bolts were applied. Figure L 6 shows the specimens after the bolts were applied and fully tightened; two of these specimens had the CFRP applied in the two step application process. The corrosion specimens were placed in the salt spray chamber for one week. Figure L 7 shows the specimens with bolts in the salt spray chamber after 24 hours of testing.

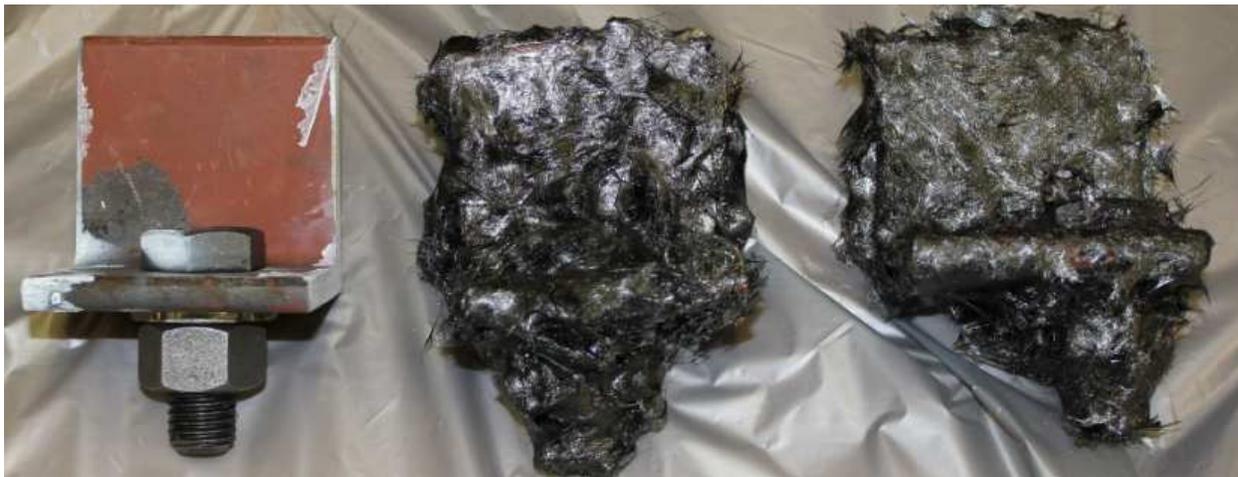
Figure L 6: Corrosion specimens with bolts, control on left other two have CFRP applied to surface

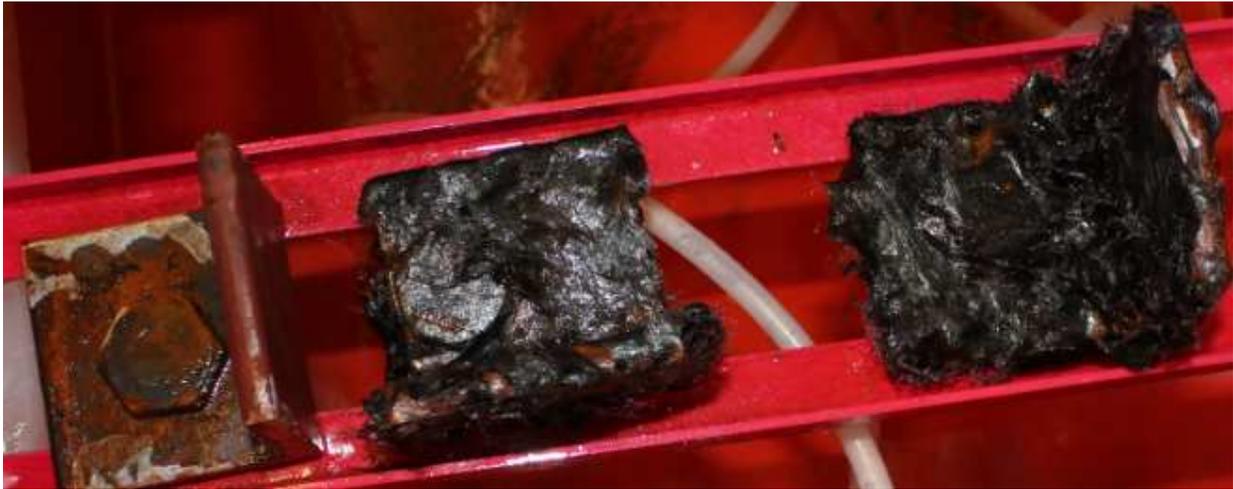
Figure L 7: Corrosion specimens with bolts, photo taken after 24 hours in salt spray chamber
