Utilizing Fiber-Reinforced Polymers to Retrofit Steel Bridge Girders Damaged by Fatigue Loading.

Submitted to the graduate degree program in Civil Engineering and the Graduate Faculty of the University of Kansas in partial fulfillment of the requirements for the degree of Masters of Science.

Keywords: Bridge, Girder, Steel, Retrofit, Composite, FRP, Kevlar, Fatigue, Fracture, Stiffen
Connection

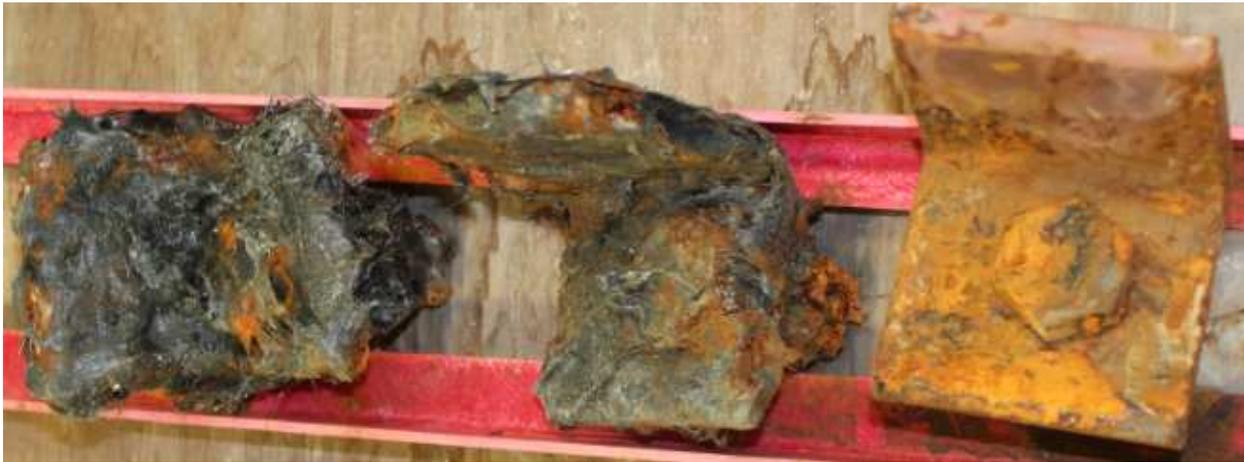
After a full week of testing the specimens with bolts were removed from the salt spray chamber. The control specimen had rust all over its surface. The other two specimens had visible rust forming on the surface of the CFRP. It is interesting to note that before the specimens were placed in the salt spray chamber there were many burrs in the CFRP which would easily prick the hands of someone handling the specimens even with leather gloves on. But after one week in the salt spray chamber the CFRP specimens could be handled with bare hands since the burs were removed by the salt spray.

Figure L 8: Corrosion specimens with bolts, photo taken after specimens were removed from salt spray chamber

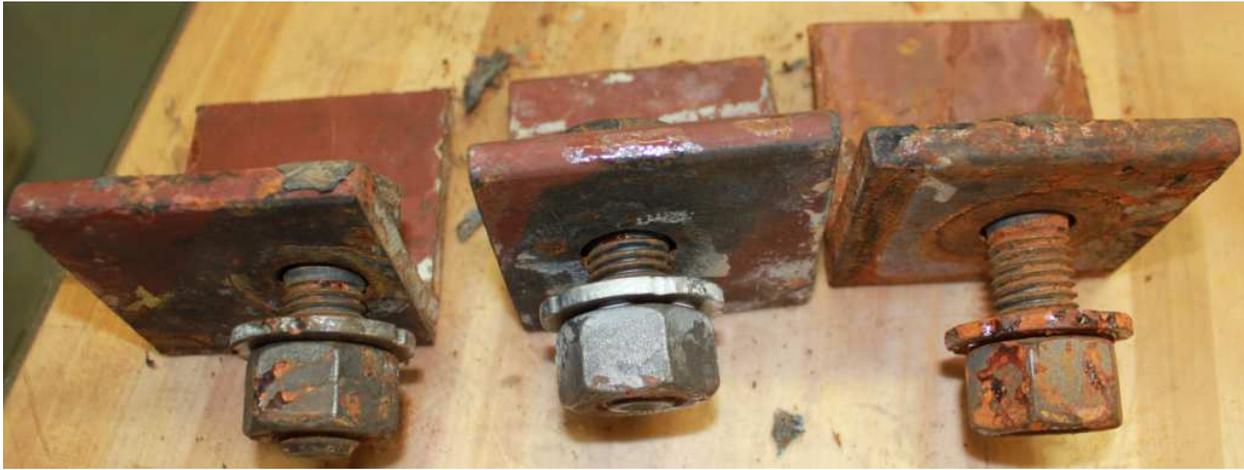
The bolts and the CFRP were removed from the specimens, and there was heavy corrosion noted all over the surface of the control specimen including under the bolt. The specimens with the CFRP had much less visible rust however rust was still able form in locations where the CFRP was unable to fully bond with the surface, this was most prevalent around the edges of the specimen.

Figure L 9: Corrosion specimens with bolts, CFRP removed from the left and center specimen, right specimen was the control

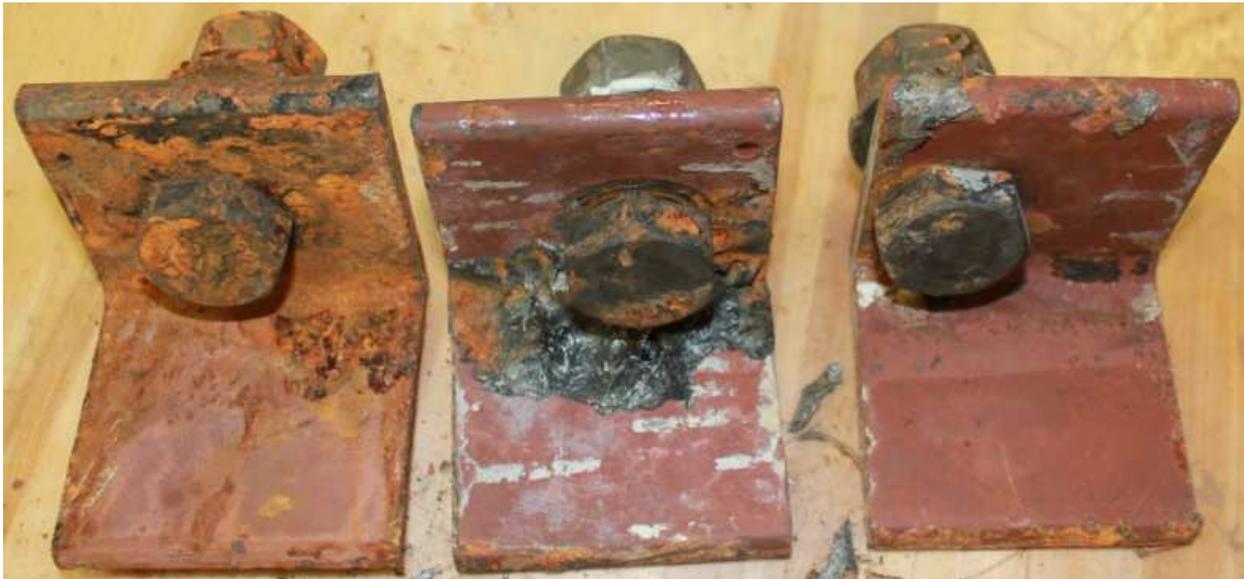
Figure L 10: Corrosion specimens with bolts, CFRP removed from right and center specimen, left specimen was the control

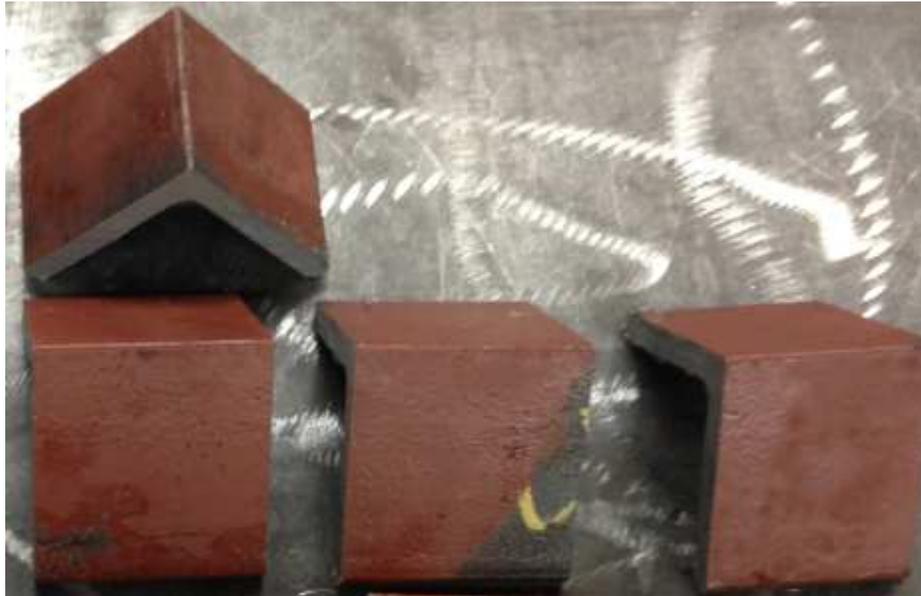
Figure L 11: Painted corrosion specimens before CFRP or epoxy is applied

Figure L 11 shows the painted corrosion specimens before any CFRP or epoxy coating is applied to their surfaces. Applying epoxy to the surface of the painted specimens proved to be very difficult because the epoxy would not flow smoothly over the surface of the specimen. Figure L 12 shows a comparison between the unpainted and painted specimens with epoxy being applied to the specimens' surface. The unpainted specimen had the epoxy smoothly and easily bond with its surface, while the painted specimen did not allow the epoxy to easily bond. The painted specimen in Figure L 12 has many locations where the epoxy pooled creating rings on the specimen without any epoxy.

There were six corrosion specimens with the paint left on. Three of these specimens had CFRP applied to their surface, one of these specimens was fully coated with CFRP, one of the specimens had CFRP applied to only one leg of the angle and the final CFRP painted specimen had CFRP applied to half of both legs of the angle. Two of the painted specimens had epoxy applied to their surfaces, one was fully coated in epoxy and the other had one leg coated in epoxy. One of the painted specimens was left as a control with no CFRP or epoxy applied to its surface. Four of the specimens had the paint removed, one specimen was fully coated in CFRP, another was fully coated in epoxy, the third had CFRP applied to one leg of the angle and the final specimen was left as the control with no CFRP or epoxy applied to its surface.

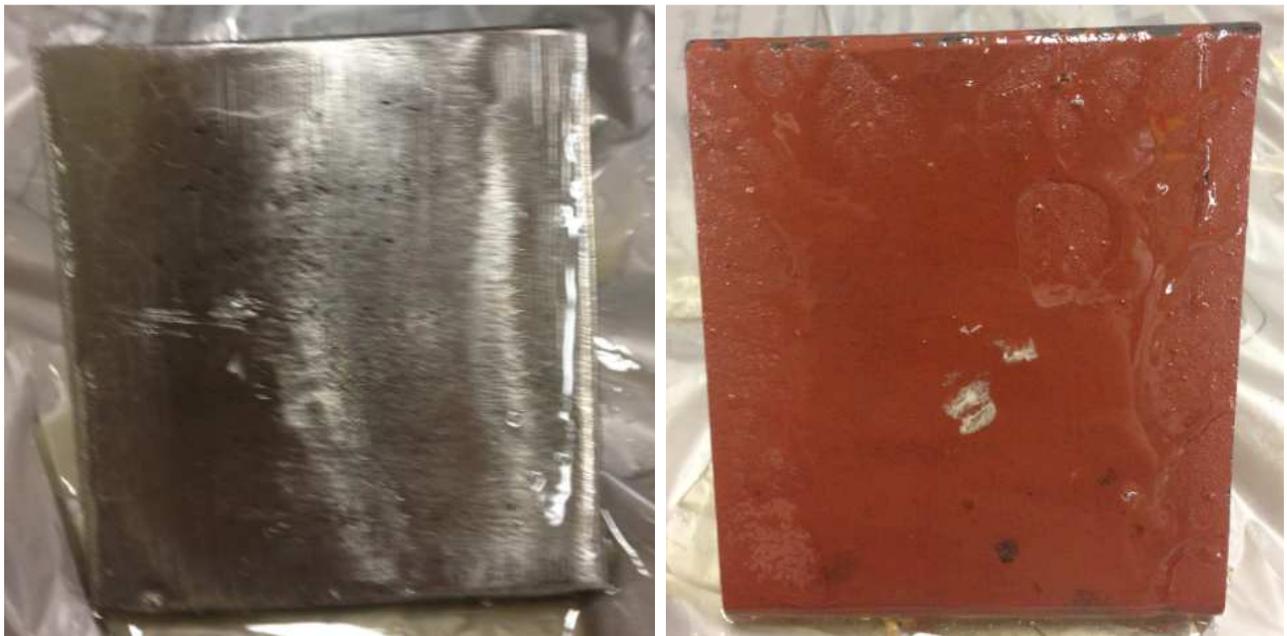
Figure L 12: Corrosion specimens with epoxy coat curing, specimen on the left has bare steel and the specimen on the right has paint

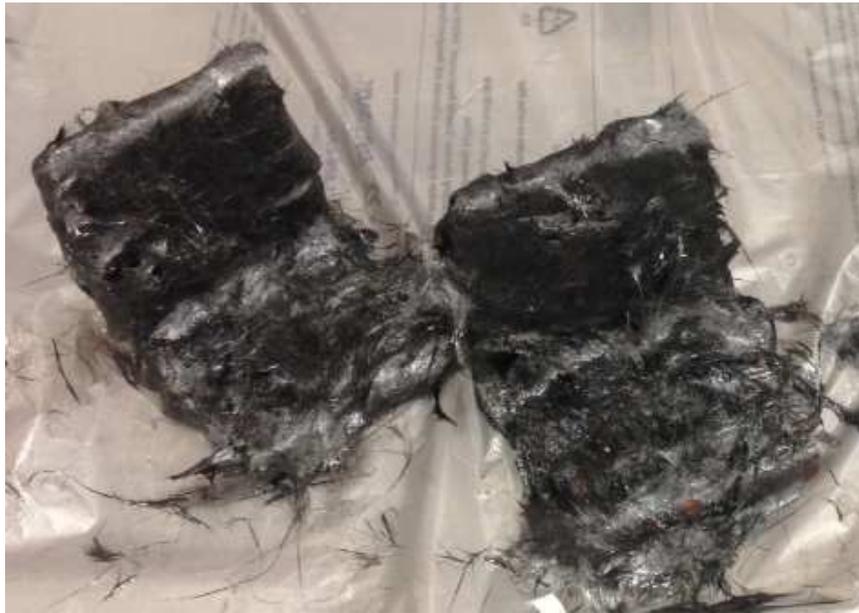
Figure L 13: Corrosion specimens being fully coated in CFRP

The specimens with CFRP applied to their surfaces are shown in Figure L 13. Because the CFRP was applied by hand it was not able to be applied in any uniform matter over the entire surface of the specimen. Around the edges of the specimen it was very difficult to get the CFRP to stay directly against the surface. There were many voids created between the edge of the specimens and the CFRP. After all of the CFRP and epoxy cured the specimens were placed in the salt spray chamber as shown in Figure L 14.

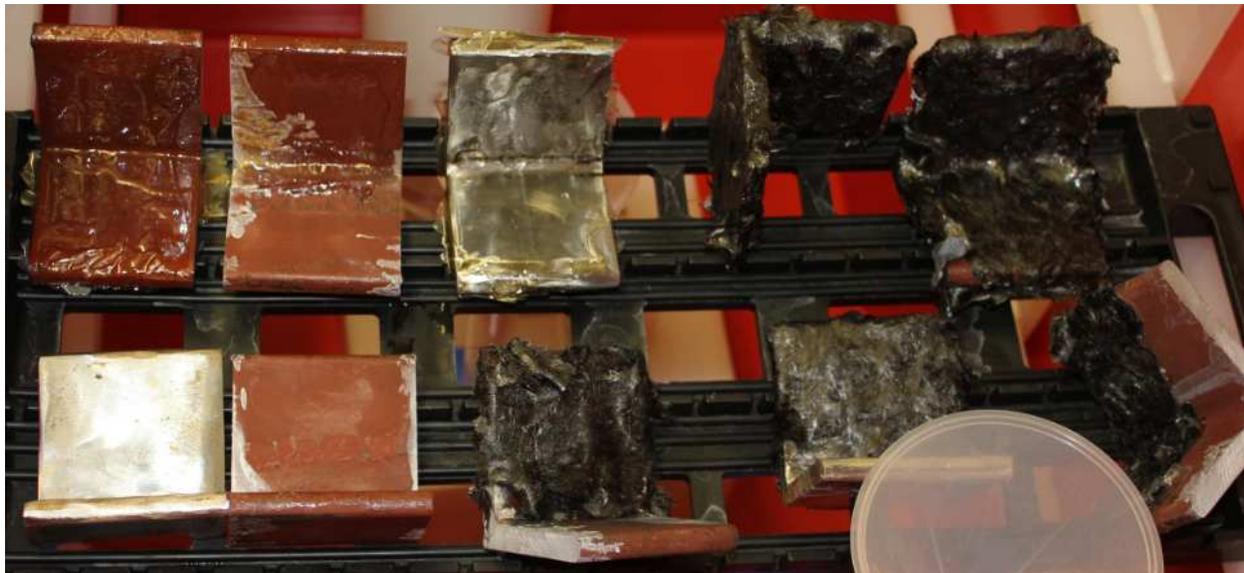
Figure L 14: Corrosion specimens in salt spray chamber

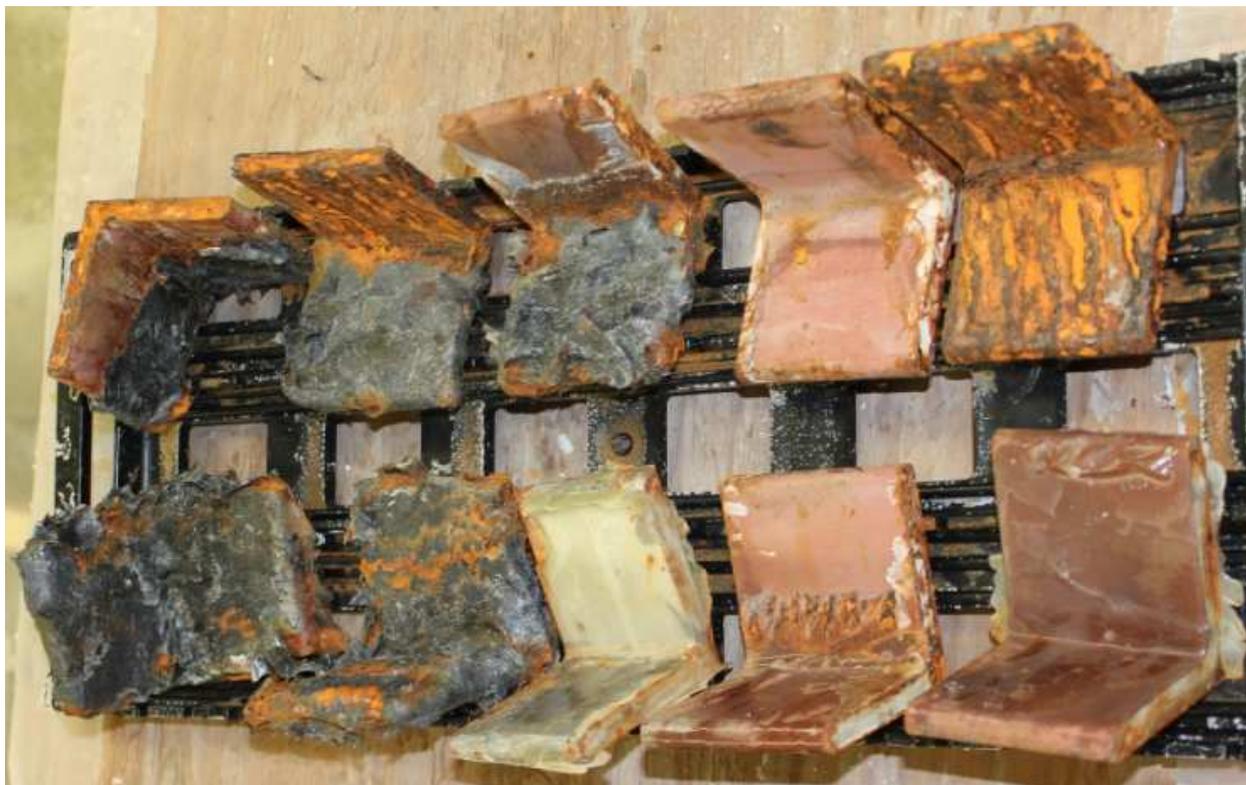
Figure L 15: Corrosion specimens after one week in salt spray chamber

After one week in the salt spray chamber the specimens were removed. Figure L 15 shows the corrosion specimens immediately after they were removed from the salt spray chamber. The control specimen with the paint removed (upper right specimen in Figure L 15) was very heavily corroded with rust on every surface. The edges of the painted specimen (to the left of the control specimen with paint removed in Figure L 15) were also heavily corroded, showing that the clear Rust-Oleum® which was applied on the edges of the specimen wasn't

very effective at preventing corrosion. Also where the two legs of the angle connected there was paint blistering forming, most likely caused from water collecting in that corner. The two specimens (painted and paint removed) which were fully coated in epoxy can be seen in Figure L 16. These specimens had rust along the edges, in some locations this rust forced the epoxy to pop off of the specimen.

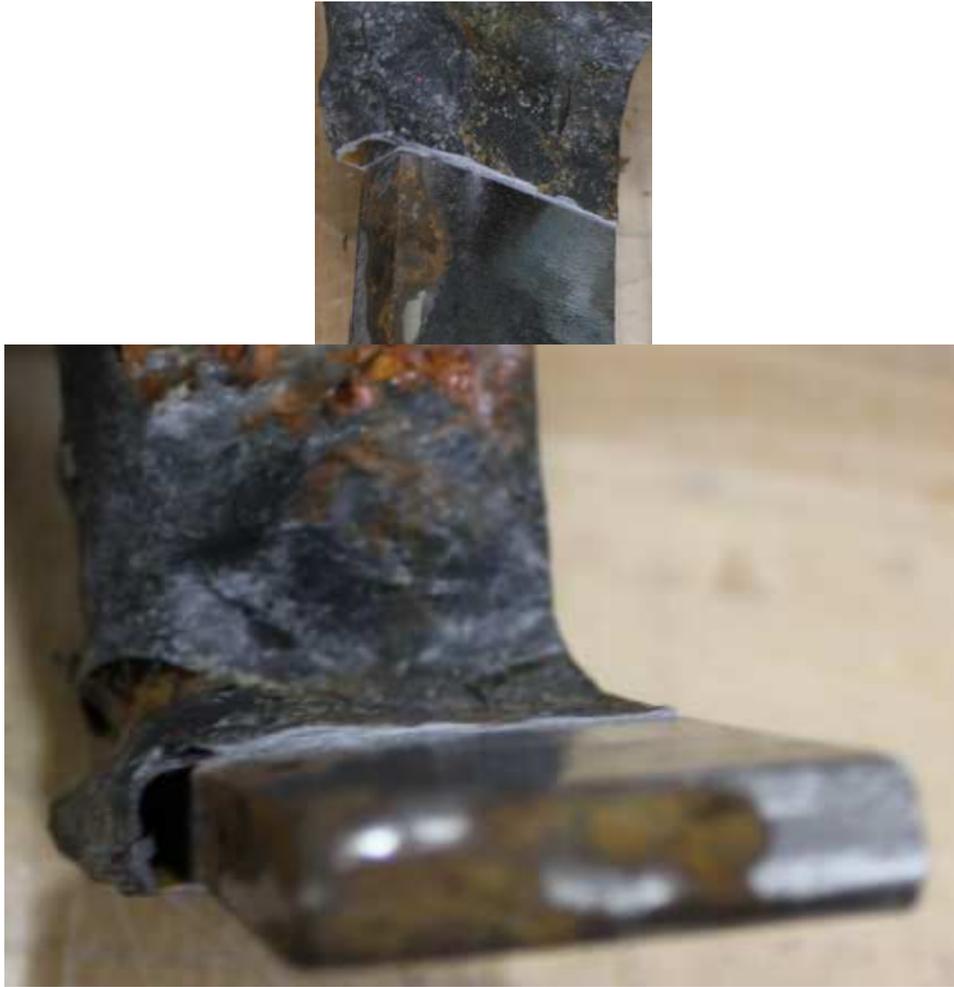
Figure L 17: Corrosion specimen with paint removed and CFRP applied to its entire surface

The specimens with CFRP applied to their surfaces had the CFRP removed in specific locations utilizing a band saw. The CFRP applied to the specimens was very successful at preventing corrosion in locations where the CFRP was able to bond with the surface of the specimen. The specimen with the paint grounded off which was fully covered in CFRP had corrosion present only on the edges where the CFRP was unable to bond with the specimens surface. Figure L 16 shows this specimen with a portion of the CFRP removed the gap between the CFRP and steel is visible in the figure on the right and that gap corresponds to the location where rust formed. The painted specimen with CFRP applied to its entire surface had similar results as the specimen without paint and CFRP applied to its entire surface. The edges of that specimen had rust forming due to the lack of bond between the CFRP and steel, in fact in some locations the rust along the edges of the painted specimen with CFRP was worse than the control painted specimen.

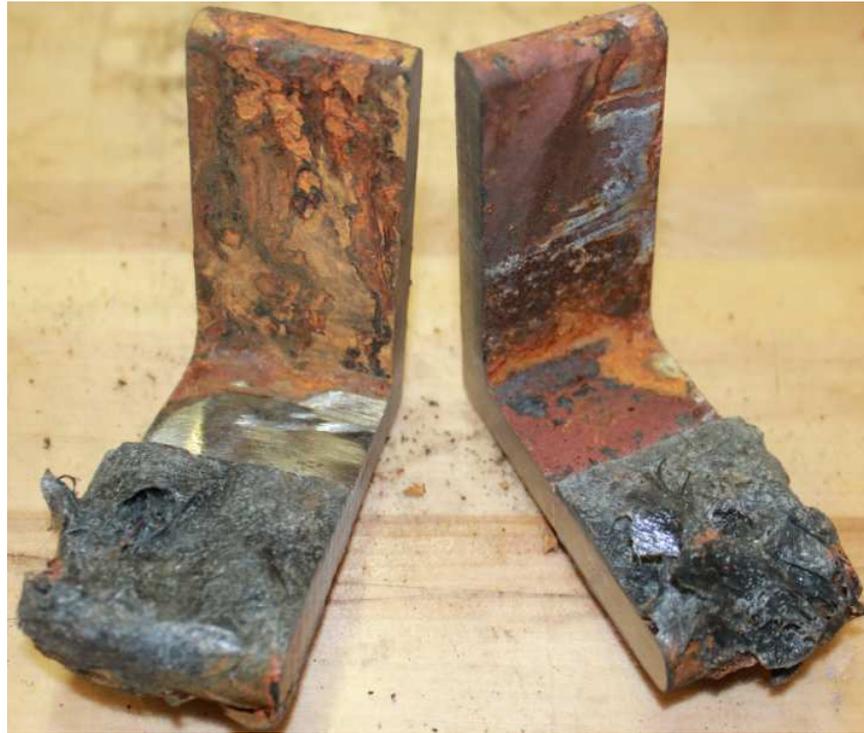
The two specimens (painted and with paint removed) with CFRP applied to only one leg of the specimen can be seen in Figure L 18. Like all of the other specimens in the areas where the CFRP was applied and properly bonded with the specimen there was no corrosion present. However on the edges of the specimen there was visible rust once part of the CFRP was removed.

Figure L 18: Corrosion specimens with CFRP applied to one leg, left specimen with paint removed, right specimen with paint
