# **KU-11-5**

## **Improving Infrastructure Sustainability II: Repairing Existing Fatigue Cracks in Steel Bridges Using CFRP Materials**

A Report on Research Sponsored by  
The Kansas Department of Transportation

Structural Engineering and Engineering Materials  
SM Report No. 110  
September 2015

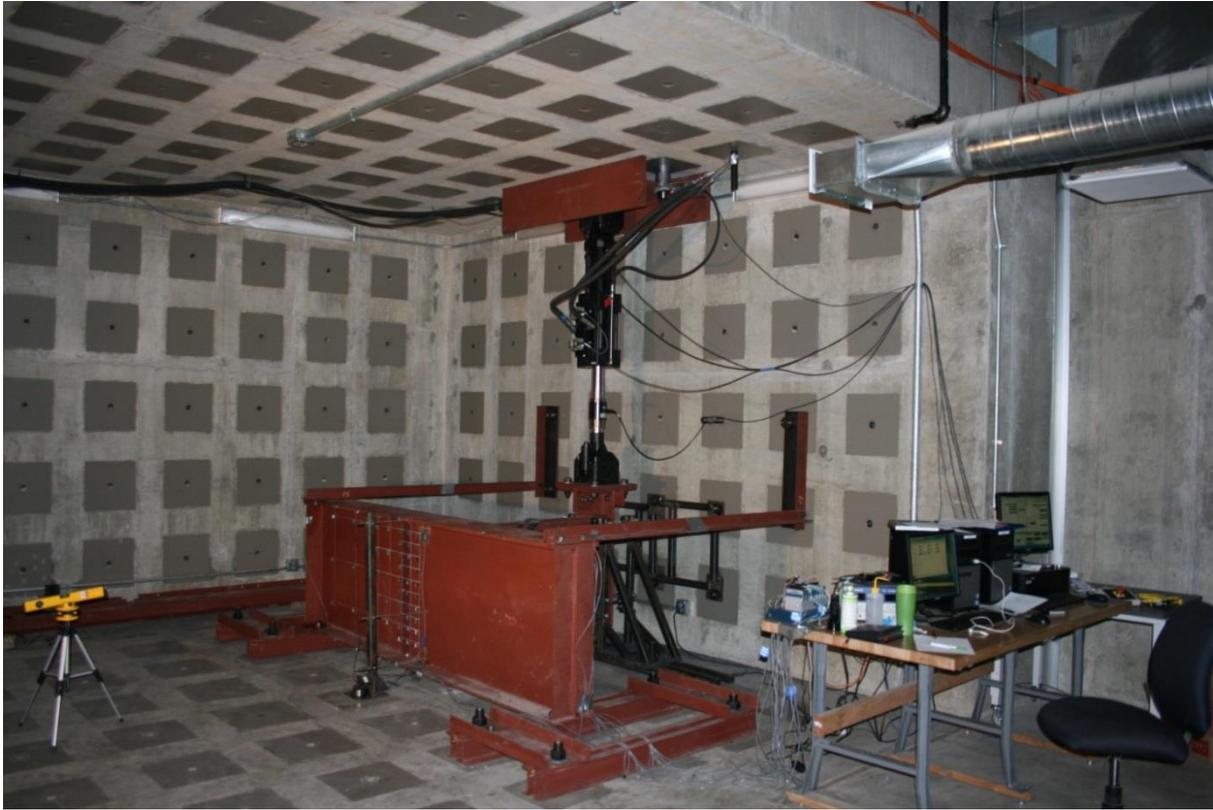
**Figure 2 Girder subassembly 2 being tested at the Fatigue and Fracture Laboratory.**

The placement of the girder was inverted with respect to that expected in a bridge (Figs. 1 and 2), with the top flange free to displace laterally and the bottom flange restrained by the reaction floor (or the concrete deck in the case of a bridge).

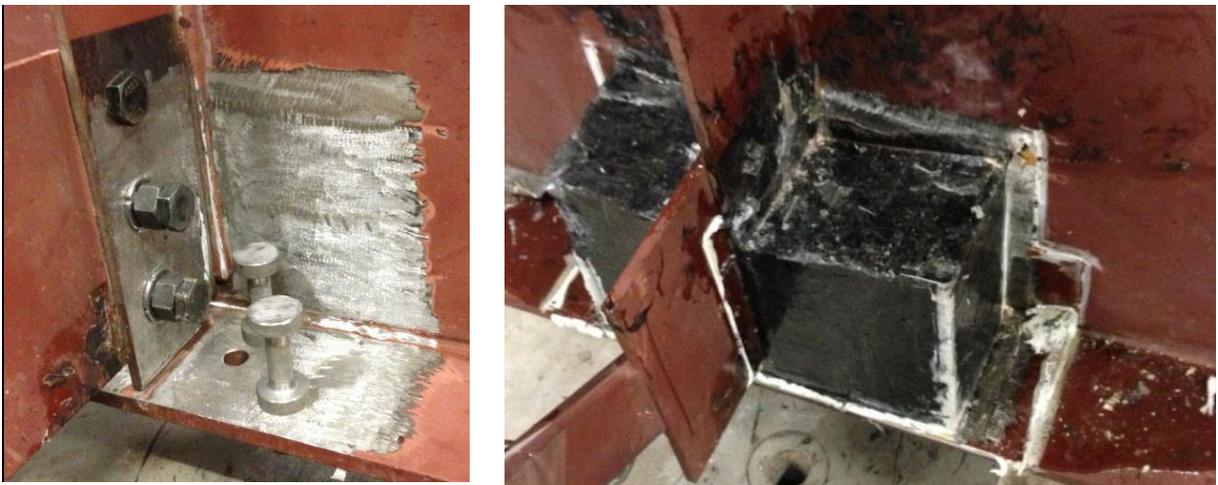
**Figure 4** Repair for girder subassembly 2 prior to and after casting CFRP block.

A second girder subassembly was retrofitted using CFRP blocks. For the second subassembly the surface was prepared by grinding the paint off the specimen in the region where the retrofit would be installed. Steel anchors were installed in the girder flange by drilling and tapping, to provide mechanical anchorage for the CFRP blocks (Fig. 4). Longer bolts were installed between the connection plate and the cross frame to improve the anchorage of the CFRP blocks to the cross frame. The resin system used in the CFRP blocks was a West System™ 105 Epoxy Resin and West System™ 209 Extra Slow Hardener mixed at a ratio of 3:1. The blocks had a 15% graphite fiber volume ratio. The blocks were fabricated according to the following sequence: first, the resin and the hardener were mixed together for 30 seconds with a drill-attached paint mixer. After mixing of the liquids, the fibers were slowly added and the composite was blended with a paint stick for a period of 5 minutes. After mixing, the composite was placed in the wooden forms with mold dimensions of 127 x 152 x 178 mm (5 x 6 x 7 in.). A 51 x 102-mm (2 x 4-in.) piece of timber was used to apply pressure on the block and compact it. Additional details regarding the fabrication technique is provided in Appendix B.

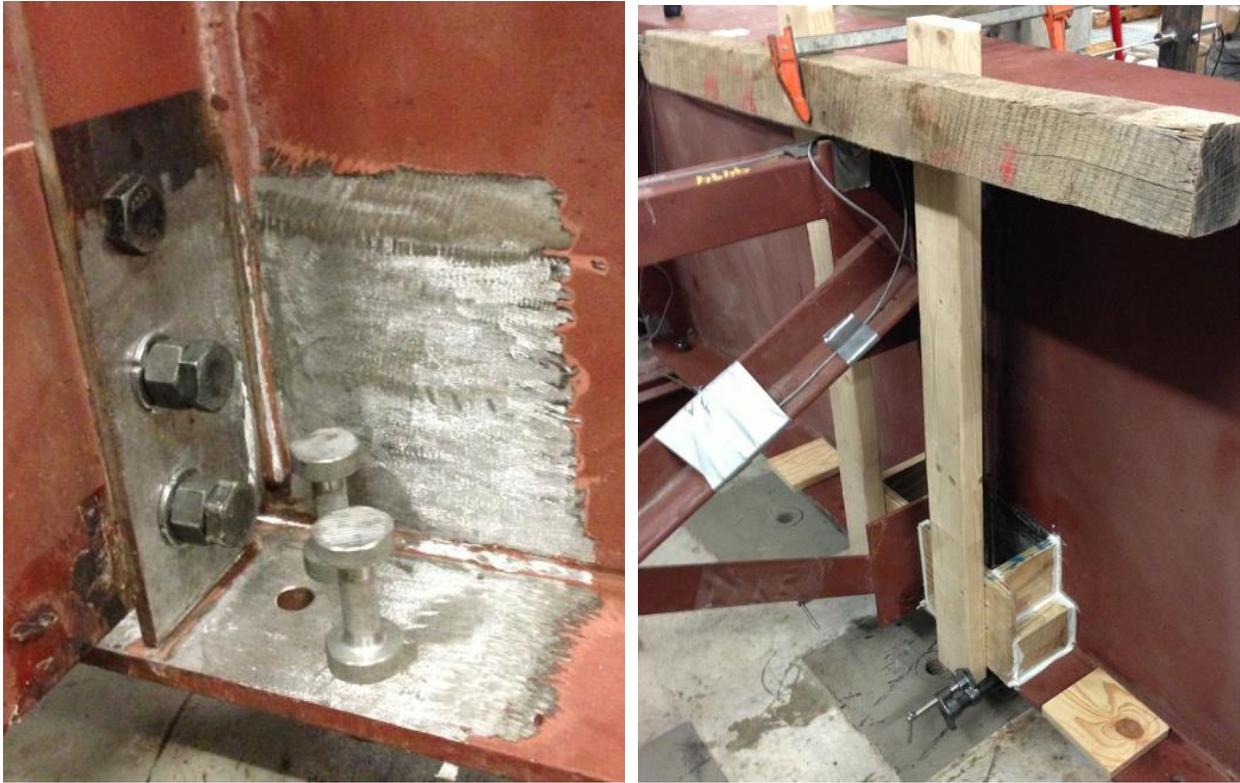
**Figure B 3: Web-gap region prepared for the composite block retrofit**

using a grinder to grind all of the paint off the specimen in the region where the retrofit would be installed. Figure B 2 shows a dimensioned plan view of the hole location where the studs were installed onto the bottom flange of the girder. The two bolts closest to the bottom flange which attached the cross frame's tab plate to the connection stiffener were removed. Bolts 25-mm (1-in.) longer replaced the two bolts which were removed and a nut with the threads drilled out was placed between the head of the bolt and the connection stiffener. This nut was used to create extra surface area for the CFRP to bond to. The studs were then bolted to the bottom flange. The bolts were fully-tightened as indicated by TurnaSure Direct Tension Indicator washers. The entire region was then cleaned with Acetone. The prepared web-gap region with the studs installed is shown in Figure B 3.

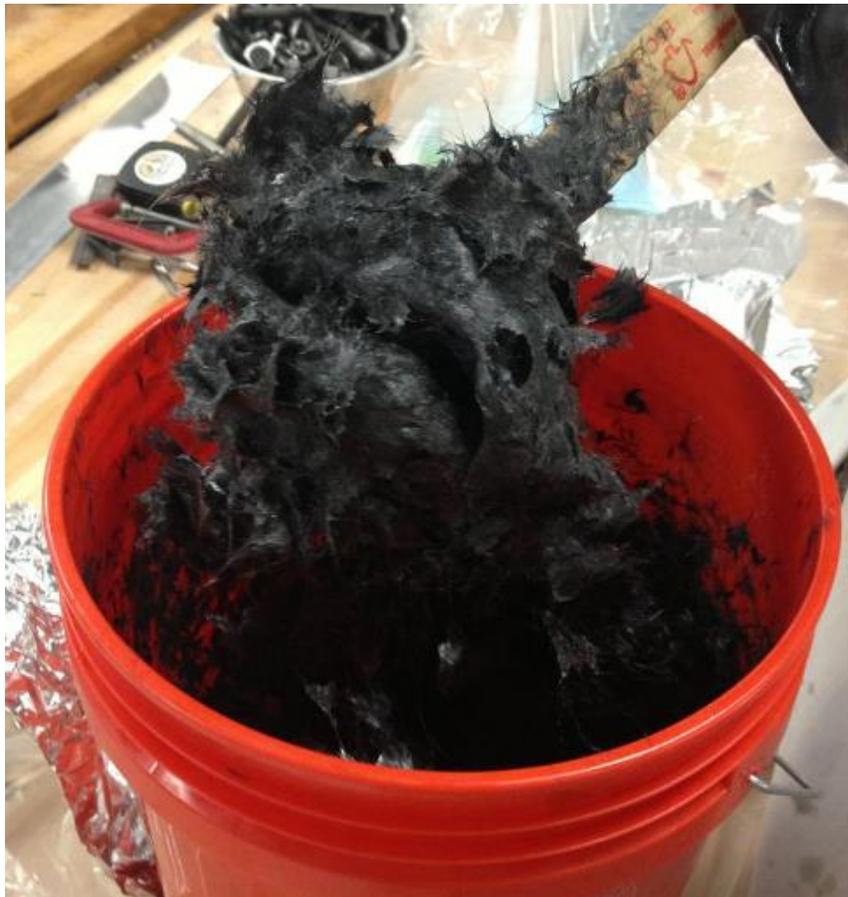
**Figure B 4: CFRP mixture after mixing**

After all materials were weighed out the resin and hardener was mixed together, a drill attached paint mixer was used to mix the two liquids together for 30 seconds. After the liquids were mixed the fibers were slowly added. A paint stick was used to mix the fibers and the epoxy together. After all fibers were added the composite was mixed for 5 minutes. Figure B 4 shows the composite mixture after five minutes of mixing.
