2 Girder-Deck Interface: Partial Debonding, Deck Replacement, and Composite
3 Action

4
5 Chaohui Li, Ph.D., IDC Consulting Engineers, Inc.

6 Rémy D. Lequesne, Ph.D., P.E., University of Kansas

7 Adolfo Matamoros, Ph.D., P.E., University of Texas at San Antonio

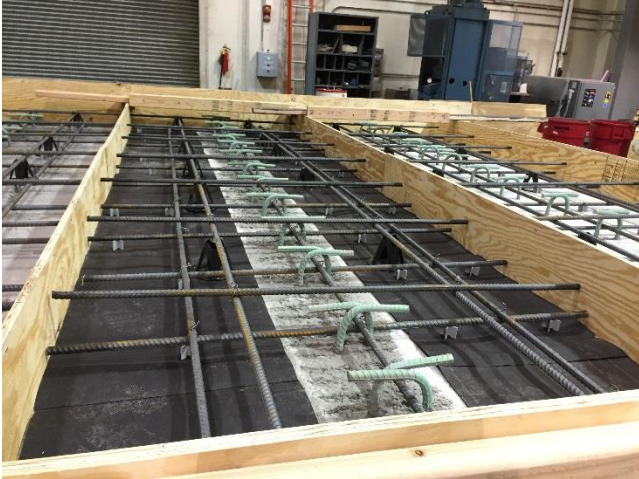
764 **Fig. 4.** Girder #2 prior to first concrete placement

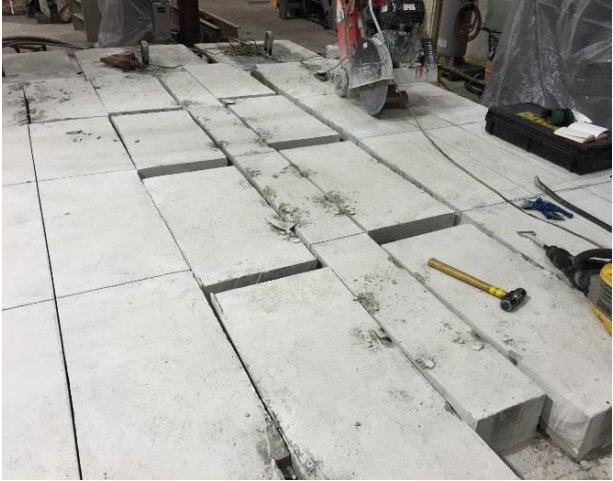
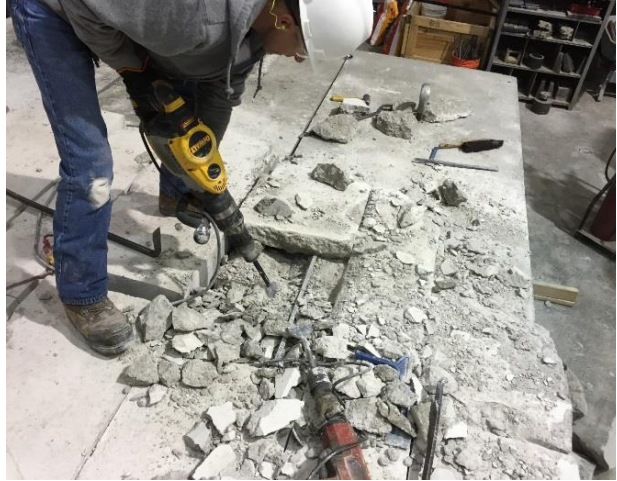
(a) Saw-cut decks and edge pieces over roofing felt (Girder #2)

(b) Edge sections on troweled flange (Girder #1)

765 **Fig. 5.** Deck removal

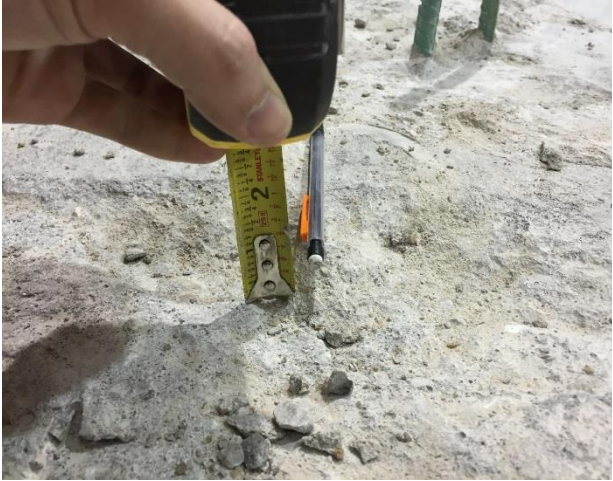
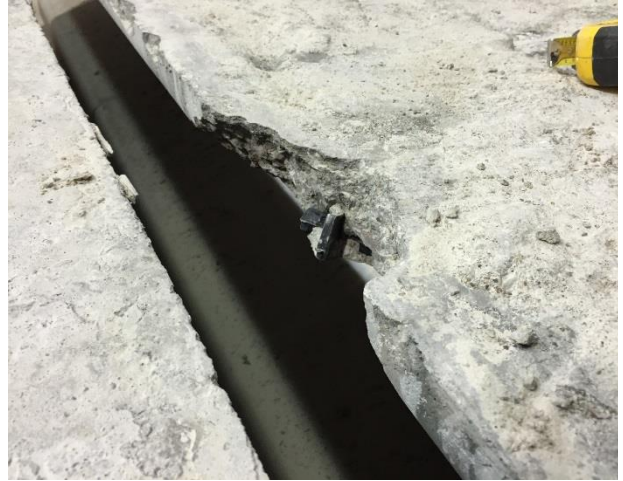
(a) Girder #1: Crater in girder top flange

(b) Girder #3: Broken flange tip

766 **Fig. 6.** Girder damage after deck removal

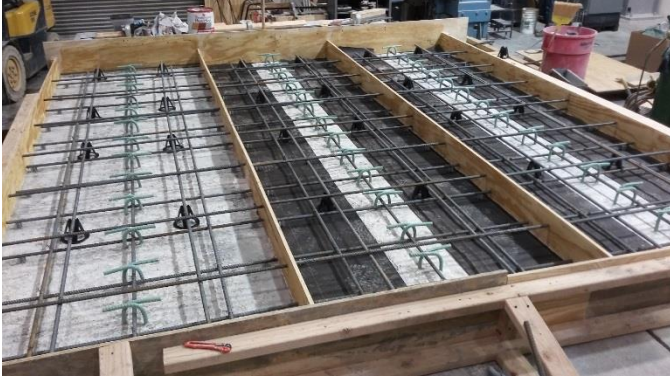
768 **Fig. 7.** Prior to second deck casting, Girders #3 to #1, left to right

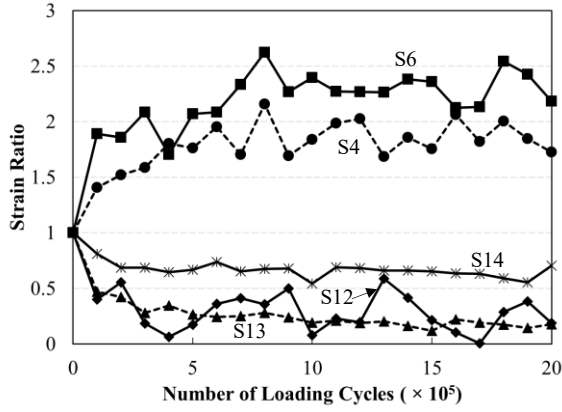
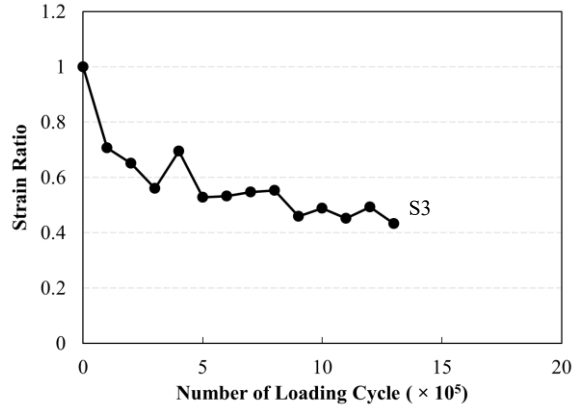
(a) Girder #1

(b) Girder #2

778 **Fig. 11.** Strain ratio versus number of loading cycles

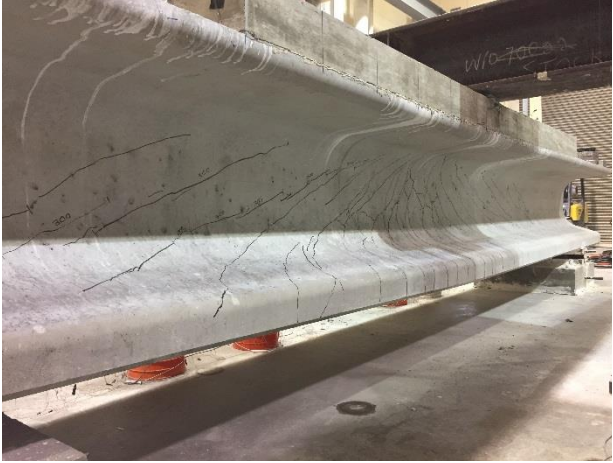
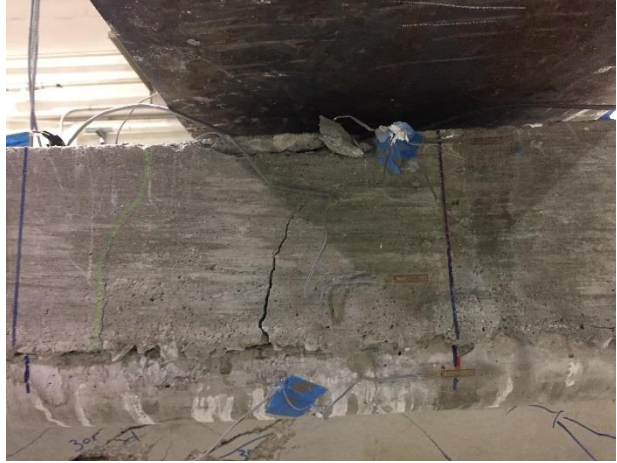
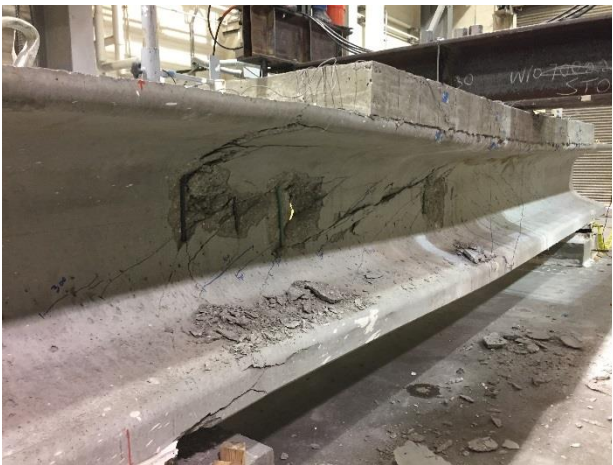
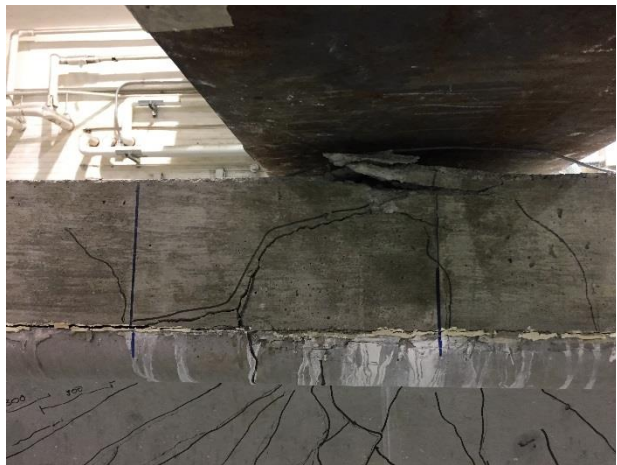
(a) Cracking at 1780 kN [400 kips] (Girder #2)

(b) Girder #1 near peak load

(c) Girder #1 after failure

(d) Compression zone failure (Girder #2, but also similar to the failure of Girder #3)

782 **Fig. 13.** Specimens during and after testing

509 After inclined cracking, force and deflection remained proportional until approximately
510 1800 kN [400 kips] of force, when flexural cracks were first observed (Fig. 13(a)). After flexural
511 cracks were observed, deflections increased at a much higher rate than force. Deflections greater
512 than approximately 25 mm [1 in.] were associated with negligible changes in force, indicating that
513 the strands were yielding. As shown in Table 5, Girders #1, #2, and #3 reached peak forces of
514 2420, 2560, and 2690 kN [545, 575, and 605 kips] at deflections of 36, 76, and 64 mm [1.4, 3.0,
515 and 2.5 in.]. It is reasonable that Girder #3 had the greatest strength given that it remained fully
516 composite throughout the tests. Girders #1 and #2 both had slightly less strength than Girder #3
517 because the deck was only partially composite at later stages of the test. Note that fully composite
518 action until failure need not be the aim in design. In practice stable composite action is only

522 The modes of failure were somewhat different among the specimens. At large deflections,
523 the deck on Girder #1 exhibited a wide flexural crack under the loading point (Fig. 13(b)) that was
524 not associated with underlying cracks in the girder top flange, indicating that the girder and deck
525 were not fully composite late in the test. At a deflection of 48 mm [1.9 in.], a sudden and explosive
526 web shear failure occurred on the east end of the girder (Fig. 13(c)) that caused inclined cracks to
527 extend through the bottom flange to the pin support and through the top flange of the girder near
528 midspan. Both Girders #2 and #3 were loaded until they exhibited compression zone failures in
529 the deck, at large deflections (Fig. 13(d) for Girder #2). Prior to failure, cracks in the deck near
530 midspan of Girder #2 were not connected to cracks in the girder top flange, and slip between the

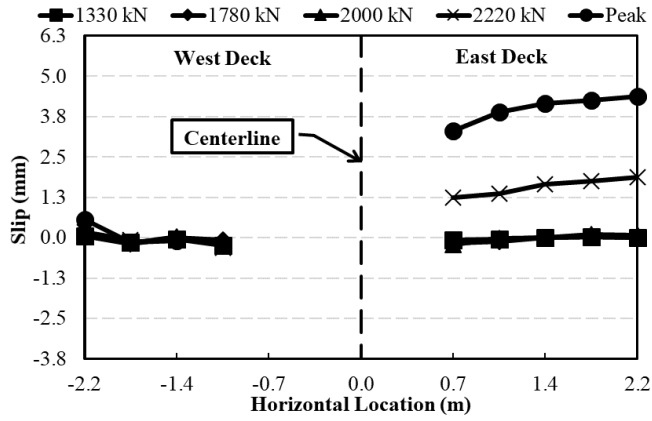
(a) Girder #1

783 **Fig. 14.** Distribution of slip over girder length [1 m = 1000 mm = 39.4 in., 1 kN = 0.225 kip]

547 The plotted data for Girder #1 (Fig. 14(a)) show that slip was small (less than 0.25 mm
548 [0.01 in.]) up to approximately 2000 kN [450 kips]. As the force increased to 2050 kN [460 kips],
549 the slip on the east half increased to between 0.5 and 0.8 mm [0.02 and 0.03 in.], indicating that a
550 crack likely formed along the interface. This is much larger than the critical slip of 0.13 mm [0.005
551 in.] identified by Hanson (1960) for monotonically loaded girders. Slip increased somewhat
552 proportionally with force until approximately 2200 kN [500 kips], beyond which slip increased
553 while force remained relatively constant due to flexural yielding. At peak strength the slip was as
554 large as 4.3 mm [0.17 in.] at the east end of the deck. Throughout the test, slip was much larger on
555 the east half of the girder than on the west half. On the west half of the girder, slip remained less
